**AIRCRAFT SERIOUS INCIDENT  
INVESTIGATION REPORT**

**SILVER AIR CORP.  
N 8 2 9 R A**

## LOSS OF CABIN PRESSURIZATION SILVER AIR CORP. BOMBARDIER BD-700-1A10, N829RA AT FL250 ABOUT 92 KM NORTH-NORTHEAST OF NAHA AIRPORT AT AROUND 18:09 JST, FEBRUARY 20, 2020

July 16, 2021

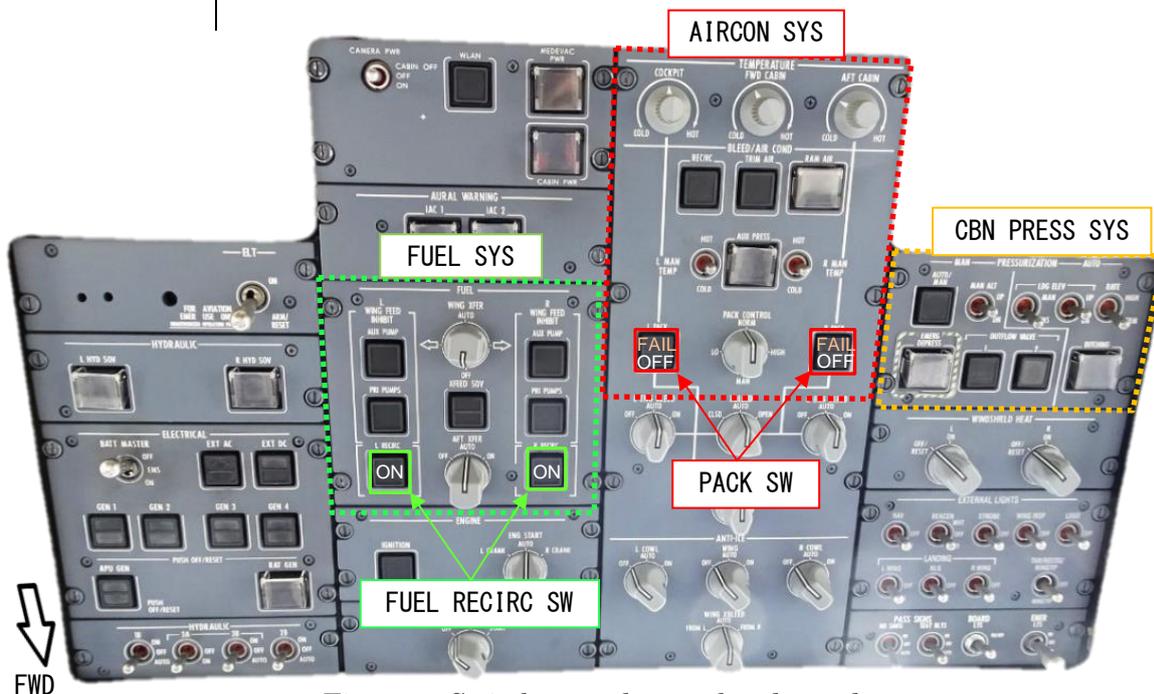
Figure 5: Switches on the overhead panel

The air conditioning system panel and the fuel system panel are located side by side on the overhead panel. These switches are similar in shape and size and action.

- (3) Fuel RECIRC and PACK switches are similar in placement and shape as well as operations, and according to the CVR records at 18:24, the flight crew member said a word about fuel recirculation system, therefore it is possible that the flight crew member was going to push “ON” the switches of fuel RECIRC system but erroneously pushed both PACK switches to position “OFF”.

- (1) Strict adherence to checklists and procedures during all phases of flight, especially in climb out and cruise, as was identified in this incident.
- (2) It was informed that it is important for a PIC to emphasis on Crew Resource Management (CRM) and crew communication is vital and will be briefed and emphasized during all phases of flight.
- (3) Review of fuel recirculation procedures on aircraft with manual fuel recirculation action, such as N829RA, crew shall do a thorough review of the fuel recirculation system to include limitations of such actions.
- (4) Re-emphasis the challenge and response items to various phases of the checklist to ensure proper cockpit switchology.

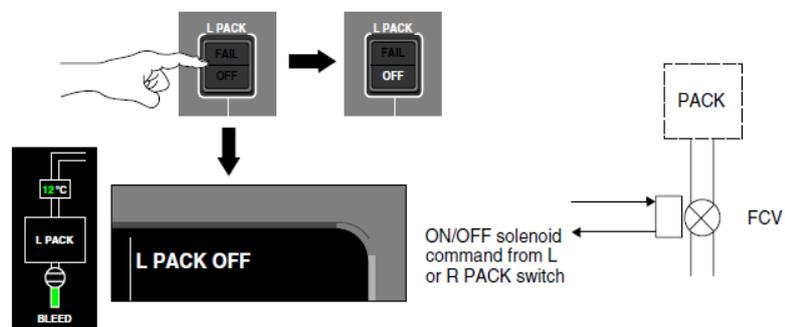
Figure 7: PACK operation

- “FUEL XFER ON” is indicates that the fuel transfer system is in the AUTO mode of operation. The wing transfer system provides a means of correcting lateral fuel imbalance.
- “TRIM AIR OFF” (Status\*<sup>6</sup>) is indicates when the Trim Air switch is set to position “OFF”, however, it is also indicated even when the Trim Air switch is set to position “ON”, if the switches of both PACKs are set to position “OFF”.
- “PACK OFF” or “L-R PACK OFF” (Status) indicates that the affected PACK has been selected OFF and the solenoid of the flow control valves (FCV) energized (Figure 7). The solenoids only energize when the PACK switches are selected “OFF”. If these switches remain “ON”, these message will not be displayed even if PACK is automatically stopped (described later in 2.7(5)).

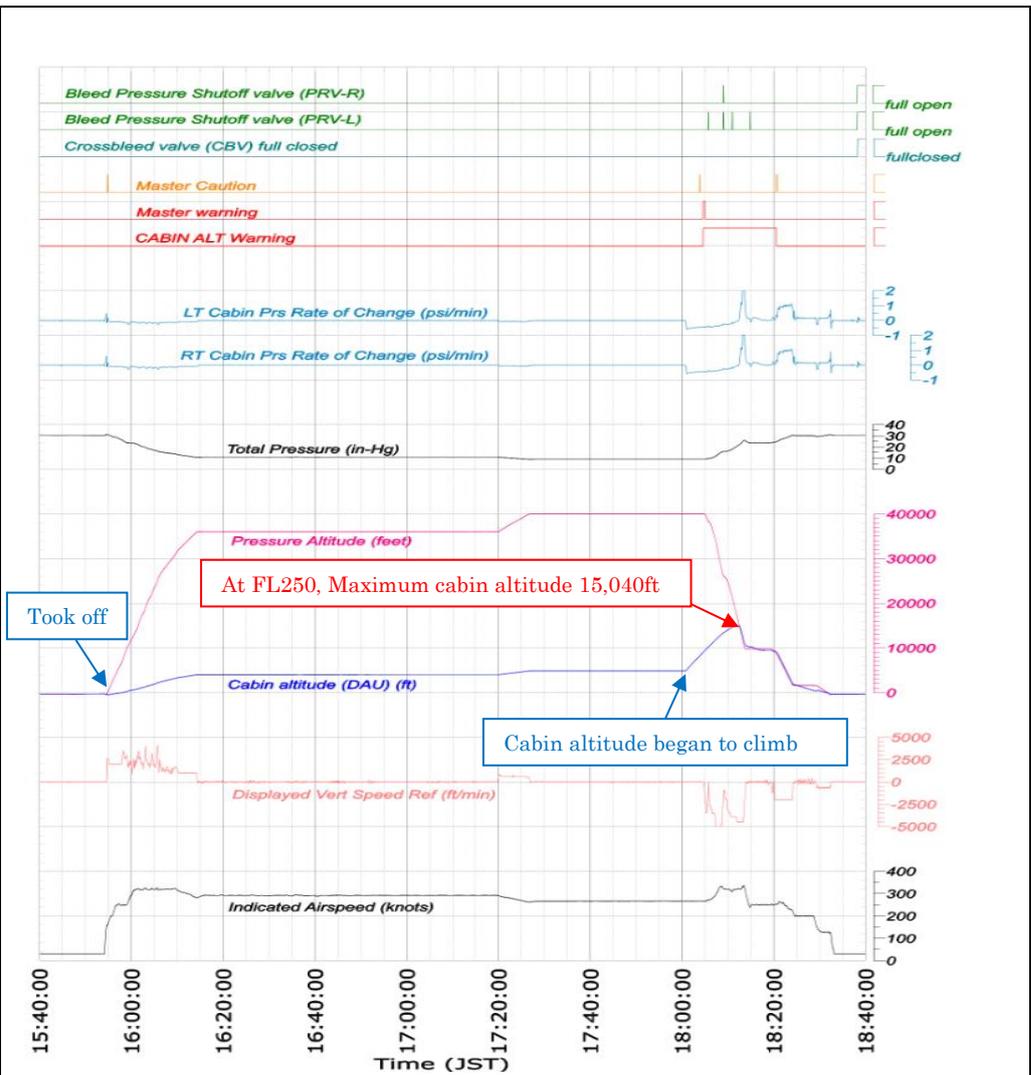
Figure 8: DFDR records

According to DFDR records, around 18:00, the cabin altitude began to climb. Any other records indicating the abnormality of the aircraft were not recognized.
