AIRCRAFT ACCIDENT INVESTIGATION REPORT

ASB FLYING CLUB
SUKHOI SU-26, RA2821K
A CRASH TO THE GROUND
AERIAL CIRCUIT IN MOTEGI TOWN, HAGA COUNTY,
TOCHIGI PREFECTURE, JAPAN
OCTOBER 31, 2003

July 30, 2004

Aircraft and Railway Accidents Investigation Commission
Ministry of Land, Infrastructure and Transport

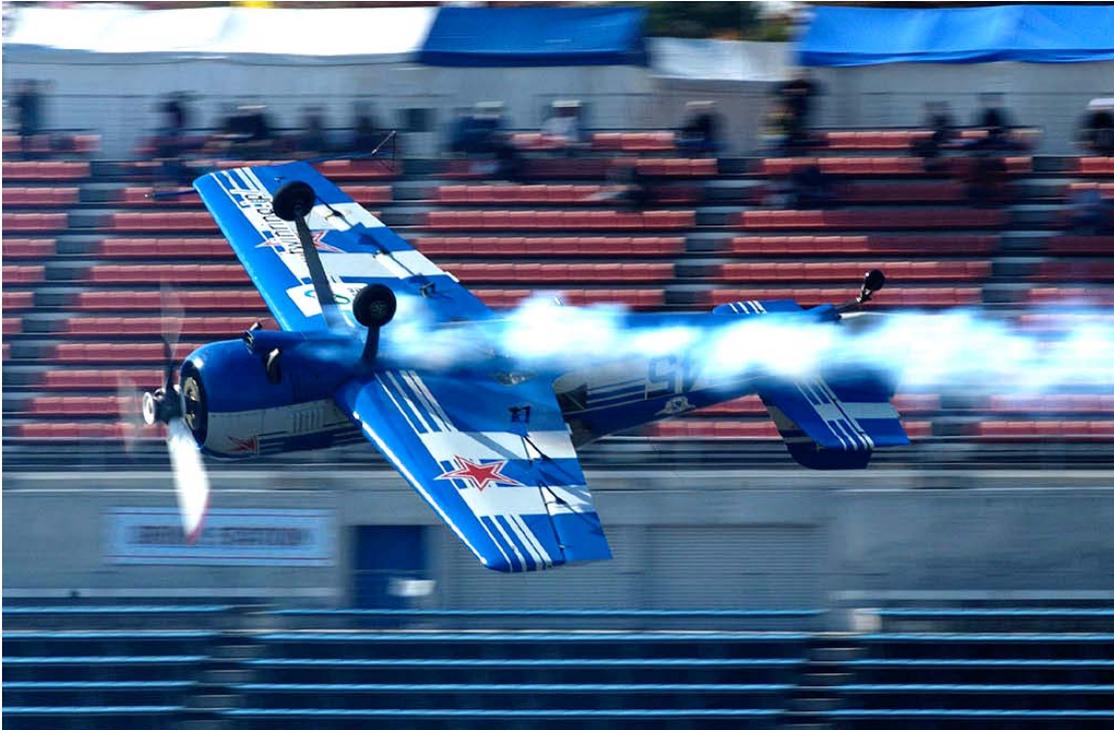
Photograph 1 Immediately before the Collision

After entering the course, when the aircraft had rolled inverted in level flight and was wings level, after the aircraft's right wing lowered (viewed from behind) and it moved to the right side of the course, then its left wing lowered and its flight direction changed from rightwards to leftwards (viewed along the course centerline). The aircraft began to climb as its left wing lowered and then just before the gate it began to descend.

Because the aircraft flew diagonally across the course to the left with its left wing lowered and it continued to descend after passing through the gate, the aircraft collided with a flood light stay and other obstructions located around 60m from the left pole of the gate in the direction of travel while inverted and crashed.

It is estimated that because the aircraft had deviated to the left of the course as a result of flying across the course in a banked attitude, and because it was in a steep descent attitude just before the tape, the Captain raised the aircraft's nose in front of the lighting pole, but it was too late and the aircraft collided with the flood light stay, which was 5.4m lower than the poles from which the tape was stretched, and other obstructions near the left of the course, in inverted flight and crashed.

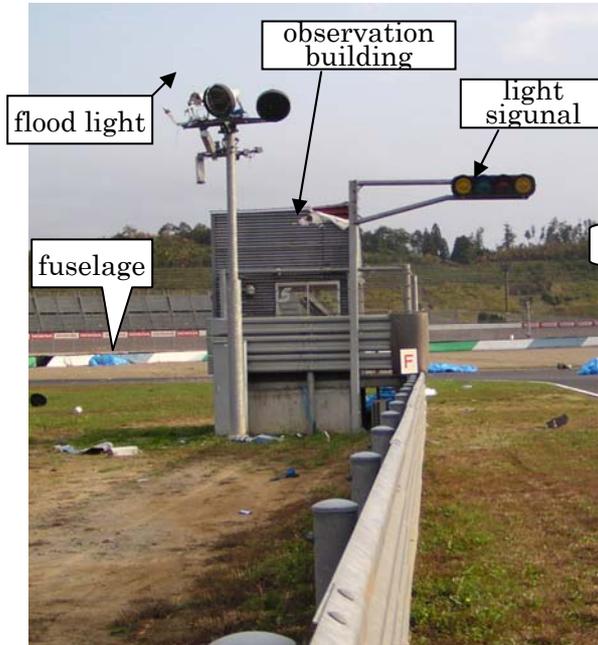
Photograph 3

A flood light stay, a light signal stay and the roof of a small observation building were damaged.

The accident site was located in the Twin Ring Motegi Auto Racing Circuit. Two of the four lights on the flood light stay which the aircraft collided with were damaged, and the arm to which the lights were attached was rotated 180 degrees horizontally. A signal pole located around 2m from the lighting pole's course side was slightly inclined in the aircraft's direction of travel, part of the roof of a neighboring observation building was damaged and a horizontal stabilizer had fallen near the observation building. There were several score marks on the asphalt surface of the racetrack caused by propeller strikes around 50m from the observation building in the aircraft's direction of travel. Traces attributed to collision with aircraft's nose and canopy were found on the shock-absorbing crash barrier made of piled tires that surrounds the racetrack around 100m from the observation building in the aircraft's direction of travel.

Flood light stay
Light signal stay
Observation building

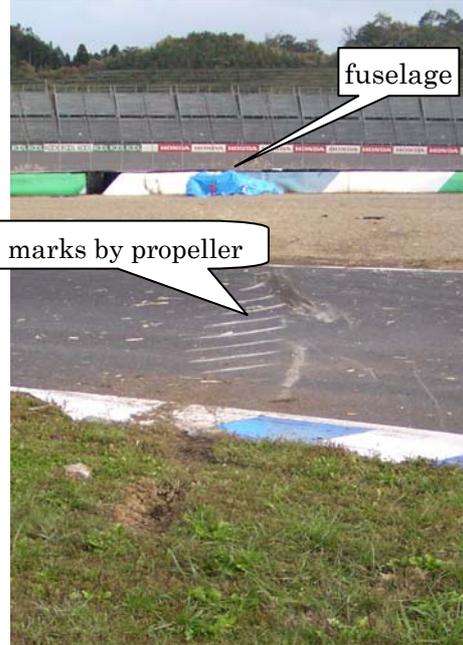
Photograph 4

The aircraft's fuselage came to rest around 5m in front of the crash barrier, and the left wing separated at the root and came to rest around 10m from the fuselage in the aircraft's direction of travel. The wooden propeller was broken into small fragments, and aircraft debris was scattered over an area around 35m wide and around 75m long in the direction of travel from near the flood light stay.

Score marks
by propeller

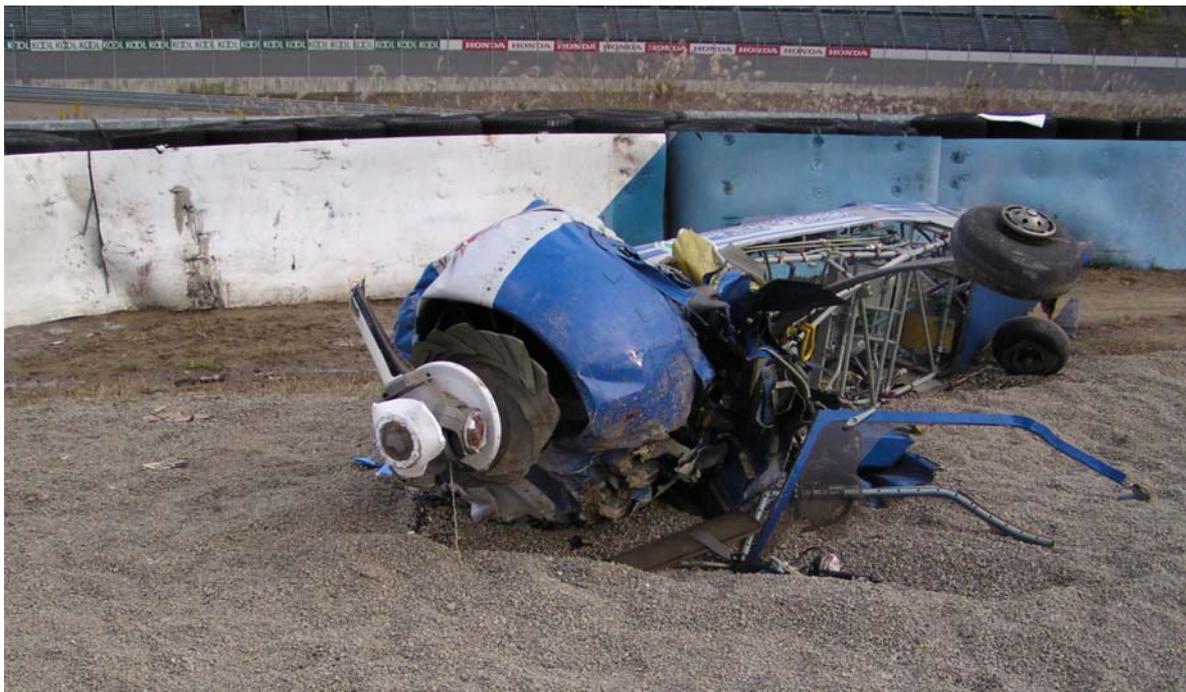
Photograph 5 Accident aircraft(Fuselage)

The aircraft was severely damaged.

| Wings: | Right wing: broken at the mid span and at the root Left wing: severed at the root. |
| Vertical stabilizer: | Broken off at the root and at upper portion. |
| Propeller: | All three wooden propeller blades were destroyed, breaking into small fragments. |
| Landing gear: | The right main gear was severely damaged by bending. The tail wheel was damaged. |

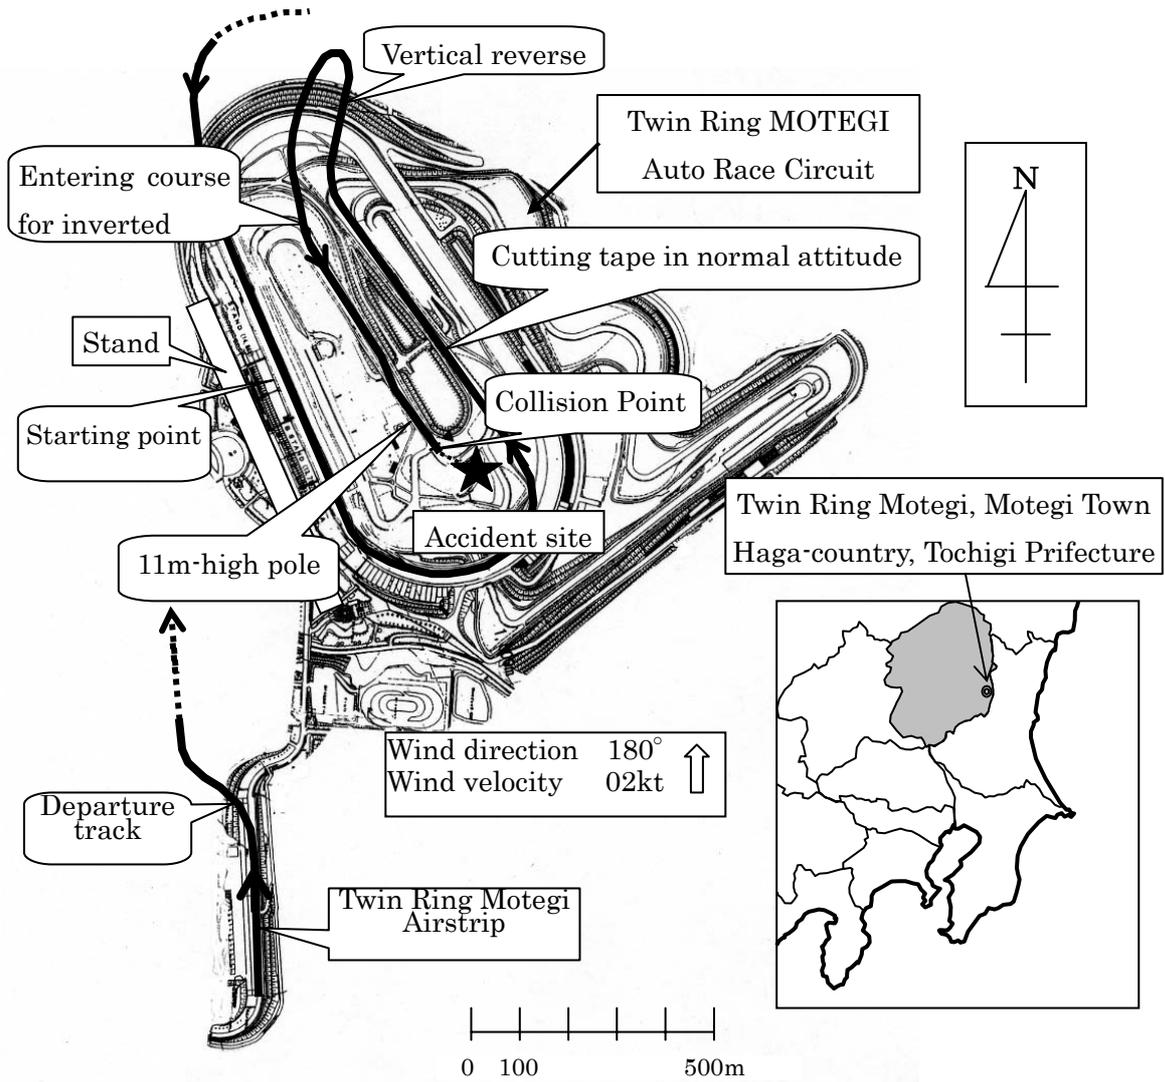
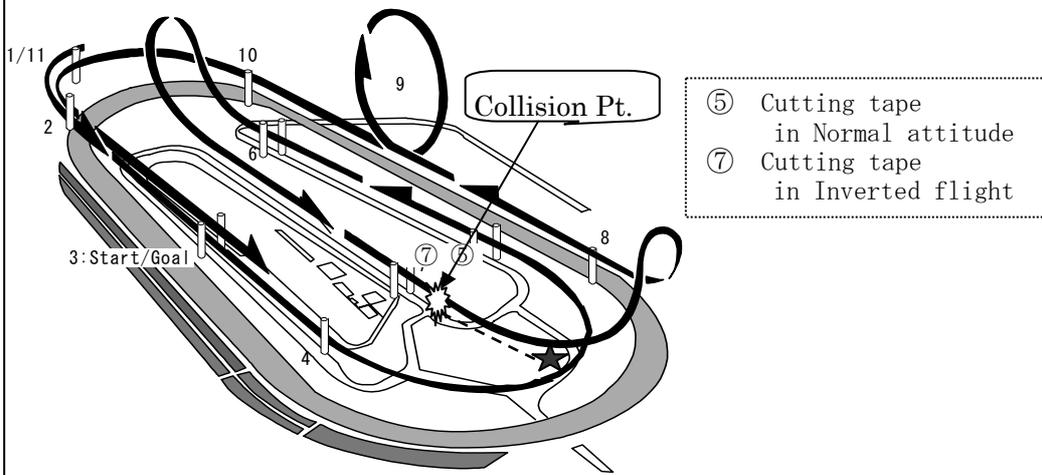
Figure1 Estimated Flight Path

After succeeding in cutting the first tape by passing through the gate in a normal flight attitude, the aircraft performed vertical reverse and then made a steep descent to enter the course for the next gate to cut the tape in inverted flight (Refer Figure 1 (7).)

3.1.4 As described in section 2.11, the aircraft performed vertical reverse and entered the course in level flight just above the course centerline, and then become inverted by rolling to the right. It is estimated that the aircraft deviated to right from of the course centerline at that time because the right side wing was lowered (viewed from rear). After that, it is estimated that the aircraft recovered to wing levels and then in order to align with the course, the left side wing was lowered (viewed from rear), and at the same time the aircraft started to climb.

The aircraft climbed to a height of around 20m while flying inverted from the right to the left of the course. After that, it is estimated that the Captain sighted the target tape in front of him and aiming for it, he descended while flying diagonally across the course.

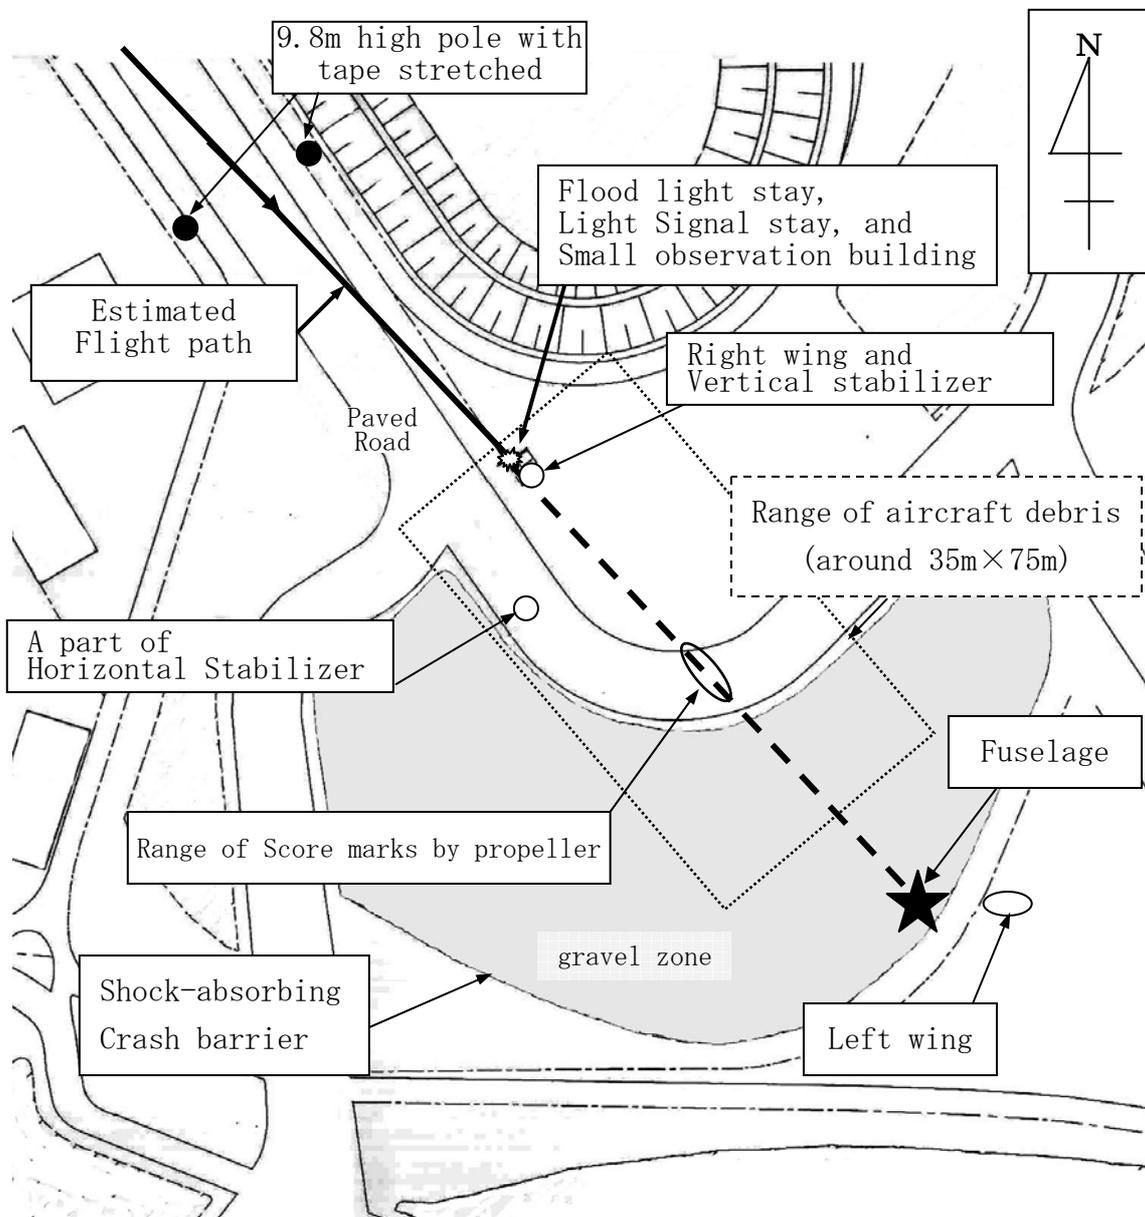
Figure 2 Topography of the Accident Site

The inverted flight portion of the air race course was set to be 200m away from the stand of the circuit.

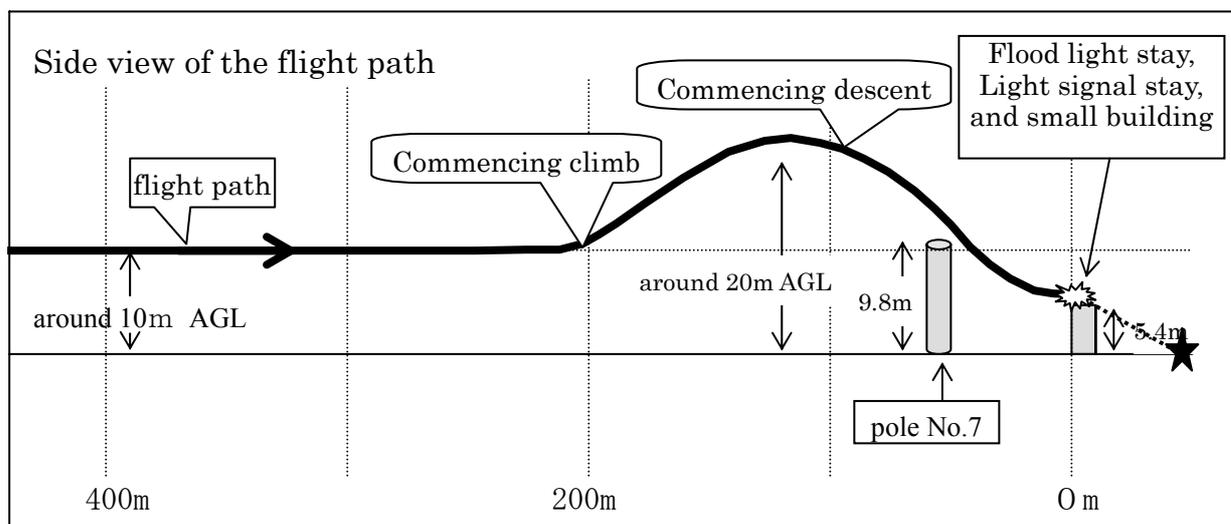
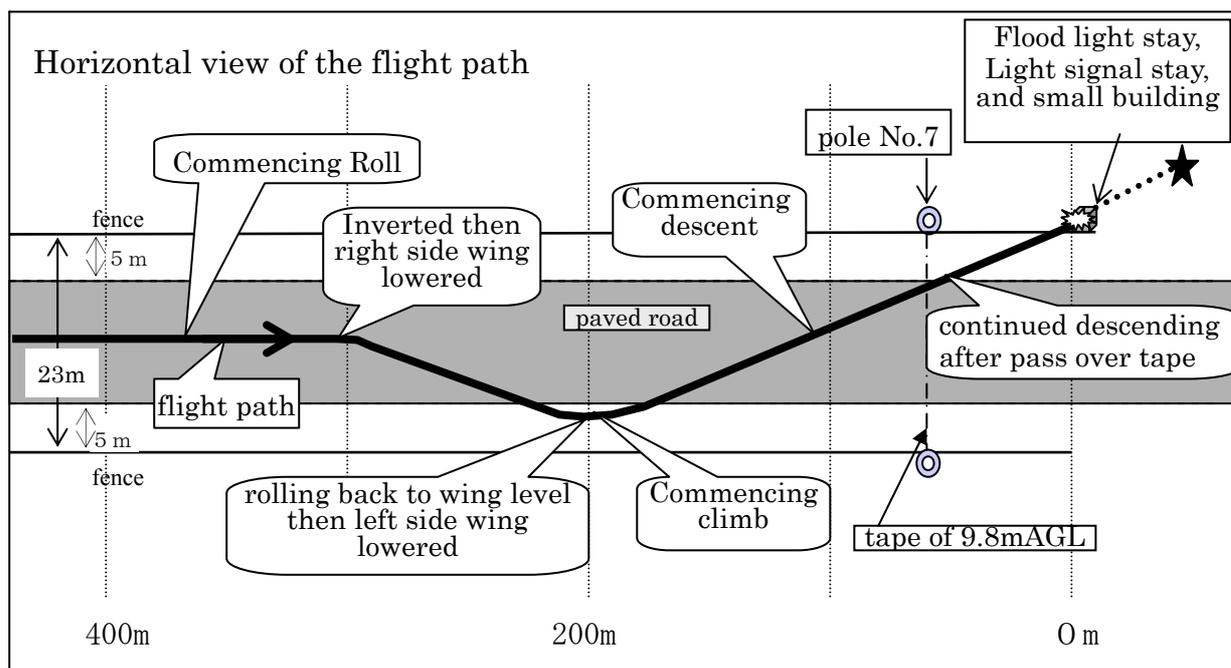
Figure3 Analysis of Estimated Flight Path

The aircraft entered the course just above the centerline of paved road at a height of around 9.8m above the ground. The aircraft rolled to the right at 1030:40, and became inverted at 1030:40.5, at which time it was around 10m above the ground. Viewed from behind, once the aircraft had become inverted the right side wing lowered and it started to deviate right of the course centerline. At 1030:42.0, viewing along the direction of travel, the aircraft entered the non-paved zone at the right side of the road, and after rolling back to wings level, the left side wing lowered viewed from behind the aircraft, and at a time the aircraft started to climb. At 1030:43.4 the aircraft reached an altitude of around 20m above ground.

Thereafter, the aircraft started to descend with the left side wing lowered viewed from behind from around 60m before the gate, and at 1030:44.3, it passed over the tape stretched 9.8m above ground at the gate slightly to the left of the course centerline. The aircraft continued descending after passing the gate with the left side wing lowered (viewed from the rear), flew diagonally across the course and deviated from the course to the left. Although the aircraft’s nose lifted just before the lighting pole, at 1030:44.9 its right wing struck the flood light stay at a height of 5.6m above the ground a distance of 60.5m from left side pole exit gate pole in the direction of the travel. The root of the tail wing then collided with a 5m-high light signal stay, and the aircraft crashed.

The aircraft’s average airspeed during the time from level flight before starting to roll until striking the flood light stay was 270km/h (approx. 75m/s), the time between starting to climb until the first collision was around 2.8 seconds, and the flight distance was around 200m.

At the time the aircraft entered the course it was flying level at a height of around 10m above the course centerline. Although the aircraft should have then maintained this height, as a result of considering that it then climbed to a height of 20m against the Captain's first intention, it is estimated that the Captain made an abrupt descent in order to cut the tape stretched at a height of 11m above ground in front of him. Moreover, regarding the fact that the aircraft descended while flying across the course in a banked

attitude, it is estimated that because the Captain was concentrating on cutting the tape, he had reduced awareness that the aircraft was banked and deviating to the left.
