AIRCRAFT ACCIDENT INVESTIGATION REPORT

QANTAS AIRWAYS FRIGHT 70
AIRBUS INDUSTRIE A330-303
REGISTRATION VH-QPE
ON TAXIWAY OF KANSAI INTERNATIONAL AIRPORT, JAPAN
AUGUST 21, 2005 AT ABOUT 00:58 JST

March 28, 2008

Aircraft and Railway Accidents Investigation Commission
Ministry of Land, Infrastructure and Transport

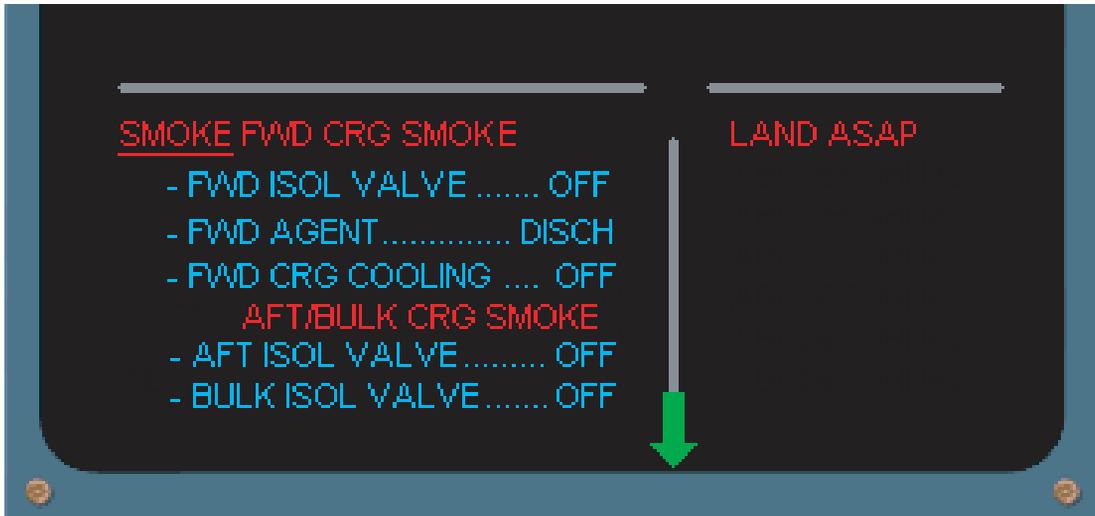
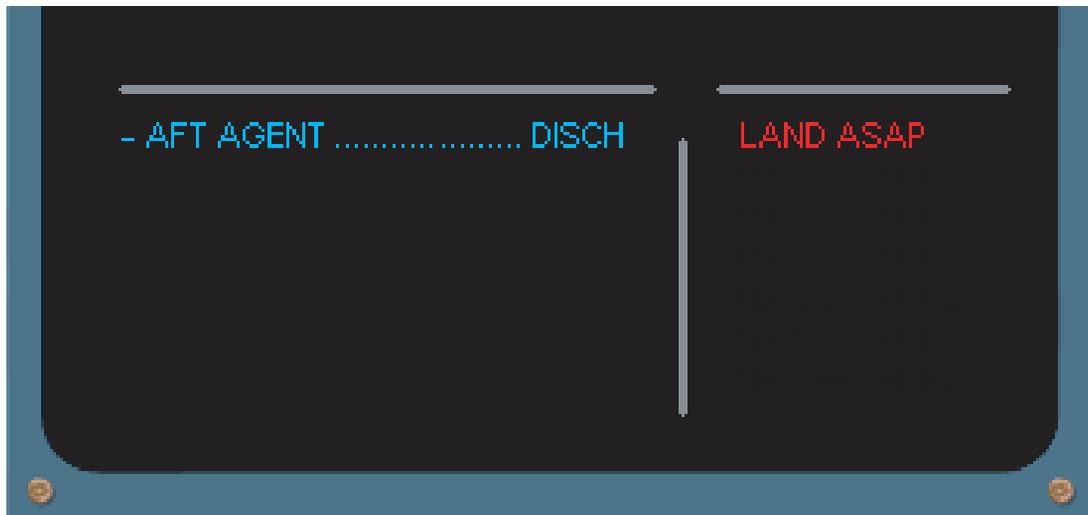
Figure 3 Indication of ECAM Display
(Smoke Warning)

remark:simultaneous smoke warning for forward
and aft cargo compartment
(Provided by the Airbus)

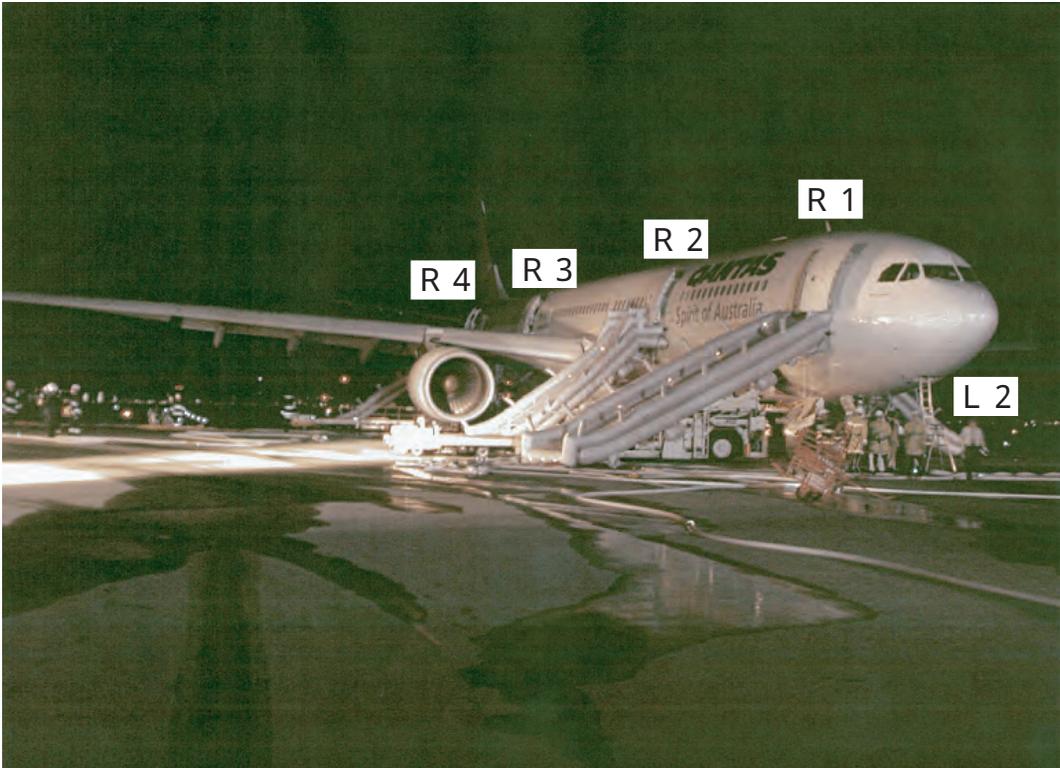
Photo 2 The Aircraft (deployed emergency escape slides)

The accident site is located at the intersection of Taxiway C and Taxiway P at Kansai International Airport. The aircraft was at a stop facing the passenger terminal complex, with its heading at 330°. Of the eight escape slides with which the aircraft is equipped, seven slides were found to have deployed normally, but the one at Door L1 had not deployed and the door was slightly opened.

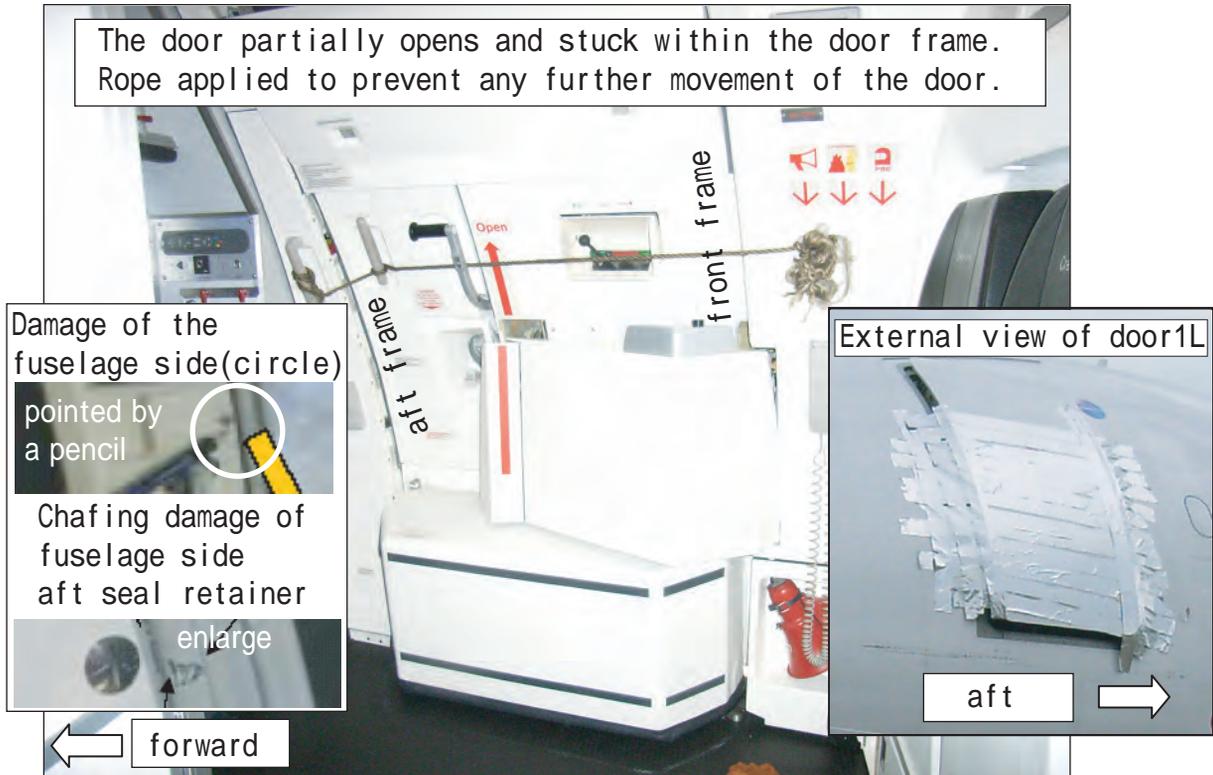
Photo 3 View of L1 door jammed within the frame
 (Two small pictures depicting contact damages
 are quoted from Airbus investigation report)

- ① The door was found approximately 8 cm open from the closed position and was

- ② While the door was mechanically armed, the door arming handle was found moved to the disarmed position from the armed position.
- ③ The slide girt bar was found attached to the floor fittings on the door frame. The slide was still in the container inside the door.
- ④ The charge level of the door assist actuator was approximately 25% of the specified level. When the filling valve nut on the door assist actuator was loosened to slightly release pressure, the door automatically opened and the escape slide deployed normally.

Door L1 jammed during the automatic opening cycle due to physical interference between the locking washer for door stop T3 and the fuselage side aft seal retainer. This was caused by the locking washer whose end was not having been fully bent and thus protruded approximately 1.5 mm compared to other locking washers. It was confirmed that the locking washer was not fully bent when it was fabricated. During normal opening and closing movements of the door, the door and the aft frame do not interfere with each other even with insufficient clearance between them. However, during automatic opening sequence of the door in emergency evacuation, the operation of the actuator slightly displaces (aft, approximately 1.5 mm) the door, and this resulted in the interference mentioned above.

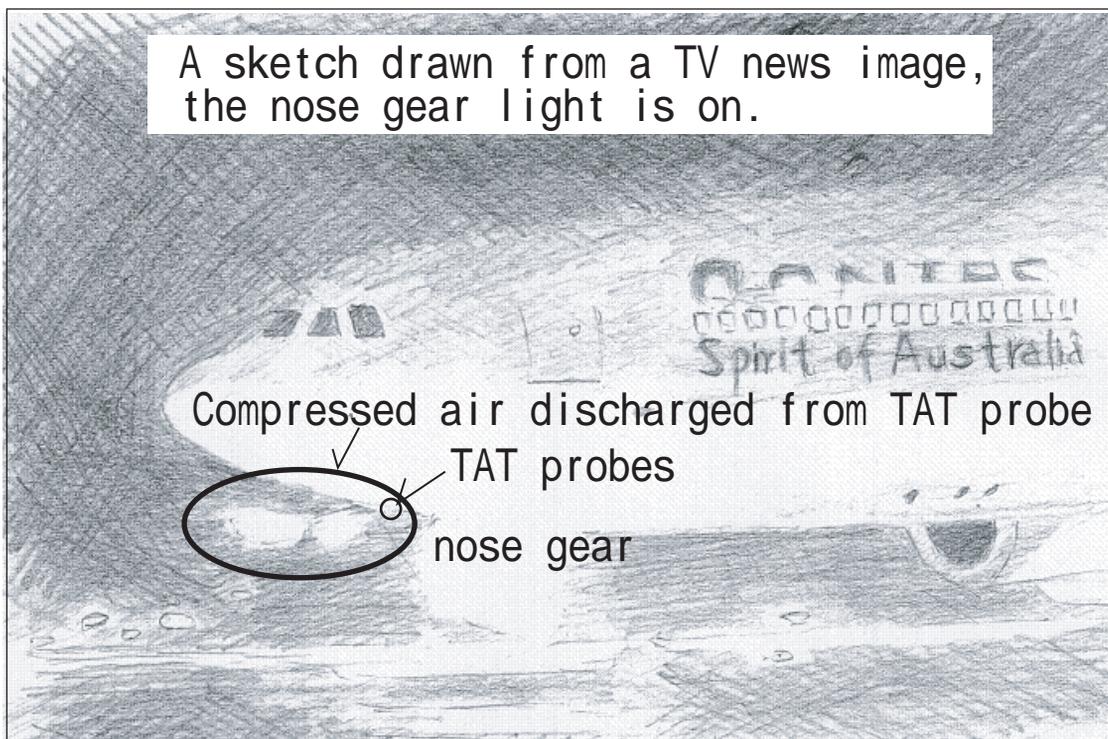
Photo(sketch) 5 Compressed air discharged from TAT probe

As described in 2.7, relative humidity was high, according to the meteorological observations at Kansai International Airport at the time of the accident. It is estimated that the white smoke observed by fire services was made from compressed air, which was discharged from the TAT probe nozzles, cooled by adiabatic expansion, then condensed the moisture in the air into something like fog.

It is estimated that the foggy bleed air coming out of the TAT probes was blown forward of aircraft under this wind condition and appeared as if white smoke was coming out from the nose.
