MA2012-7

**MARINE ACCIDENT
INVESTIGATION REPORT**

Japan Transport Safety Board

Accident Type	Fatality during mooring operation																		
Date and Time	At about 1005 (local time, UTC+9), on January 11, 2011																		
Location	South Berth A, Funabashi Chuo Wharf, Katsunan District, Chiba Port, Chiba Prefecture. Approximately 076° true, 2.0 nautical miles from Chiba-ko Katsunan Ichikawa Lighthouse. (Approximately 35° 40.5' N, 139° 58.4' E)																		
Summary of the Accident	While the cargo ship EN KAI was berthing at South Berth A, Funabashi Chuo Wharf, a tensed mooring rope suddenly bounced and struck the chest of a boatswain working on the forecastle deck. The boatswain was killed. (Photo 1: Whole View)																		
Process and Progress of the Investigation	(1) Set up of the Investigation The Japan Transport Safety Board appointed an investigator-in-charge and another investigator to investigate this accident on January 12, 2011. (2) Collection of Evidence January 12 and 13, 2011: On-site Investigations and Interviews. January 14 and 17, 2011: Interviews. (3) Comments from Parties Relevant to the Cause Comments on the draft report were invited from par

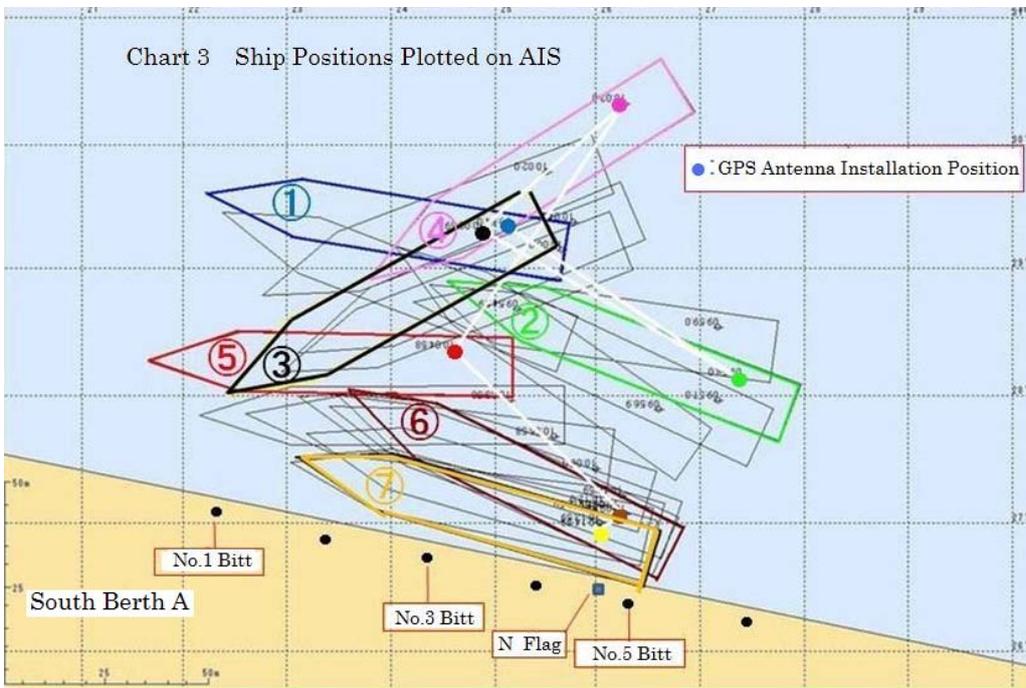
Chart 3 Ship Positions Plotted on AIS

※ Time Column ①~⑦ link to Ship Position in Chart 3 (Ship Positions Plotted on AIS)

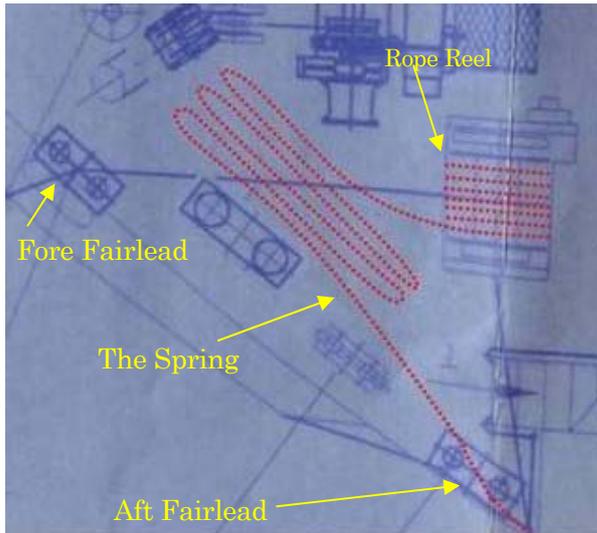
Chart 4 Snake Down Coil of the Spring

<p>coil on the deck.</p> <p>He then passed the end of the spring line through the fairlead located aft the port side (hereinafter referred to as “the aft fairlead”) on the forecastle deck.</p> <p>(Chart 4: Snake Down Coil of the Spring)</p> <p>The Chief Officer planned to put the Spring through the roller of the fore fairlead on the port side on the forecastle deck (hereinafter referred to as “the fore fairlead”) after the Spring was secured on No.3 bitt.</p> <p>(Chart 5: Layout Plan of head line and spring line)</p>
<p>Situation surrounding the Occurance of the Accident</p>	<p>As the ship was just about to approach the Berth A, the Master who was conning from the port side wing, stopped the ship and casted the starboard anchor. (Chart 3 ①)</p> <p>As the bow approached about 20m on the Berth A (Chart 3 ③), the Chief Officer instructed the crew to throw the heaving lines of the head line and the Spring to the Berth A. And then Chief Officer confirmed that the head line’s eye was secured on No.1 bitt.</p> <p>While the Spring coiled on the deck was being let out from the aft fairlead, it was found to be 1~2m shorter than needed to reach No.3 bitt. So the Chief Officer instructed the AB A to reel out more of the Spring from the rope reel.</p> <p>The rope reel started to spin, but immediately and unexpectedly stopped. The Chief Officer reported it to the Master by a transceiver.</p> <p>Since the ship had proceeded a little forward of the intended berthing position, the Spring was not able to reach the Berth A, and the Chief Officer reported that the rope reel stopped, then the Master ordered the engine slow astern.</p> <p>The Spring was secured on No.3 bitt while the ship continued astern propulsion.</p> <p>The Chief Officer saw the boatswain who operating the windlass, went down the starboard side stairway of the forecastle deck. After that the rope reel started to spin again, the Chief Officer thus thought that the boatswain had managed to recover the operation of the hydraulic pump after going to the hydraulic pump room beneath the forecastle deck.</p> <p>Thus the Master ordered the engine slow ahead in order to readjust the berthing position slightly. (Chart 3 ④)</p> <p>Since the ship was proceeding at a speed of approximately 0.51 m/s that was faster than the reeling-out speed of the Spring (Nominal Speed: first layer approximately 0.25m/s), the Chief Officer could not put the Spring through the fore fairlead due to the insufficient length of the Spring.</p> <p>The Chief Officer saw the boatswain went up the port side stairway of to the forecastle deck. And then while the Chief Officer was watching the condition of all the mooring lines, all of a sudden, he heard a sound around the rope reel. He found the boatswain lying down on the port</p>

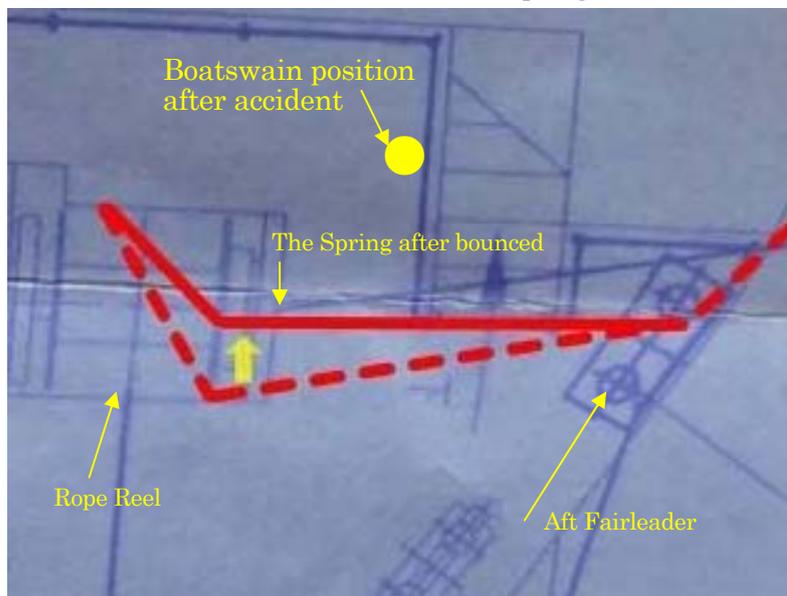
Chart 6 The Situation of the Bounced Spring

<p>side, behind the rope reel. (Chart 3 ⑤, Chart 6: The Situation of the Bounced Spring and Photo 2: The Scene Situation of the Bounced Spring)</p> <p>The ship agent standing at the Berth A witnessed a crew member being thrown up into the air at about 1005, and thought that he might be injured. The ship agent informed the Master of the accident by cellular phone, and at about 1011 informed the fire station.</p> <p>The ship arrived alongside the Berth A at about 1015. (Chart 3 ⑦)</p> <p>The ambulance arrived at about 1026.</p> <p>The boatswain was taken from the vessel at about 1056 hrs accompanied by the doctor arrived at the ship at about 1038 to the hospital at about 1117. Despite medical treatment, the boatswain died at about 1210.</p> <p>According to the death certificate, the cause of the death of boatswain was a massive hemothorax resulting in a tension pneumothorax.</p>
Other matters	<p>(1) According to the AB B, usually, before throwing the heaving line to a berth, the Spring was put down on the deck in a snake down coil. After throwing the heaving line to the berth, the mooring gang engaging in the mooring work secured the end of the line onto the bitt, then the boatswain directed the AB to send out or reel back the rope. the Spring line was then put through the fairlead.</p> <p>(2) The boatswain was wearing a helmet and his proper working uniform.</p>

No.3 bitt and then the ship proceeded faster than the reeling-out speed of the Spring, therefore the Spring could not be put through the fore fairlead, as a result, the Spring bounced due to sudden tension and struck the boatswain's chest who stood near the Spring.

Weather and Sea Conditions	<p>Weather : fine, wind direction NW. wind force 5, good visibility</p> <p>Sea conditions : wave height unknown</p>
Analysis	<p>(1) It is probable that the Spring was to be put through the fore fairlead after the Spring was put in snake down coil on the deck to prepare for berthing and the end of the Spring was secured on the bitt.</p> <p>(2) It is probable that while the ship was berthing at the Berth A in Chiba Port, where the Master ordered the engine slow ahead to slightly readjust the berthing position after the Spring was secured on No.3 bitt and then the ship proceeded faster than the reeling-out speed of the Spring, therefore the Spring could not be put through the fore fairlead, as a result, the Spring bounced due to sudden tension and struck the boatswain's chest who stood near the Spring, which resulted in his death from a massive hemothorax.</p> <p>(3) It is possible hat the Spring was caught by something under the rope reel when it became tense as the Spring was not put through the fore fairlead and then the Spring bounced after it was suddenly released from under the rope reel.</p> <p>(4) It is possible that this accident could have been avoided if the Spring had been put through the fore fairlead.</p>
