MARINE ACCIDENT INVESTIGATION REPORT

Adopted by the Japan Transport Safety Board

ACCIDENT TYPE	Grounding
DATE AND TIME	Around 22:08, July 14, 2014(local time, UTC-7 hours)
LOCATION	Offshore southwest of Prince Rupert Port in British Columbia, Canada Vicinity of 166° true bearing, 0.7 nautical miles (M) from Gull Rocks Lighthouse (approximately 54°07.30'N, 130°31.04'W)
PROCESS AND PROGRESS OF THE INVESTIGATION	On July 23, 2014, an investigator-in-charge from the Yokohama office and one other investigator were appointed to investigate this accident. Opinions on the draft report were invited from parties relevant to the cause of the accident. Comments on the draft report were invited from substantially interested state.
FACTUAL INFORMATION VESSEL TYPE AND NAME, GROSS TONNAGE VESSEL NUMBER AND OWNER LxBxD AND HULL MATERIAL ENGINE, OUTPUT, DATE OF LAUNCH	Cargo ship AMAKUSA ISLAND, 44,547 tons 141294 (IMO Number 9303900), IINO KAIUN KAISHA, LTD./KYUDEN SANGYO CO., INC. (ship owner), IINO MARINE SERVICE CO., LTD. (ship management company) 228.00m x 36.50m x 19.13m, Steel Diesel Engine, 9,966kW, August 20, 2005

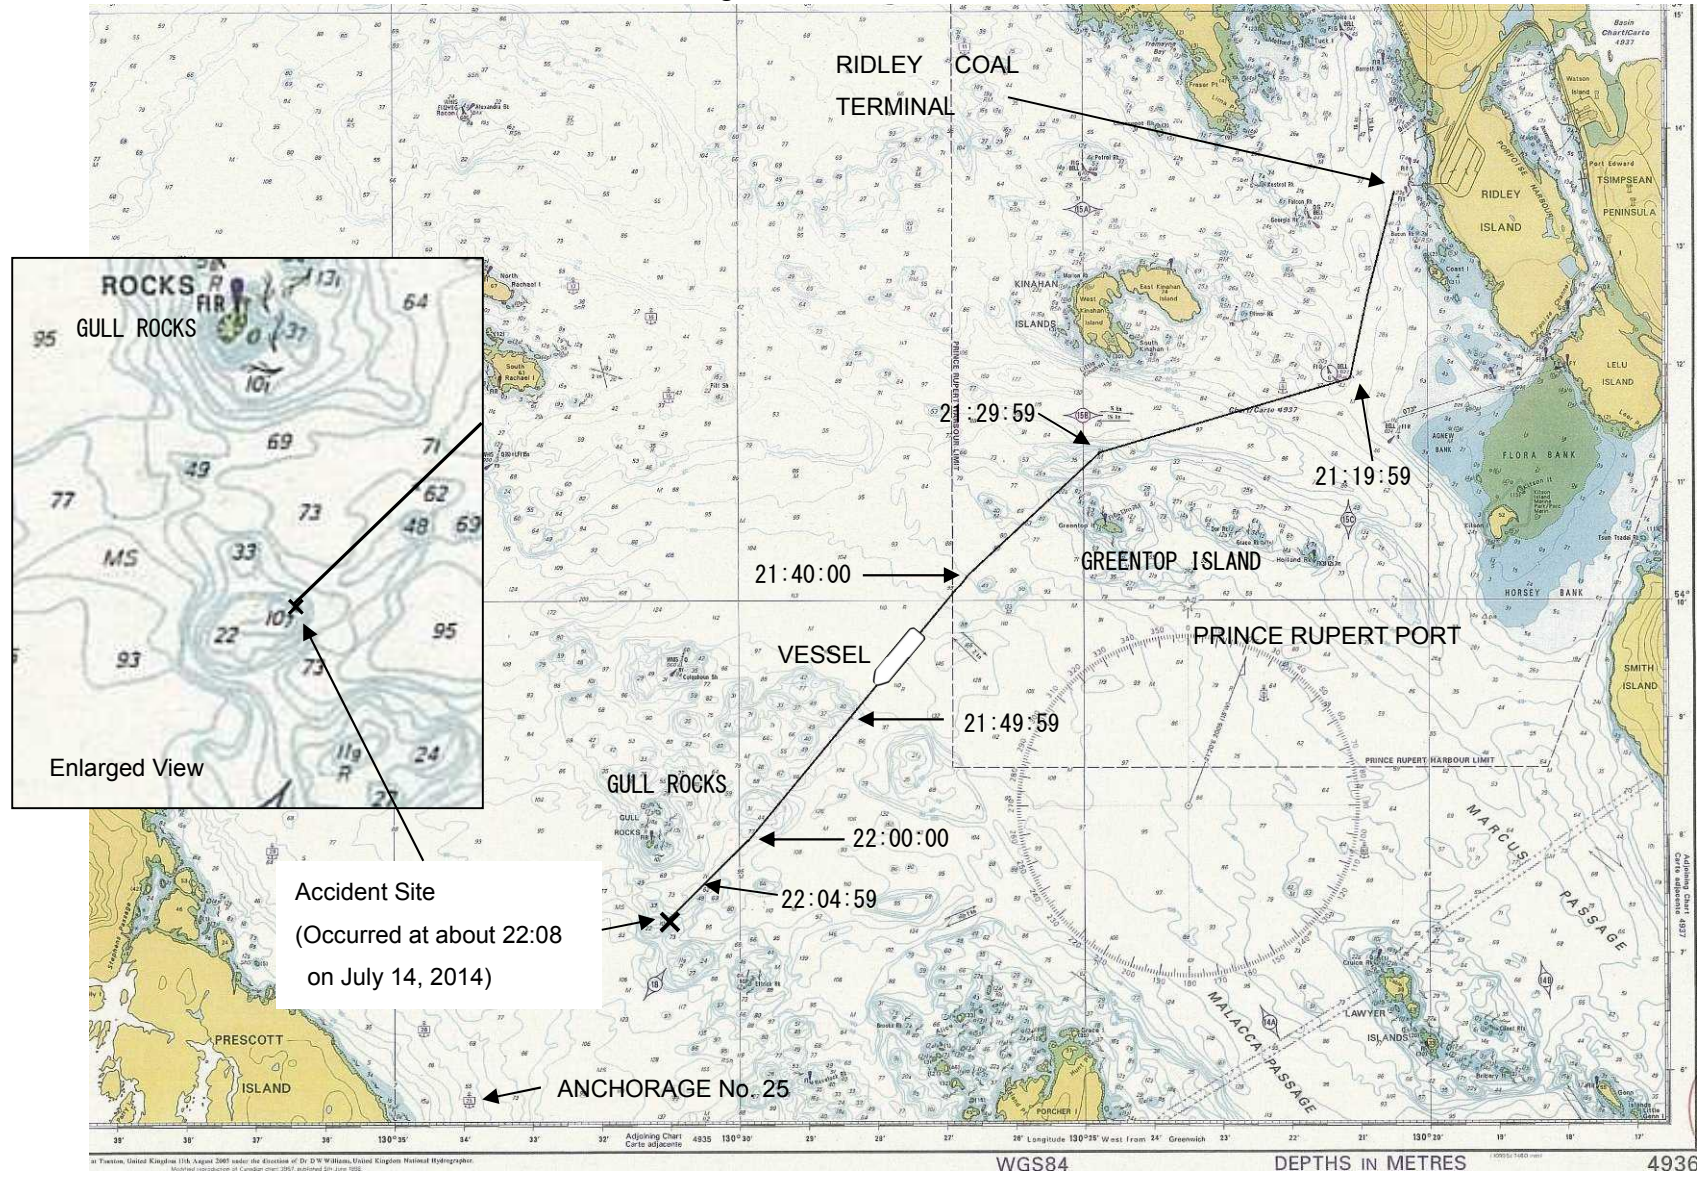
Attached figure 1 Presumed cruise course

EVENTS LEADING TO THE ACCIDENT	<p>This vessel with a crew of 20 people, including the master (all members from the Republic of the Philippines), and also the pilot onboard and loaded with 80,021 tons of coal, with its fore and aft at approximately 13.33m of draft, left the pier at the Ridley coal terminal for Anchorage No. 25 at Prince Rupert Port at about 20:45 (local time) on July 14, 2014.</p> <p>Upon receiving the instruction to stand by at the anchorage from the operation company before leaving the pier, the master discussed the passage plan to the anchorage with the pilot on the bridge.</p> <p>After passing the water area offshore north of Greentop Island, this vessel proceeded directly toward the anchorage. At the location approximately 3.5M from the anchorage, the main engine was set to dead slow ahead and the vessel proceeded southwest at about 6.0 knots (kn) speed over the ground. Then, at about 22:08 the bow ran aground on a shoal.</p> <p>The master received a report from the chief officer on the fore that he felt vibration. Since the vessel was unable to hold headway, the pilot instructed to stop the main engine. Examination of British Admiralty Nautical Chart 4936 (Prince Rupert Port) revealed that the vessel had run aground at a depth of 10.7m.</p> <p>The master ordered the crew member to measure the depths of the ballast tanks, and discovered that water had entered the forepeak tank and starboard ballast tanks No. 1 and No. 2. The master reported the accident to the ship management company.</p> <p>The pilot reported the accident to the Canadian Coast Guard.</p> <p>At about 02:25 on the 15th, this vessel was able to refloat on its own by the engine astern. At approximately 04:15, the vessel anchored at a different anchorage.</p> <p>After temporary repair, this vessel left for Japan at about 09:20 on September 9.</p> <p>(Refer to Attached figure 1: Presumed cruise course, Appendix 1: VDR position information (excerpt))</p>

<p>ANALYSIS</p> <p>INVOLVEMENT OF CREW AND OTHERS</p> <p>INVOLVEMENT OF HULL/ENGINE, etc.</p> <p>INVOLVEMENT OF WEATHER/SEA CONDITIONS, etc</p> <p>ANALYSIS OF FINDINGS</p>	<p>Yes</p> <p>None</p> <p>None</p> <p>It is considered probable that, since the master of this vessel planned the route from the pier at the Ridley coal terminal to the anchorage at Prince Rupert Port via the shallow water area offshore southwest of Prince Rupert Port, the vessel proceeded toward the shallow water area and ran aground.</p> <p>It is considered somewhat likely that, when the master of this vessel checked the nautical chart by referring to the navigation plan presented by the pilot, the master mistakenly recognized the water depth of 10.7m as 107m.</p>
<p>PROBABLE CAUSES</p>	<p>It is considered probable that, because the master of this vessel planned the course to pass the shallow water area offshore southwest of Prince Rupert Port after leaving the pier at the Ridley coal terminal toward the anchorage at Prince Rupert Port, the vessel proceeded toward the shallow water area and ran aground, resulting in this accident.</p>
