**MARINE ACCIDENT
INVESTIGATION REPORT**

Vessel type and name: Cargo ship BEAGLE III

Vessel type and name: Container ship PEGASUS PRIME

Accident type: Collision

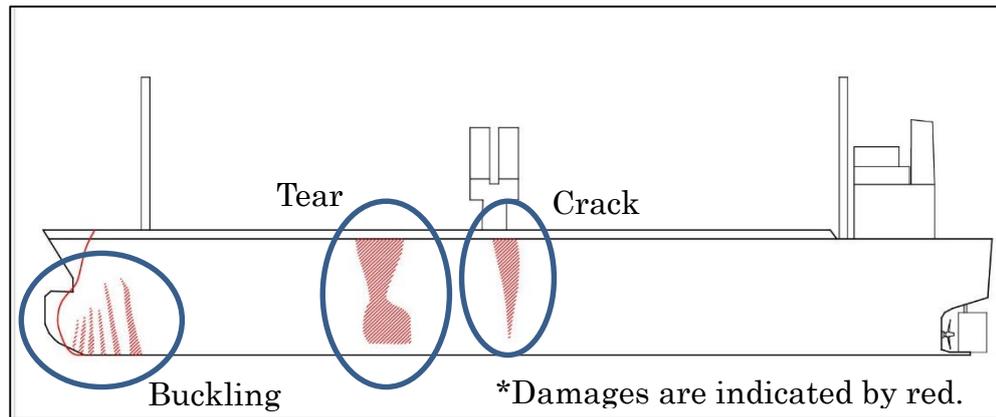
Fig. 2.3 Schematic illustration of damages on Ship A (port side)

According to the reply to the questionnaire by the operator of Ship A, WISDOM MARINE LINES S.A. (hereinafter referred to as Company A₁), Ship A, after the foundering, had a tear and crack on the side shell plating of the central port side hull and a buckling on the bow. (See Fig. 2.3.)

From 2.1.3, 2.1.4, and 2.3, it is probable that Ship A foundered due to a tear on the side shell plating of the central port and a buckling at the bow and a crack at the side shell plating of the central port were caused in the foundering, and that Ship B had a buckling at the bow and a damage at the bow thruster.

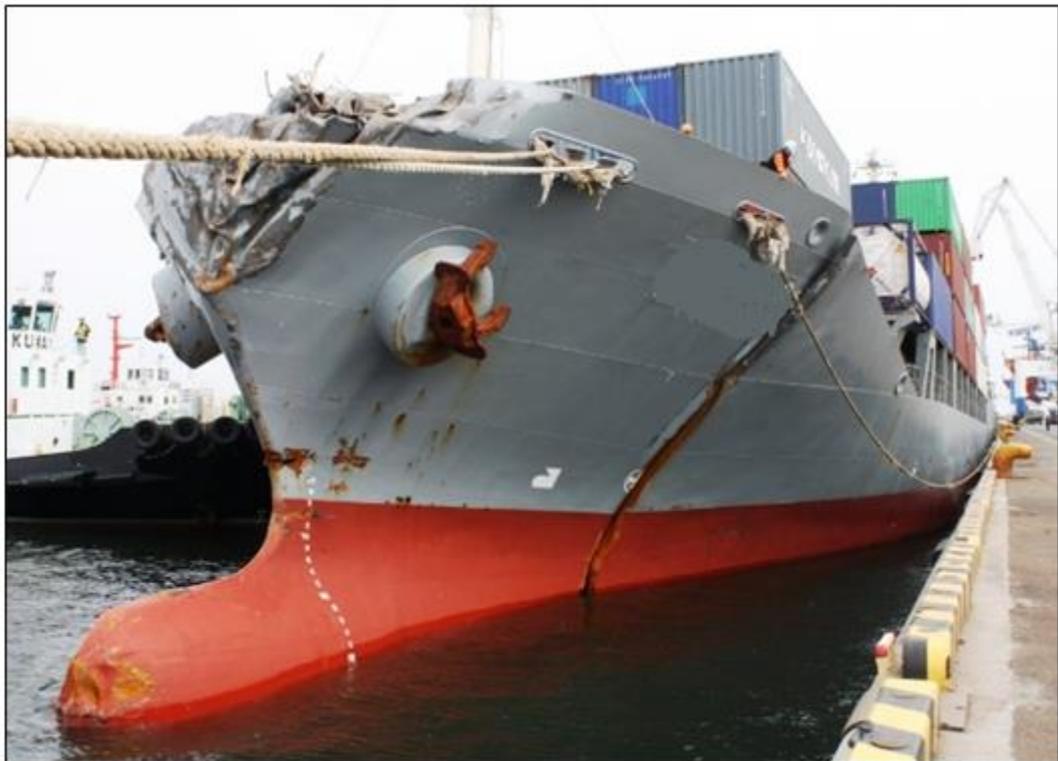
Photo 2.3 Bow of Ship B

Ship B had a buckling on the bow and the bow thruster was destroyed. (See Photo 2.3.)

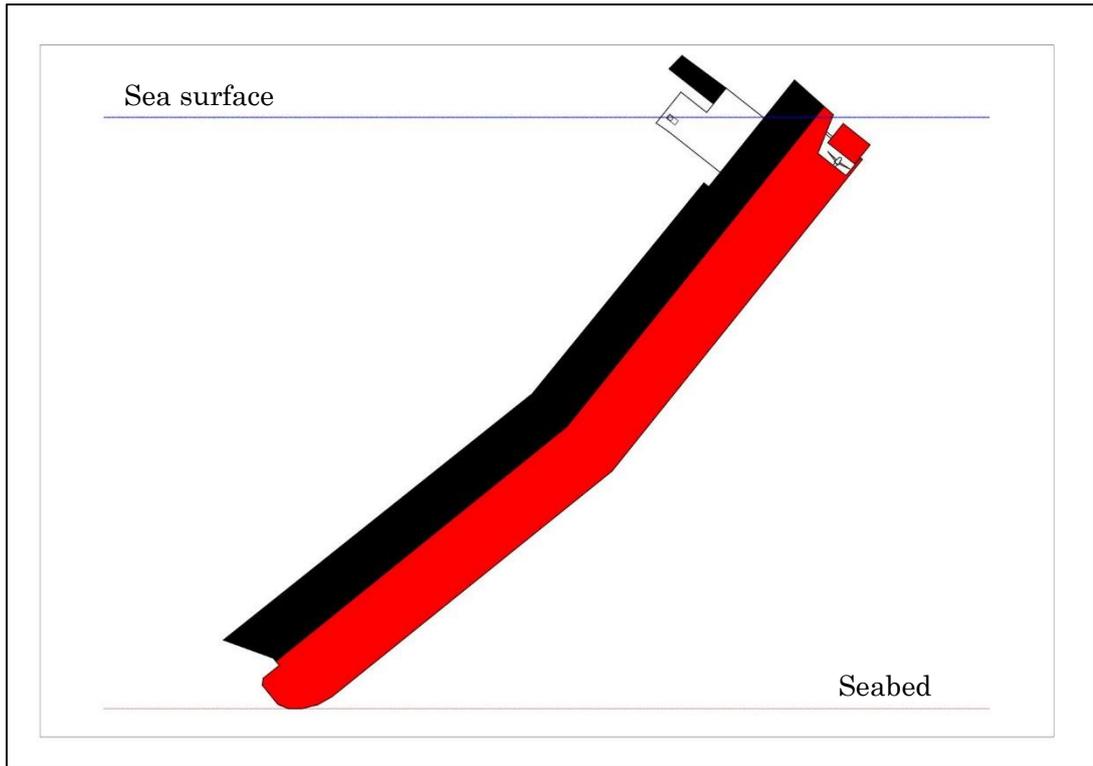
Fig. 3.1 Bow of Ship A reaching the seafloor

- (3) It is probable that, after the front side of the deck house of Ship A foundered, the bow reached the seafloor about 93m deep and the its foundering stopped and that only the rear side of the deck house and the stern remained above the sea and then the stern gradually foundered. (See Fig. 3.1.)

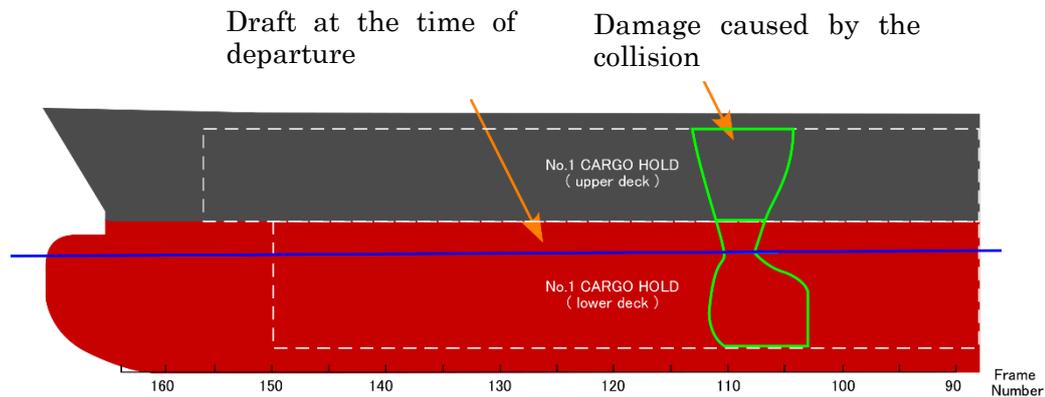
Figure 3-1 Shape of the hole

The broken hole shape that was described in the results of diving survey of vessel A is shown in Figure 3-1. The dimensions of the hole was made based on this figure. In order to calculate the area, it is necessary to determine the height and width of the broken hole. The width of the broken hole is expressed as a function of the depth (mold) considering the direction of the depth (mold) of vessel A as a base. This enables to determine the area of the broken hole from the depth (mold). As a result, total area of the broken hole is estimated as about 71 m².

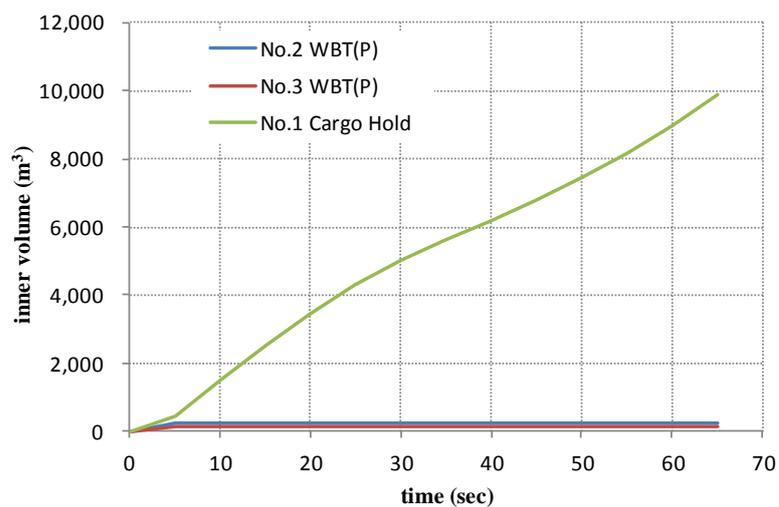
Figure 3-4 The time series variation of the flooded seawater volume

As the flooded volume became about 866 m³ in 5 seconds after disconnection of vessel B and exceeds the capacities of the WBT No.2 (P) and the No. 3 WBT (P) located in the part of the ship where the collision occurred, therefore it is estimated that these tanks were filled with water within 5 seconds from the beginning of flooding. The tilt moment generated by this flooding is estimated as 2715.6 t-m. It is estimated that ship listed to the port side by this heeling moment. It is estimated that all flooded seawater came into the cargo hull after 5 seconds from beginning of flooding. The volume of flooded water in the cargo hull was estimated to be about 3,450 m³ at 20 seconds, about 6,170 m³ at 40 seconds, and about 8,970 m³ at 60 seconds after the beginning of flooding.

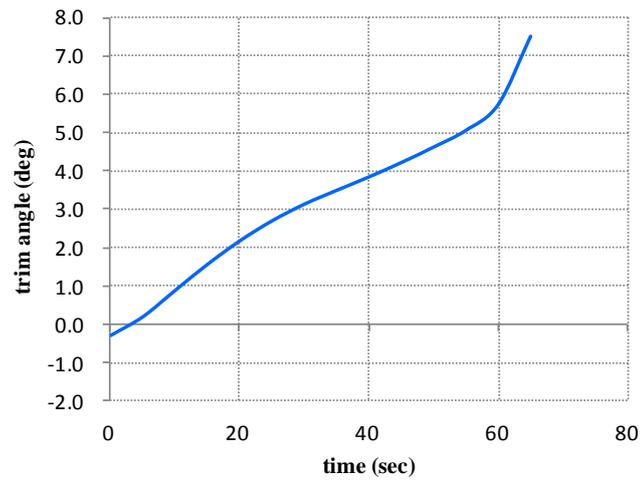
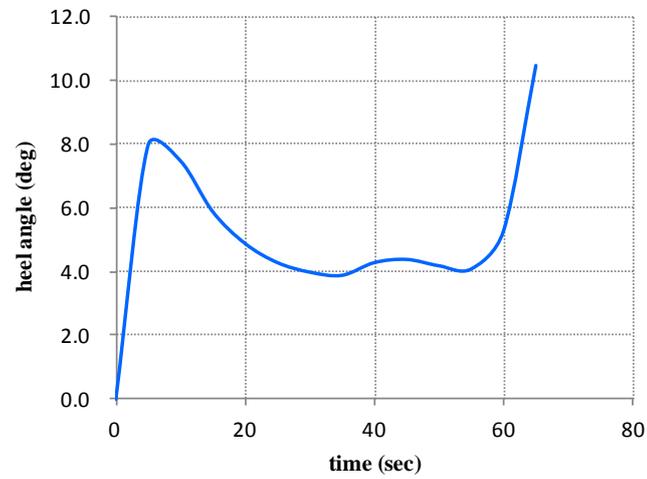
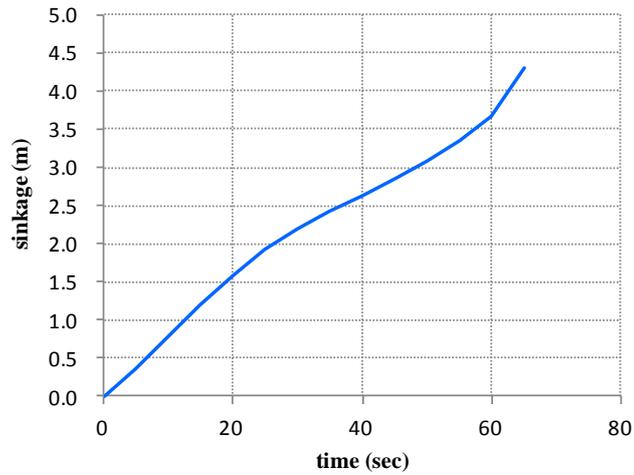
Figure 4-1 the time series variation of attitude change

It is estimated that the vessel A was sailing with aft trim before the accident, and since the vessel B collided at the "No.1 CARGO HOLD" in the foreside and flooded seawater stayed in the fore side, the fore trim proceeded as time passed. From these results, it is estimated that the fore trim increases at almost constant angular velocity up to around 60 seconds, and it became unstable and rapidly proceeded after 60 seconds.

Amount of hull sinkage indicates the amount of increase in midship draft. The based is the draft before the flooding. It is estimated that the hull sank in proportion to the volume of flooded seawater as volume of the flooded seawater is almost constant in this calculation. The sinkage of hull is estimated as about 1.2 m at 20 seconds later, about 2.4 m at 40 seconds later, and about 3.4m at 60 seconds later.

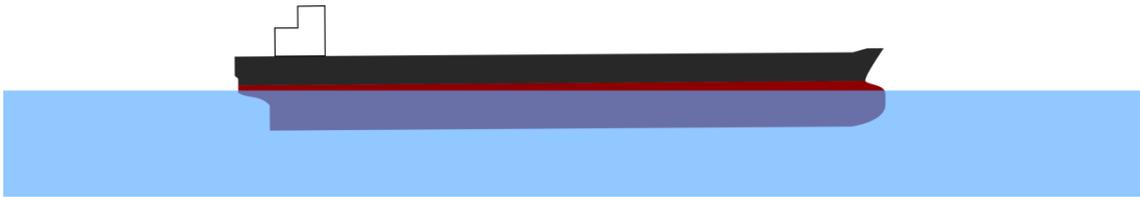
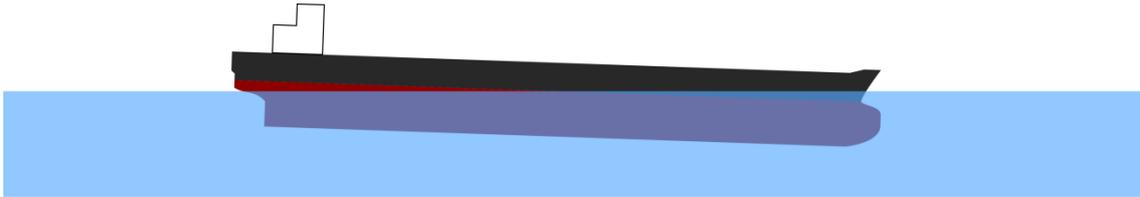
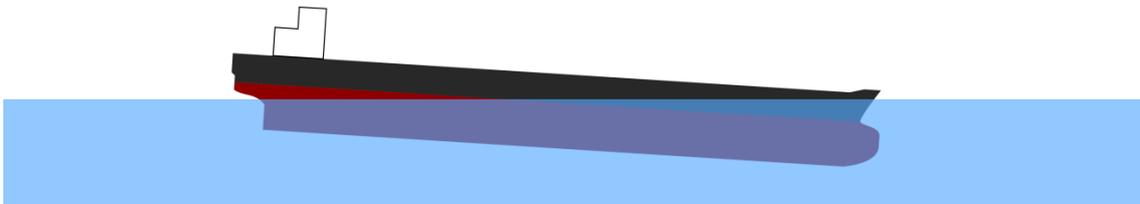
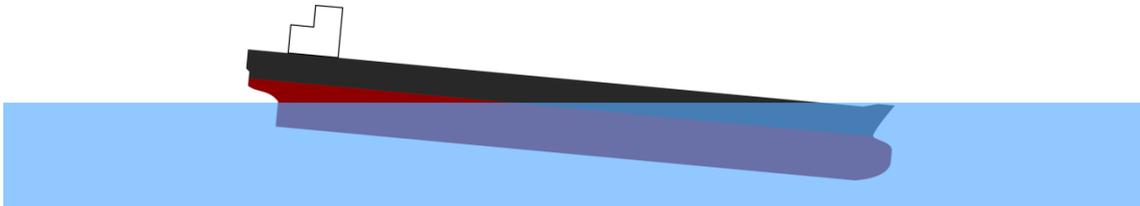
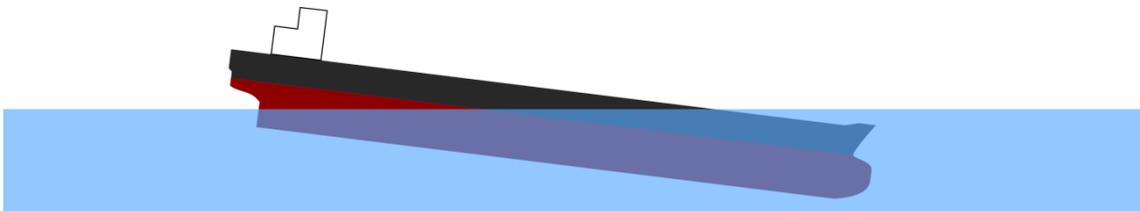
Figure 4-2: Just before the start of flooding (trim angle: -0.3 deg.)

Figure 4-3: 20 seconds later since the start of flooding (trim angle: 2.2 deg.)

Figure 4-4: 40 seconds later since the start of flooding (trim angle: 3.8 deg.)

Figure 4-5: 60 seconds later since the start of flooding (trim angle: 5.7 deg.)

Figure 4-6: 65 seconds later since the start of flooding (trim angle: 7.5 deg.)

From these figures, it is estimated that the bow sank at an almost constant rate as the flooded seawater to the "No.1 CARGO HOLD" increased, and, at about 60 seconds later, the upper side of the bow came below the sea surface. After that, the bow sank further

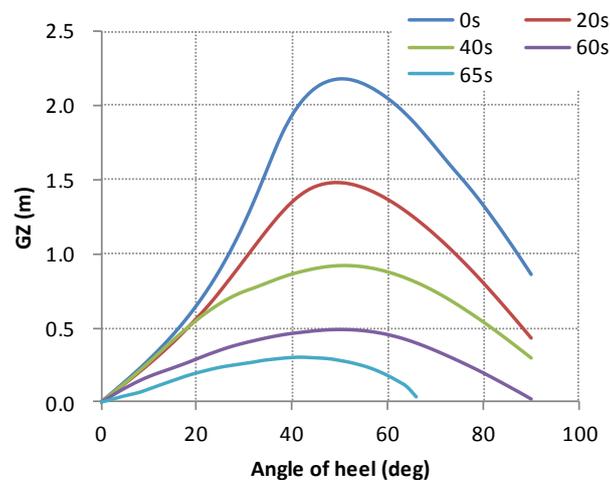
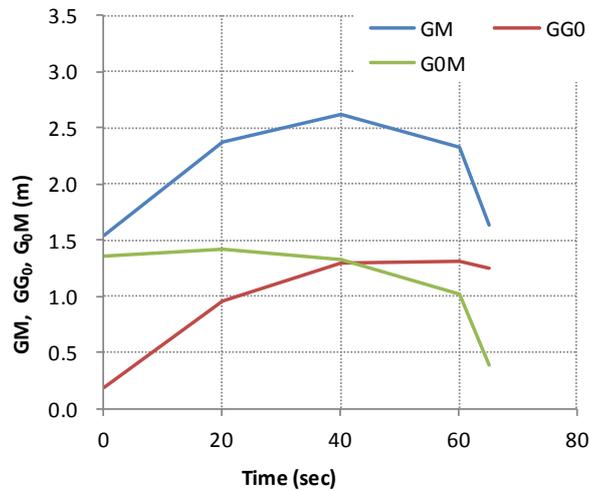
It was observed that, although the vessel had sufficient righting lever before the beginning of flood (0 sec), as time passed, increase of volume of the flooded water caused sinkage of the hull and reduction of the freeboard, and reduced the righting lever. However, the value of righting lever at and after 65 seconds is still positive, and it is estimated that this situation did not lead to capsizing of the vessel A.

The distance between the apparent center of gravity take in to account of free water effect and metacenter (G_0M) before beginning of flooding was 1.36(m) and was sufficient. Although it once increased to 1.42(m) at 20 seconds later from the start of the flooding, the free water effect became remarkable with the increase of the flooded seawater, and decreased to 0.39m at 65 seconds later. This shows that above mentioned rapid attitude change was caused by this reduction of G_0M . It is estimated that the vessel A did not capsized as the value of G_0M is still positive.
