MA2017-8

**MARINE ACCIDENT  
INVESTIGATION REPORT**

Vessel type and name: Cargo Ship “HUNAN”

Accident type: Missing crew member

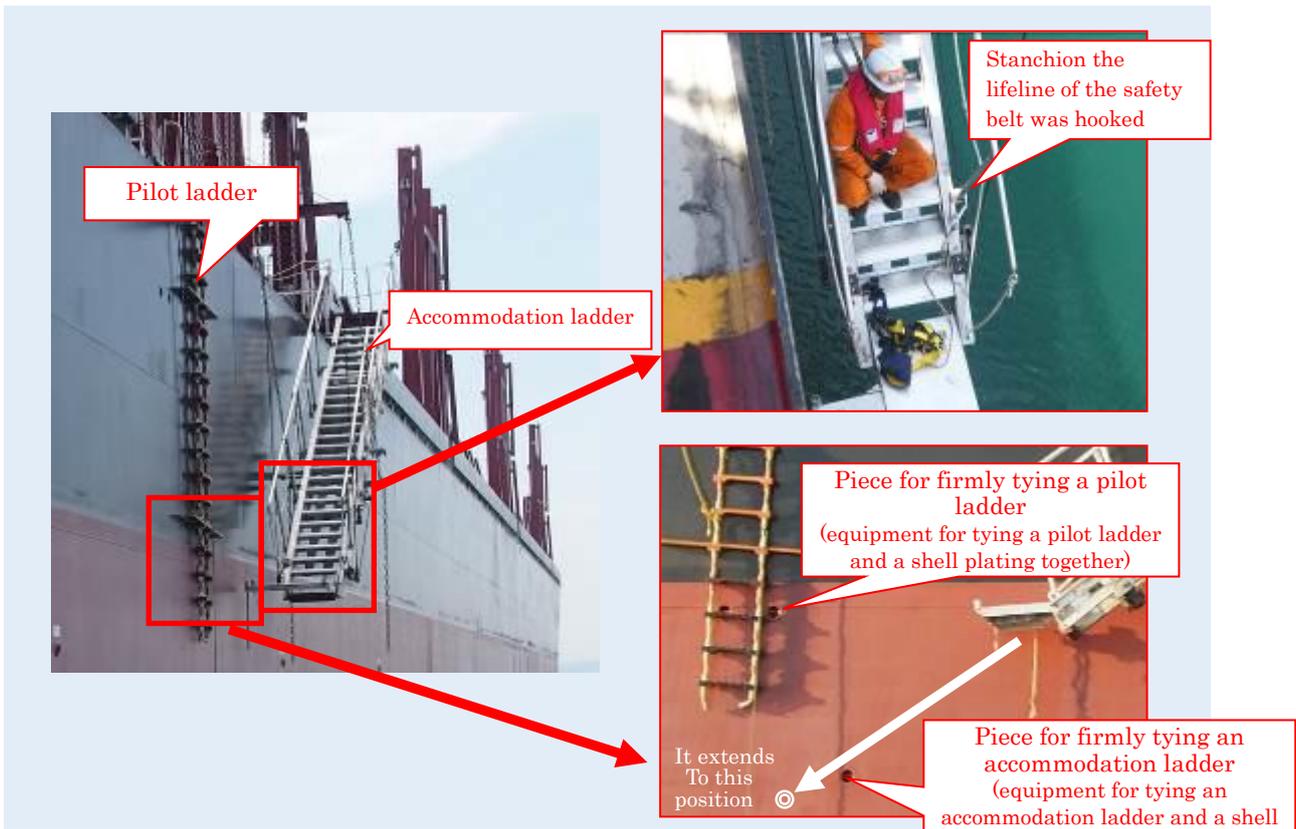
Photo 2.1 Accommodation Ladder

Since the boatswain was not able to see all around a lower part of the accommodation ladder from the spot for pulling up the pilot ladder, he leaned over the board and looked down, and saw AB B hanging off a stanchion by the bottom step of the accommodation ladder with a lifeline of the safety belt.

AB B was in a state of being submerged under sea surface below the knee and having his face also exposed to the sprays of the waves.

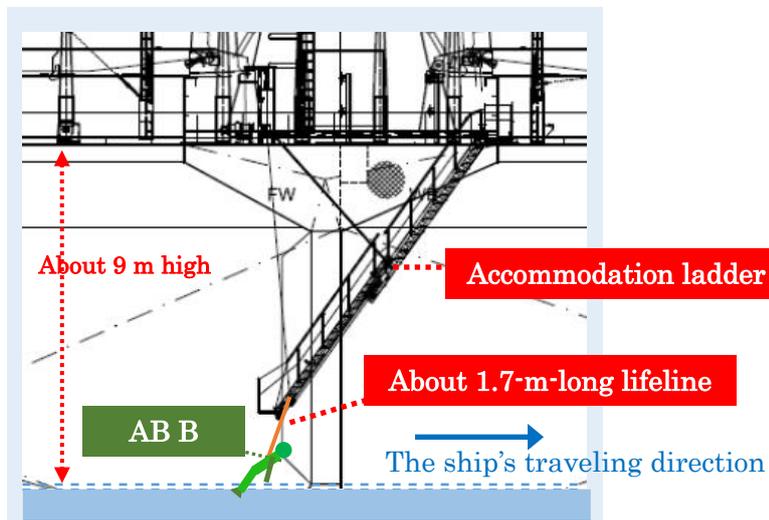
Figure 2.1 Situation of AB B hanging down

C/O saw AB B try to grab the rope with the left hand but not able to do so with his body being tossed about by the waves, the body fell off the safety belt and him dropped under the water.

- (1) It is probable that when AB B raised both arms in an attempt to grab the rope or others in the state of hanging off the accommodation ladder, the safety belt disengaged from the body and he dropped under the water.
- (2) It is probable that concerning the safety belt, though the chest buckle remained after the accident, the two buckles on the thighs were disengaged.
- (3) An investigation on the wearing conditions of the safety belt was carried out, and a body did not fall out of the safety belt in the case where the belt was pulled up overhead

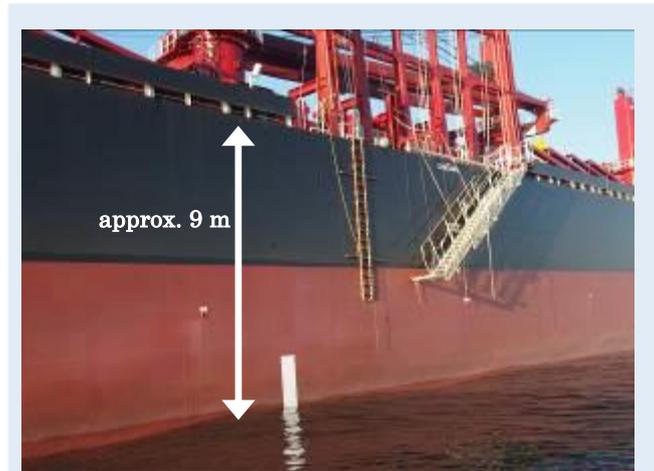
Photo 2.8 – 2 Pilot Transfer Arrangements of the Ship

- (2) It is probable that the work of lifting up and stowing the pilot ladder falls under the dangerous task such as outboard work since AB B moved down to the lower end of the accommodation ladder with wearing the safety belt for the purpose of untying a rope which had tethered the ladder to the shell plating.

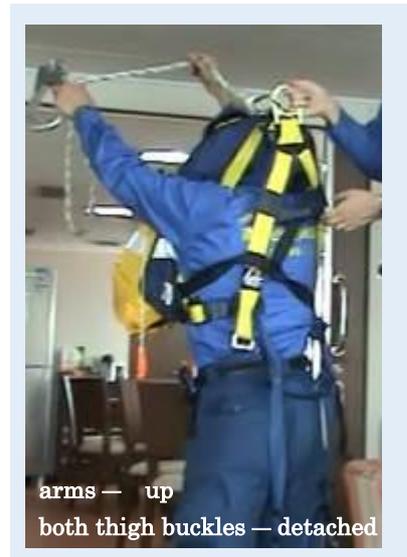
Photo 2.9-3

- (3) When the belt was pulled up overhead in the state of the chest buckle being fixed, the two thigh buckles were detached and both arms held up, the safety belt disengaged from the body.

It is probable that the separation of the body of AB B from the safety belt stems from his failure to have two thigh buckles of the safety belt fastened.

- (1) The management company shall disseminate wearing of protective equipment such as a safety belt and enforce thorough implementation after conducting a review of the work procedure of the safety management manual.
- (2) The management company shall disseminate a response to be given in case of falling overboard occurrence to crews in safety education or the like and instruct them to periodically engage in a response exercise.
