**MARINE ACCIDENT  
INVESTIGATION REPORT**

Vessel type and name: Chemical Tanker BUCCOO REEF  
Vessel number: 142281 (IMO number: 9733674)  
Gross tonnage: 21,101 tons

Accident type: Fatality of a crew member  
Date and time: Around 19:15, April 22, 2016 (local time, UTC +2 hours)  
Location: Port of Bordeaux, French Republic  
Around 342° true bearing, 1.8 nautical miles from the Cariette Lighthouse  
(approximately 44°54.9'N, 000°32.7'W)

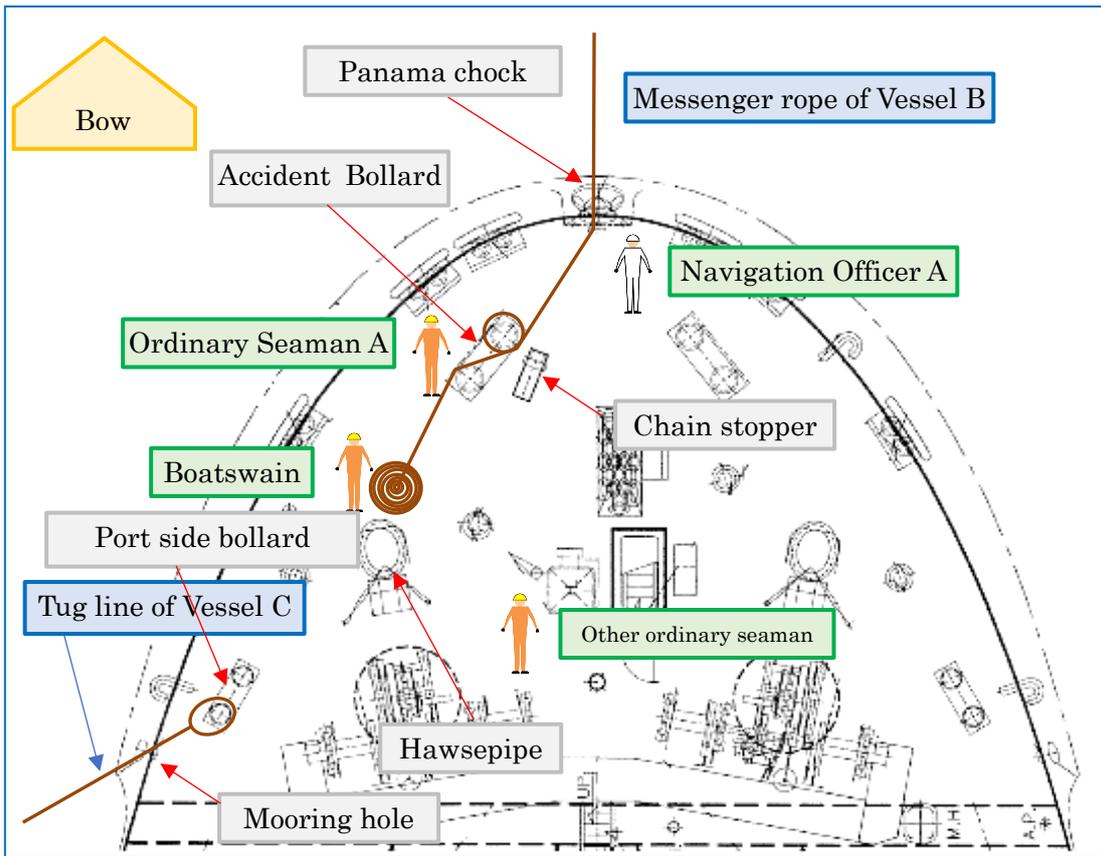
Figure 2.1-1 Stations of Crewmembers on Vessel A's Bow

Because the scheduled place for docking was approaching, Officer A discussed the mooring method with Master A on the bridge. Officer A subsequently took his position on the bow and explained the mooring method to boatswain, the ordinary seaman in charge of letting out the tug line (national of the Republic of the Philippines) (hereinafter referred to as “Ordinary Seaman A”) and another ordinary seaman.

Ordinary Seaman A stood on the port side of the Accident Bollard and let out the Accident Tug Line from the Panama chock by gradually letting out the messenger rope, which he had wound once around the Accident Bollard, the boatswain placed the leftover messenger rope on the deck near the port anchor hawsepipe<sup>\*5</sup> after paying the messenger rope coiled out<sup>\*6</sup> for Ordinary Seaman A, and Officer A verified that the eye of the Accident Tug Line being let out had reached the water’s surface.

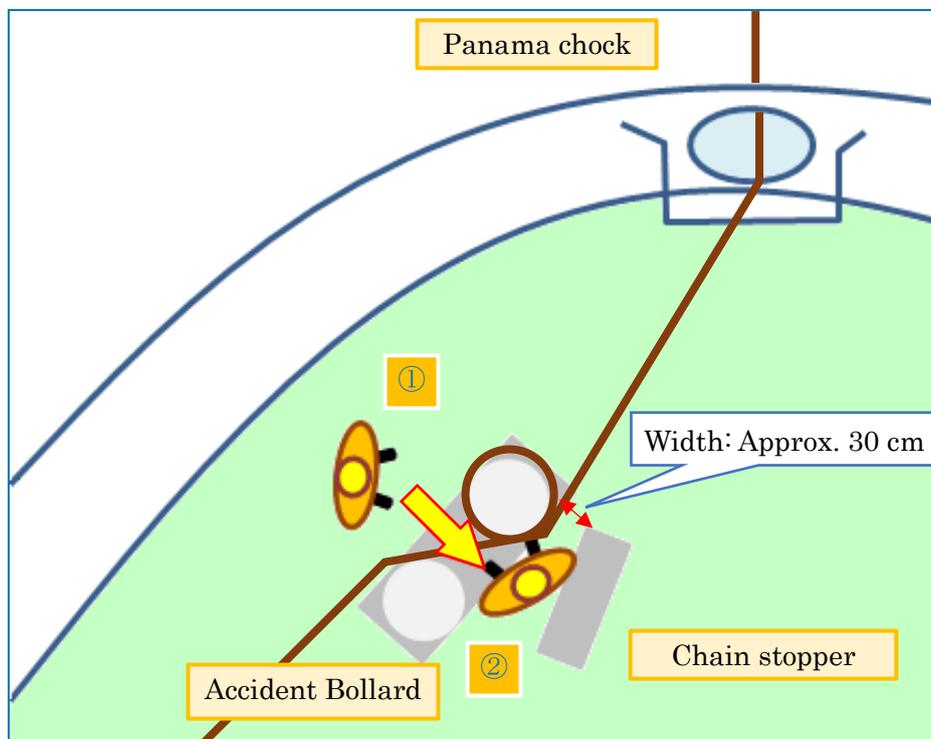
Figure 2.1-2 Ordinary Seaman A's Movement of Work Position

At around 19:15, Officer A and the boatswain noticed that the speed of the messenger rope’s exit had quickened and saw that Ordinary Seaman A was moving to the port side through the space between the bitts of the Accident Bollard. Although they shouted at Ordinary Seaman A to let go of the rope and step clear, Ordinary Seaman A fell to the deck and was dragged with the rope entangled around his leg (whether it was his right or left leg is unknown) until his body struck a structure near the chain stopper<sup>\*7</sup>. He then fell

overboard from the Panama chock.

(① indicates position at start of work, ② indicates position just before the accident)

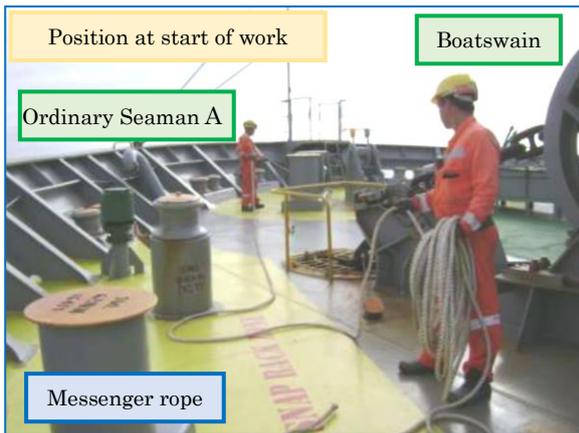
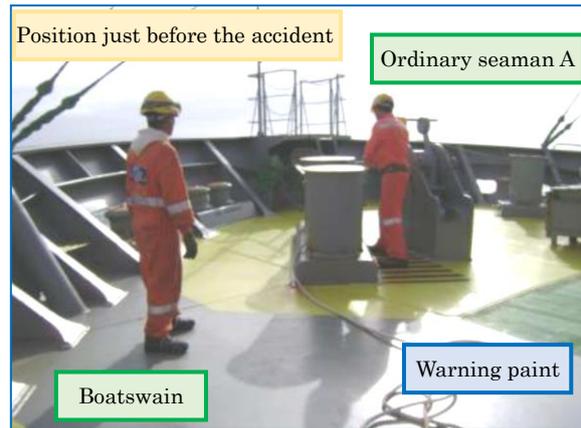
Reenactment of Ordinary Seaman A's Work by Crew Members of Vessel A (Provided by Company A<sub>1</sub>) (The yellow and black warning paint on the surface of the deck used to reenact Ordinary Seaman A's work positions was applied after the accident.)

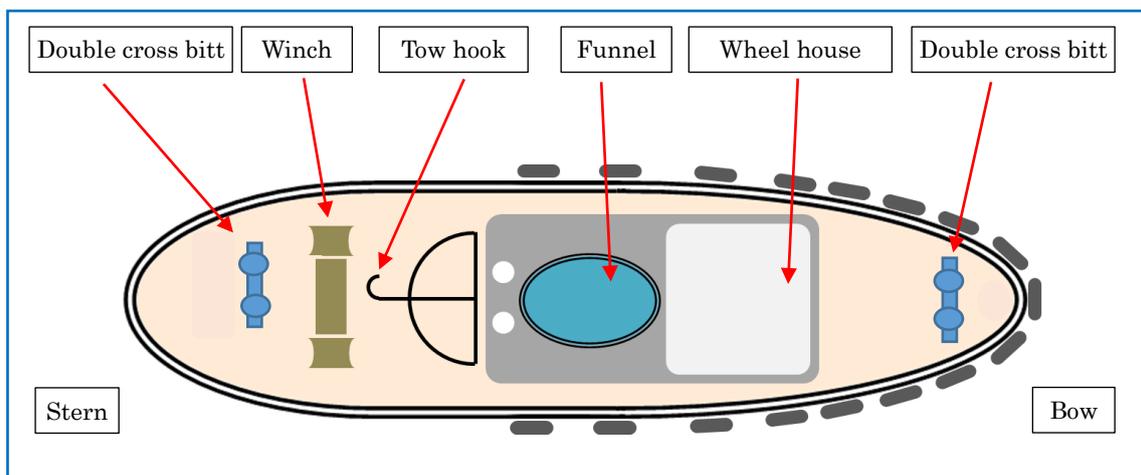
Figure 2.4-2 Plan of Vessel B (Outline)

According to the information provided by the French Investigative Authority, there was a portion of the wheel house's view astern that was blocked by the funnel. (See Figure 2.4-2)

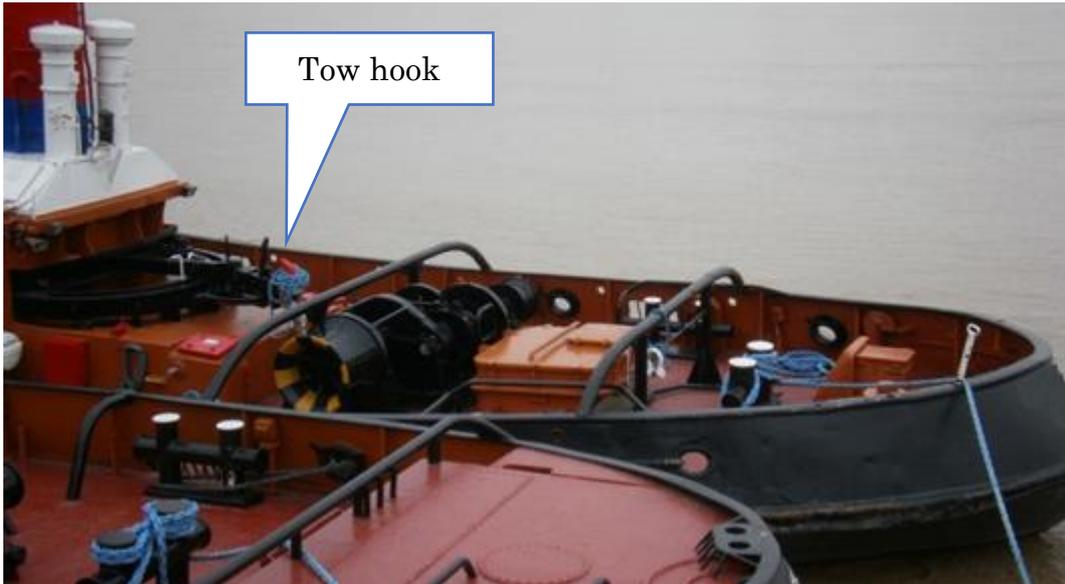
Photo 2.5 Circumstances of Vessel B's Aft Deck

The end of the Accident Tug Line on the Vessel B side was locked on the tow hook on Vessel B's

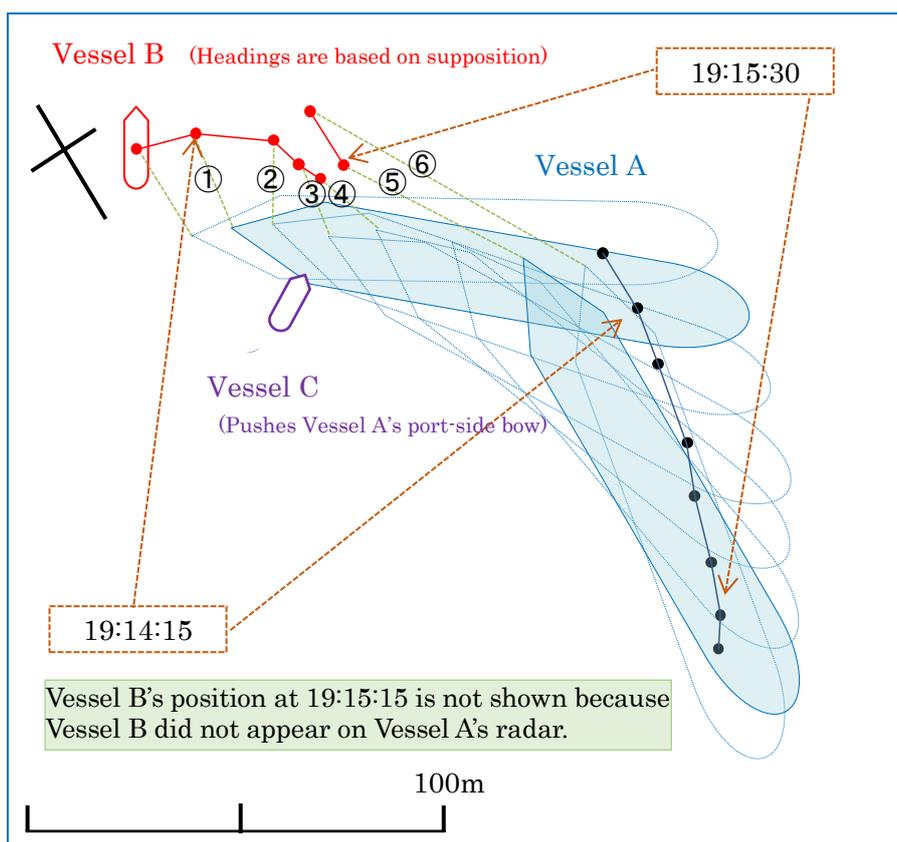
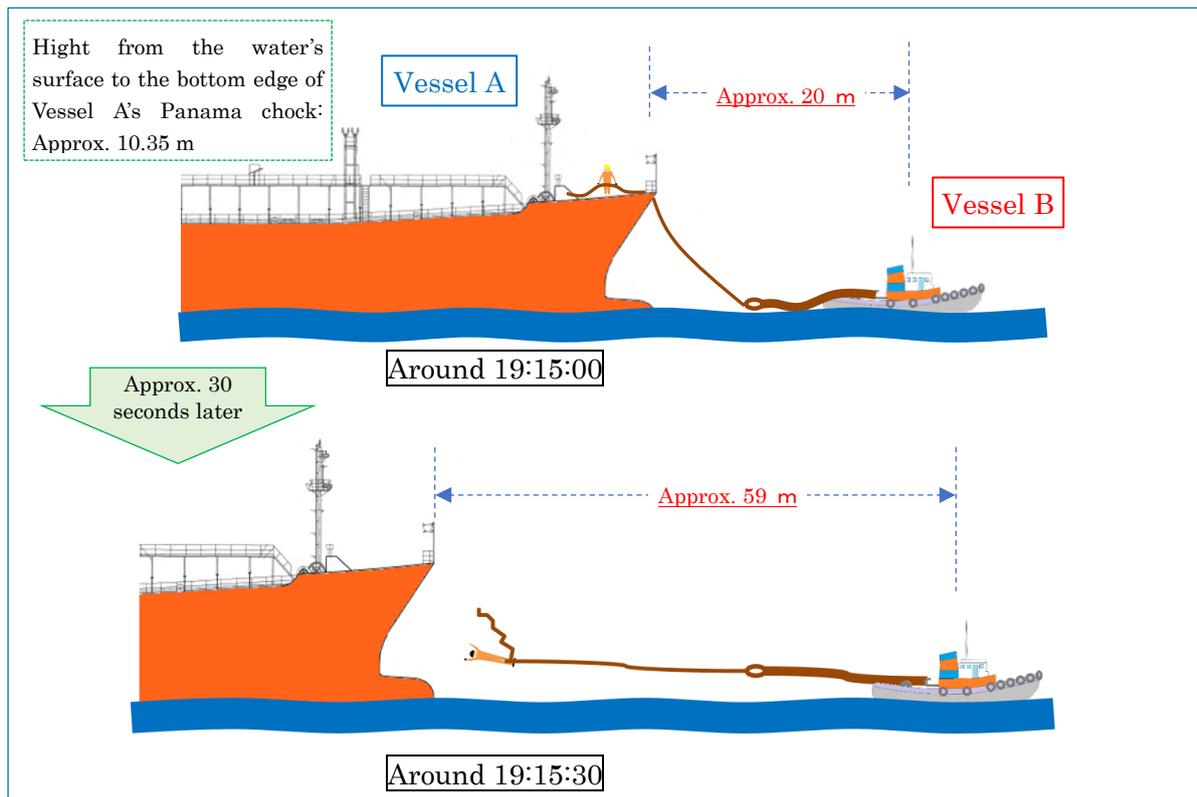
Based on the table, Vessel A's bow end and Vessel B reached their closest distance at around 19:15:00 and then their distance began to widen, and between 19:15:30 and 19:15:45 the speed of separation between the two vessels increased to more than two meters per second. (See Figure 3.2-1 and Figure 3.2-2)

- (4) It is probable that Vessel B's position did not change significantly between 19:15:00 and 19:15:30.
- (5) It is probable that from 19:15:00, the exit speed of the messenger rope on Vessel A's deck increased as tension was applied with the increasing speed of separation between Vessel A's bow end and Vessel B.

It is probable that the increase in the messenger rope's exit speed was caused by an increase in the separation speed between Vessel A's bow end and Vessel B that occurred when Vessel A gathered sternway while continuing her starboard turn.

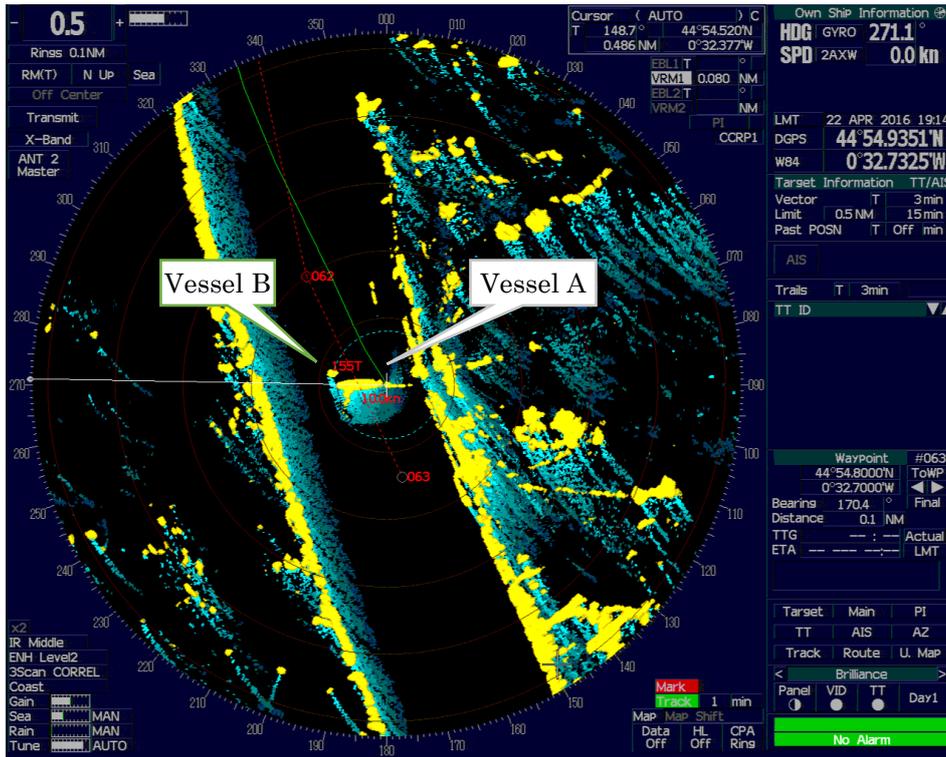
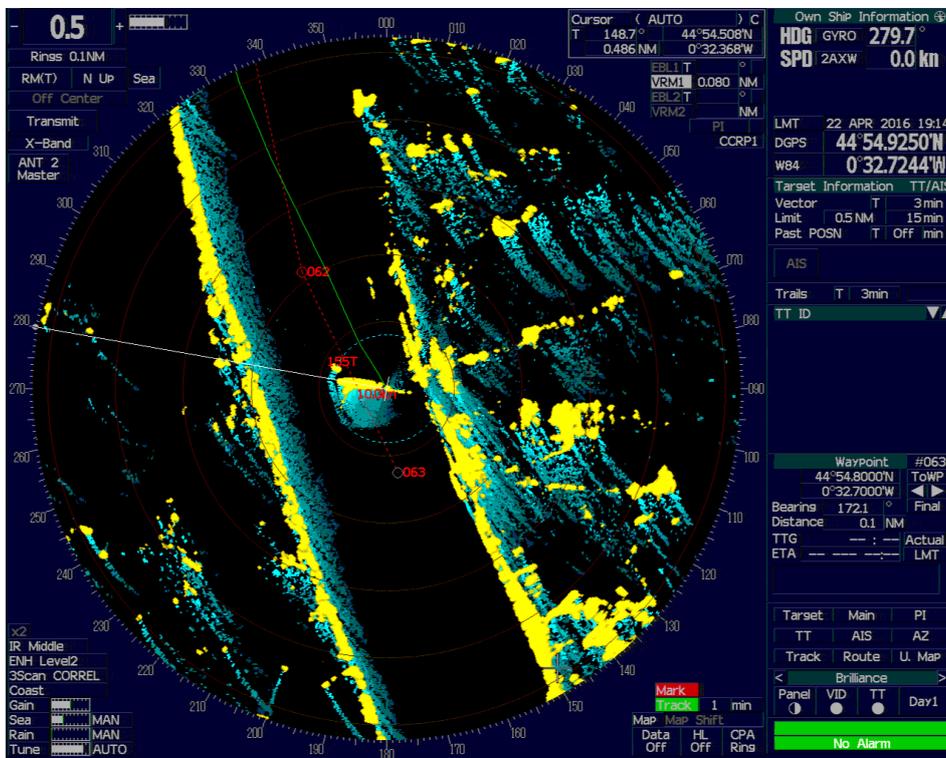
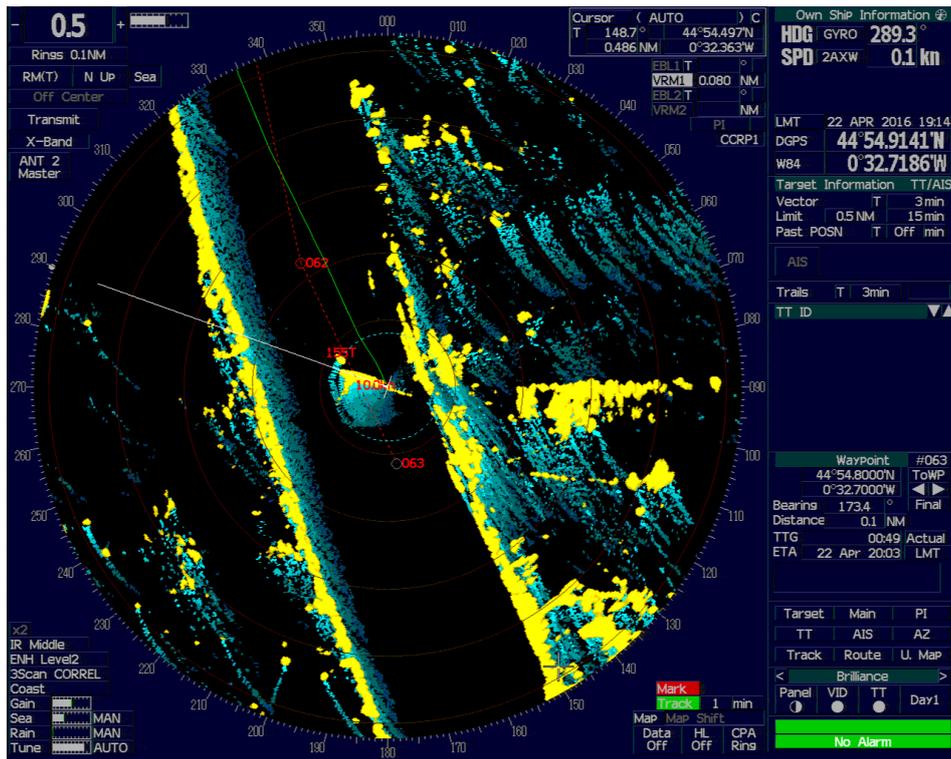
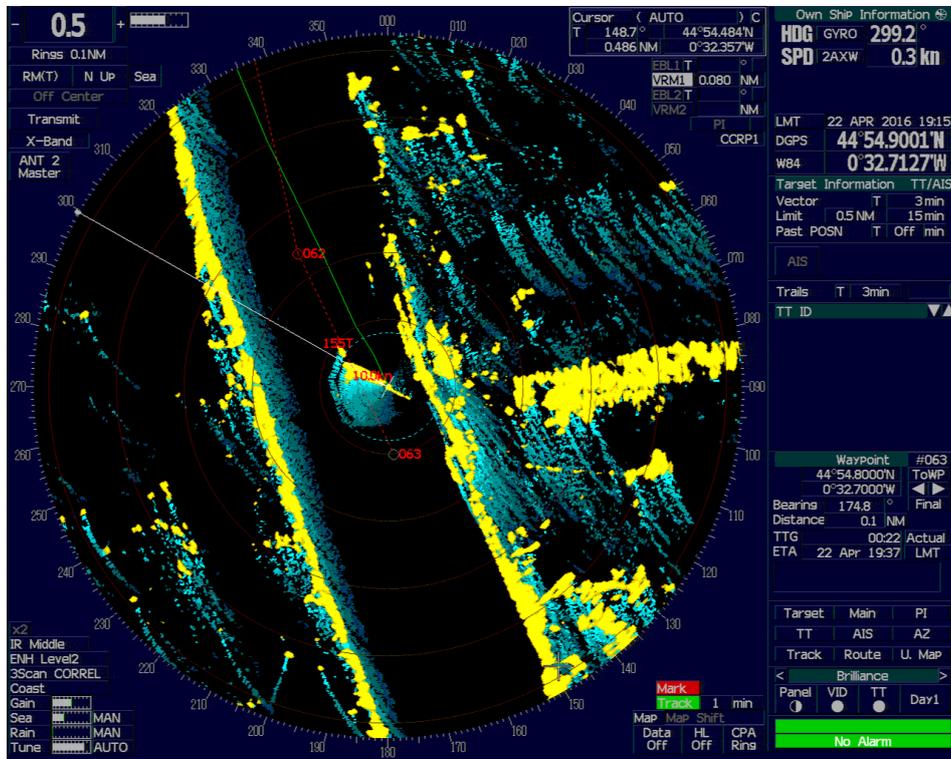
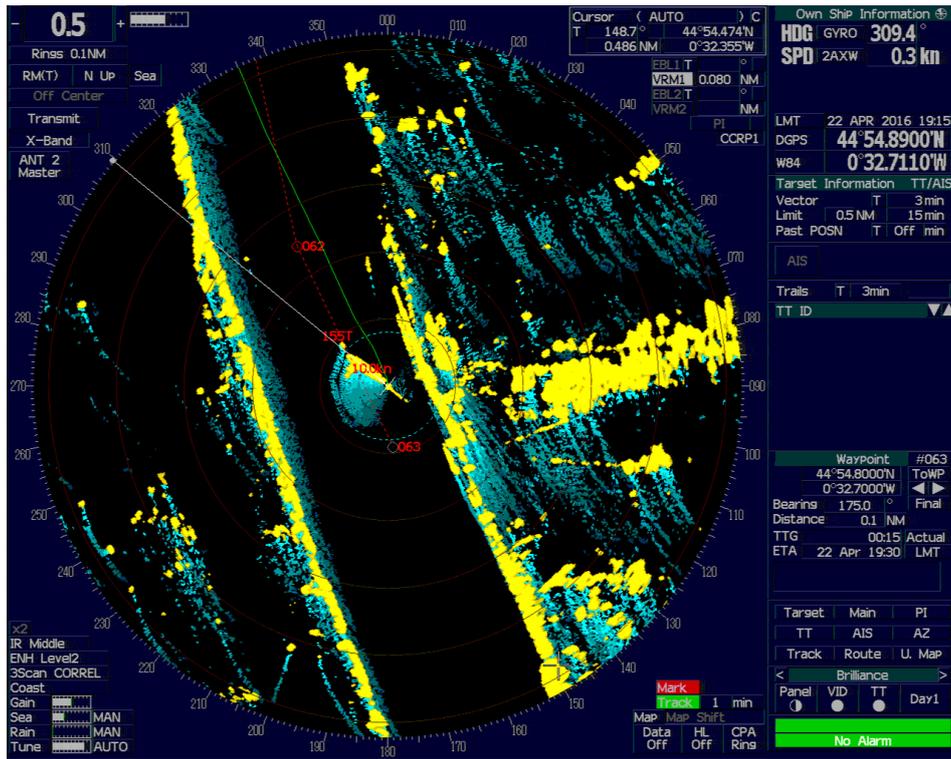
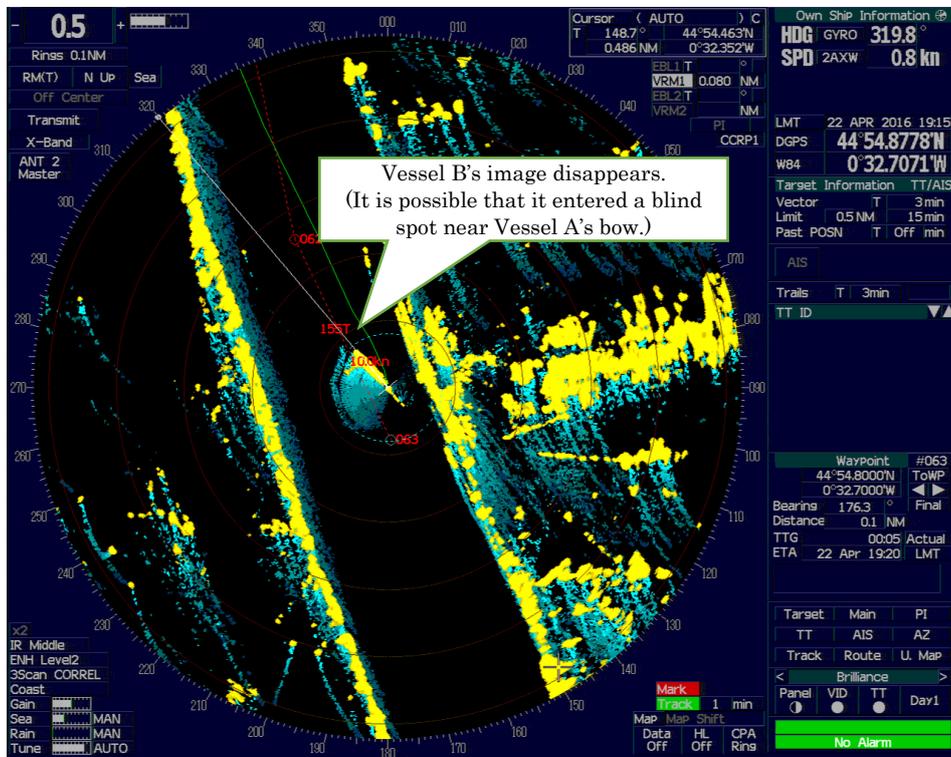
# Attached Figure 1 Radar Images from Vessel A's VDR (19:14:00 – 19:15:45)

According to the record of radar images taken every fifteen seconds between 19:14:00 and 19:16:00 on April 22, 2016, that was recorded in Vessel A's VDR, bearing and distance from Vessel A to the area near the center of the image of RM PAUILLAC (hereinafter referred to as "Vessel B") were as shown in Table 2.1-2.
