MA2017-9

**MARINE ACCIDENT
INVESTIGATION REPORT**

MARINE ACCIDENT INVESTIGATION REPORT

Vessel type and name: Cargo Ship BBC ASIA

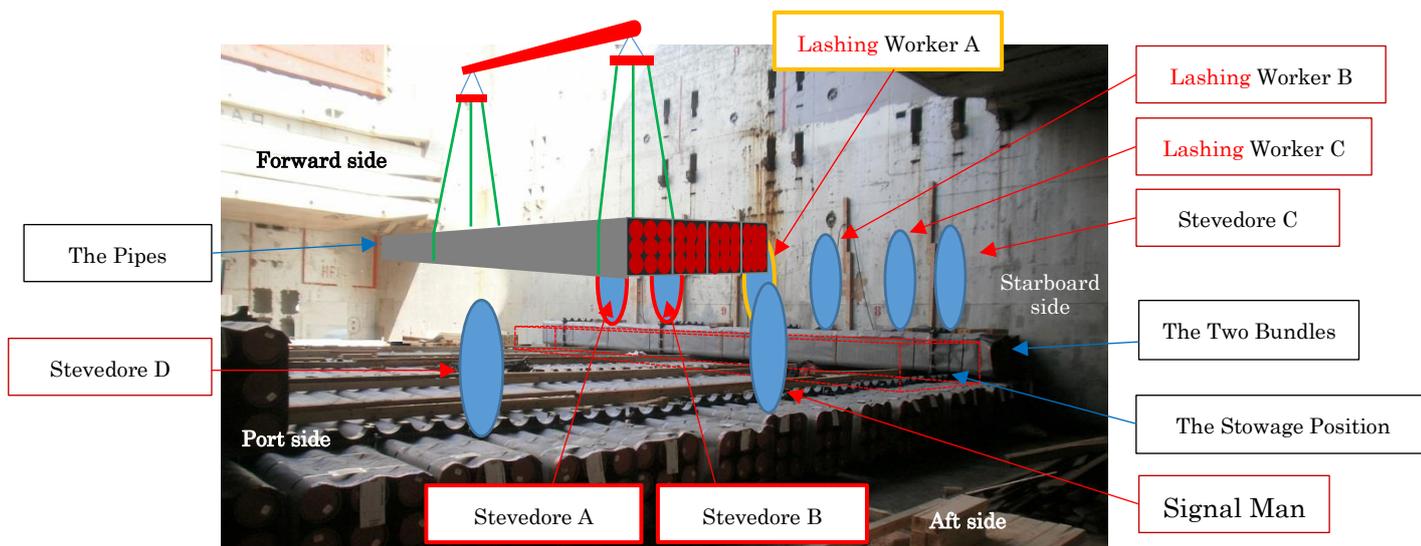
Photo 2.1-4 Arrangement of Workers at the Time of the Accident

The Signal Man instructed the Winchman to momentarily stop operating the crane by transceiver so that he could check the positions of the workers and the Stowage Position, having the Pipes stopped “at a position at which the Pipes’ starboard side was approximately three meters from the starboard wall and bottom was approximately two meters above the top of the first layer of Bundled Pipes” (hereinafter referred to as the “Stop Position”) (See Photo 2.1-4)

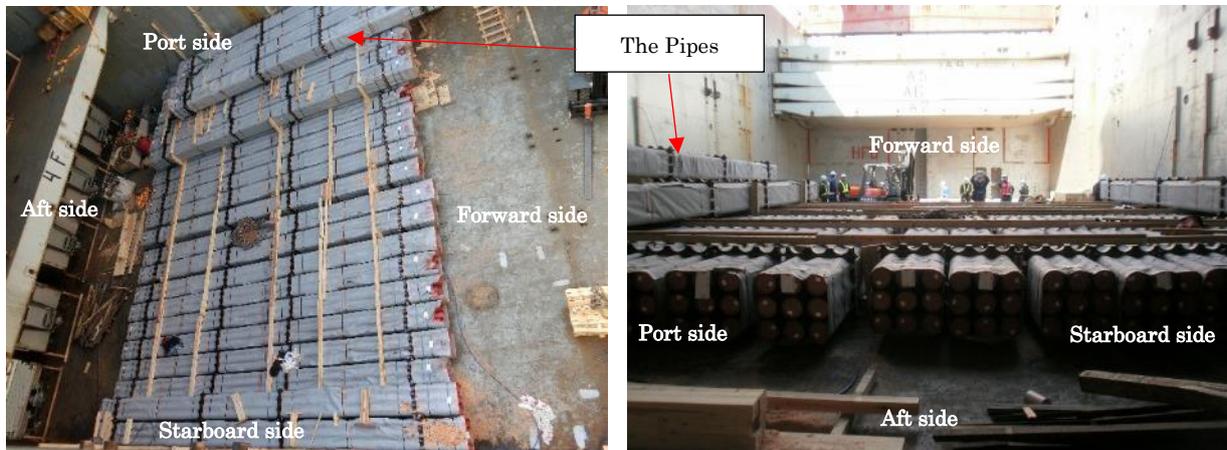
Figure 2.1-5 Circumstances Inside the No. 2 Cargo Hold After the Accident

The Winchman saw the Pipes hit workers and therefore instantly lifted the Pipes by operating the crane and placed them temporarily on top of Bundled Pipes that had been stowed on the port side. (See Photo 2.1-5)

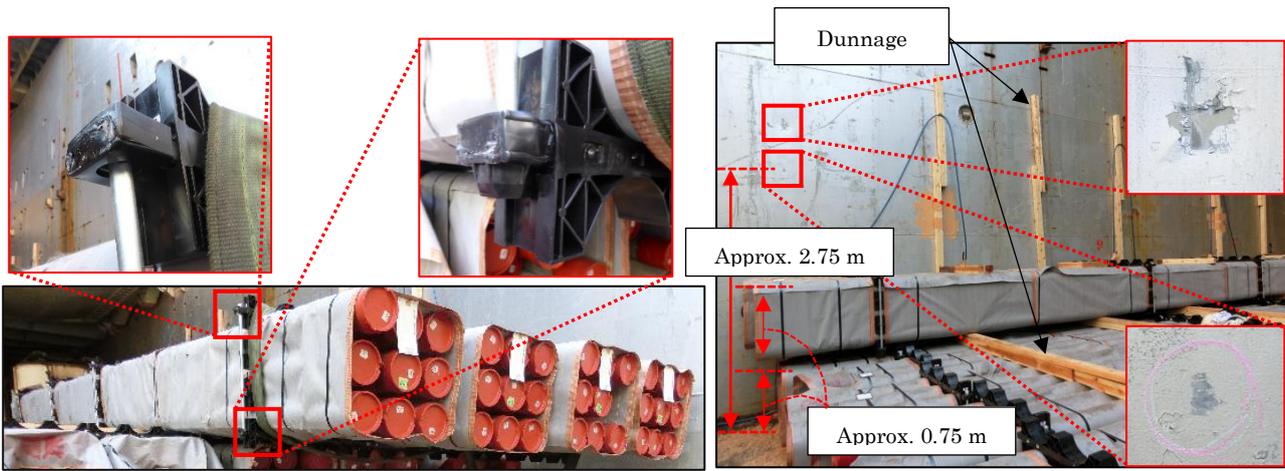
Vessel A had abrasions on the starboard wall of her No. 2 cargo hold. Eight bundles of Bundled Pipe, including the Pipes, also had abrasions. The location of the abrasions on the starboard wall of the No. 2 cargo hold was approximately 15.82 meters from the forward wall of the cargo hold and approximately 2.75 meters above the inner bottom plating. (See Photo 2.3-1 and Photo 2.3-2)

Photo 2.3-1 Pipe Cases

Photo 2.3-2 Abrasions on the Starboard Wall

According to 2.3, it is highly probable that the accident caused abrasions on the starboard wall of Vessel A's No. 2 cargo hold and abrasions on eight bundles of Bundled Pipe, including the Pipes.

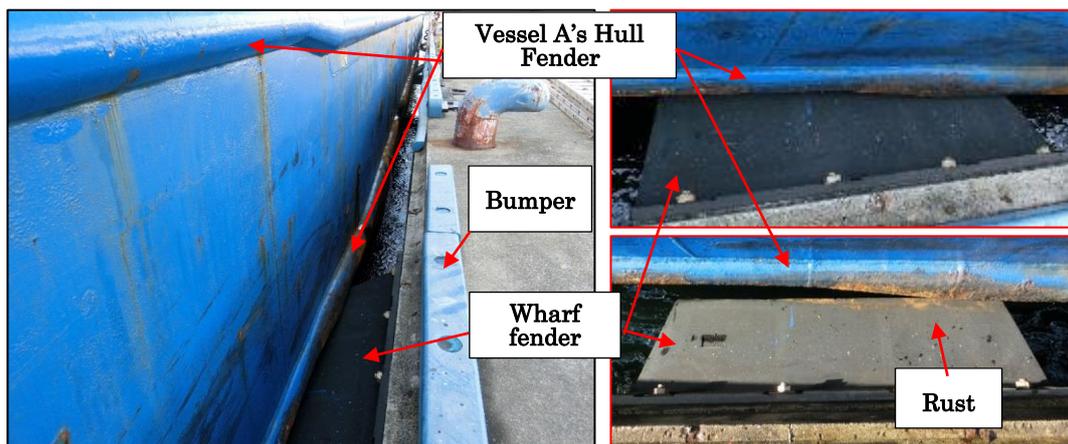
Photo 2.5-2 Fenders on the Wharf

At around 13:00 on November 1, with a height of tide (end of outgoing tide) and draft equivalent to those at the time of the accident, the underside of Vessel A's starboard-side Hull Fender contacted with and became caught on the tops of three fenders on the Wharf at approximately 30 meters, 49.6 meters, and 69.4 meters from Vessel A's stern end toward the bow. When the underside of the Hull Fender came off the tops of the wharf fenders, Vessel A's hull inclined toward the starboard side and rolled several times. Additionally, rust from the underside of Vessel A's Hull Fender was on the tops of the fenders on the Wharf. (See Photo 2.5-2)

- (2) Demand that crew members of vessels with fenders installed on the hull sides cooperate in preventing hull rolling caused by the catching of hull fenders and wharf fenders by, for example, holding meetings prior to the start of cargo-handling and adjusting draft to the tide so that catching does not occur.

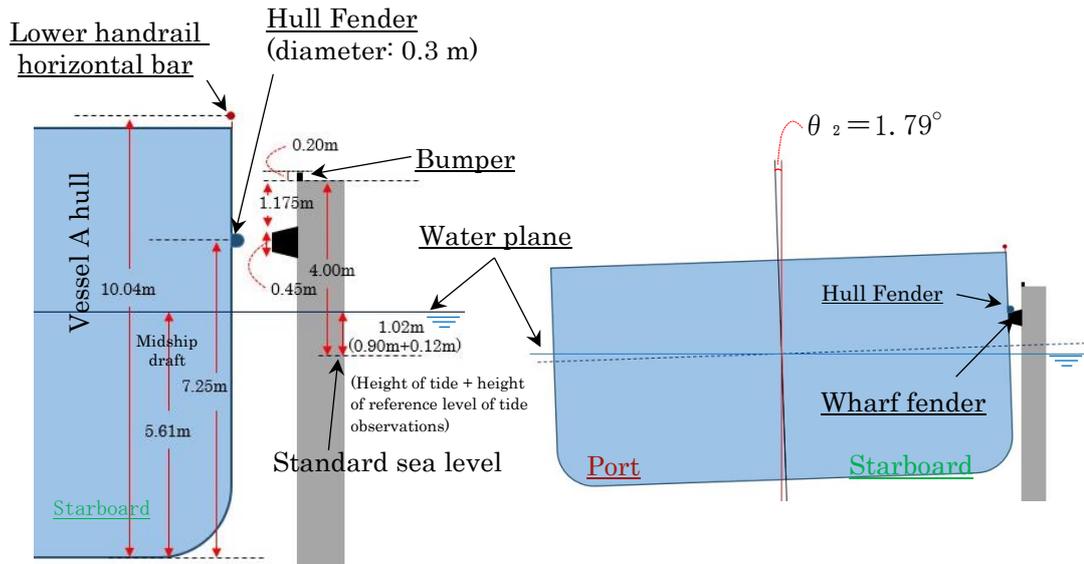
Figure 2.9-1 Positional Relationship between the Hull and Wharf

The positional relationship between the hull and the wharf is as shown in Figure 2.9-1. The hull inclination angle θ_2 is approximately 1.79° to the port side.

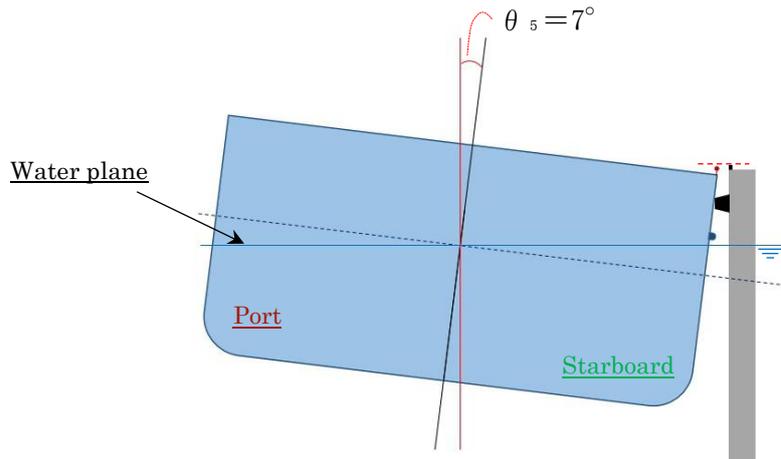
Figure 2.9-2 Circumstances of the Hull Inclination Angle at the Time of the Accident

According to the statement of Stevedore F, the hull inclination angle at the time of the accident was in a state in which the lower horizontal bar of the handrail installed on Vessel A's starboard upper deck was roughly at the same height as the Wharf's bumper. This would make hull inclination angle θ_5 7° to the starboard side, which roughly matches inclination angle θ_4 . (See Figure 2.9-2)

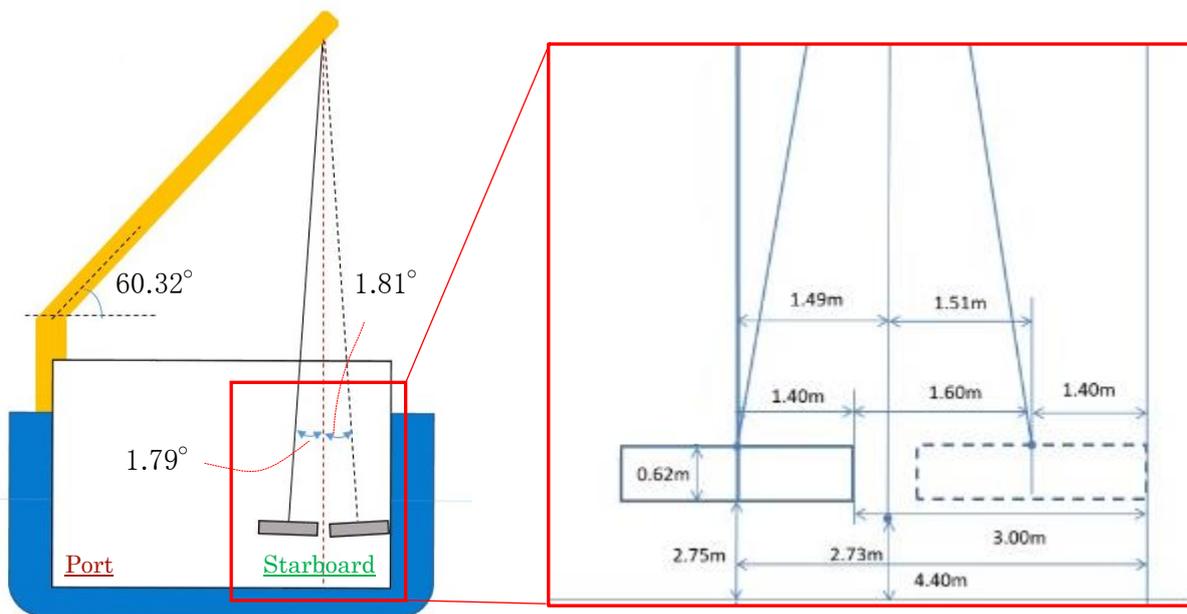
Figure 2.9-3 Positional relationship between the Pipes and the Starboard Wall

In the case of (2) 2) above, the Pipes were stopped at a position approximately three meters from the No. 2 cargo hold's starboard wall. Thus, the Pipes were in a state in which they would contact with the starboard wall on a pendular traveling path centered on the crane jib's end in the event of an approximately 1.81° inclination of the hull to the starboard side. (See Figure 2.9-3)

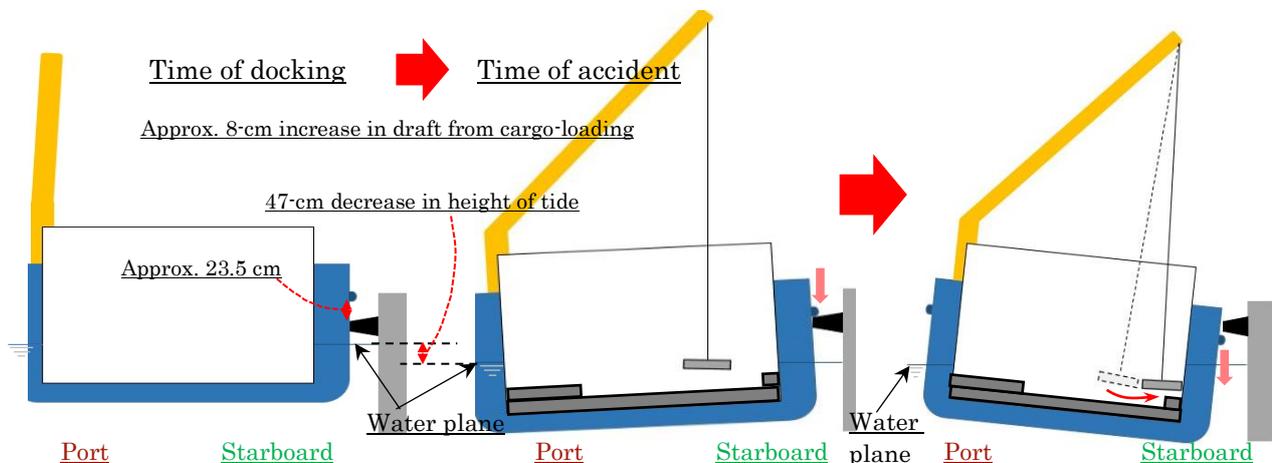
Figure 3-2 Circumstances of the Accident

- (3) Because, at the time of the accident, Vessel A's hull rolled and she inclined approximately 7° to the starboard side, the stopped Pipes swung in the starboard direction on a pendular traveling path centered on the crane jib's end and collided with the starboard wall of the No. 2 cargo hold. (See Figure 3.2)
