MARINE ACCIDENT  
INVESTIGATION REPORT

Vessel type and name: Cargo Ship REAL

Accident type: Grounding

Location: Fushiki-Toyama Port, Toyama Prefecture

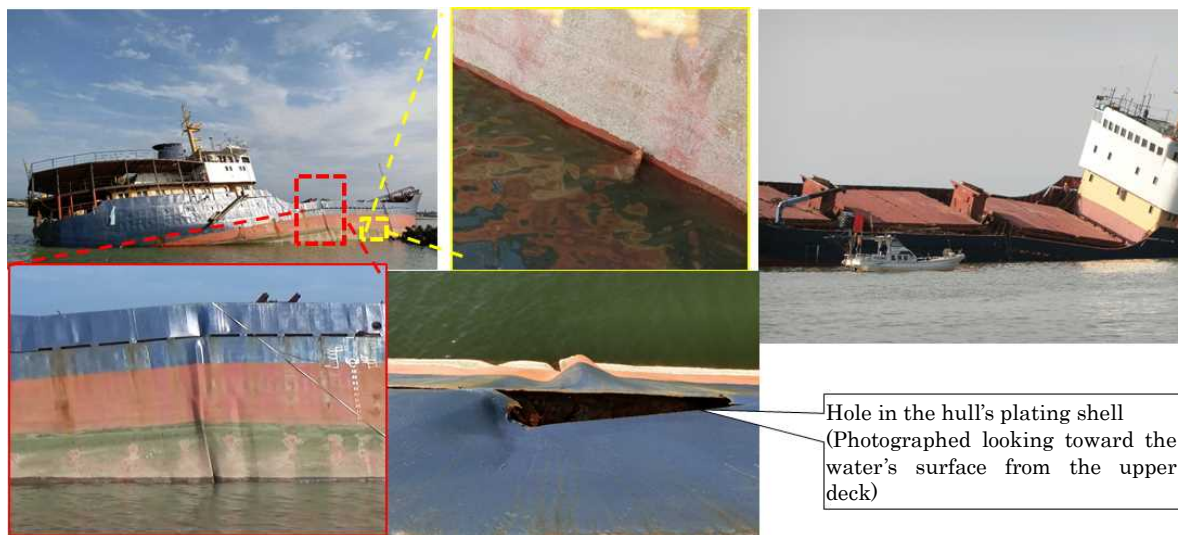
Photo 2.3 Hull Damage

According to the onsite investigations and statement of the person in charge at the salvage company, the Vessel was a total loss, as the area near the Vessel's midship was fractured to a large extent and there were breaches, cracks, and dents in all parts of the hull. The Vessel was removed from the Breakwater by the salvage company on January 7, 2018.

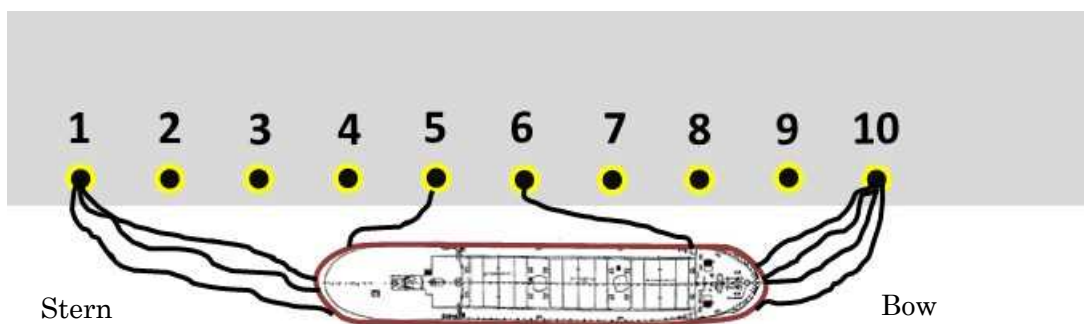
Figure 2.7-2 Mooring Condition of the Vessel (Conceptual Image)

- (5) Given that, although additional mooring ropes were added in preparation for heavy weather, the Vessel was moored in a state in which ropes of different diameters were used together and all of the ropes were made fast in a slack condition with none being taut, it is somewhat likely that the addition of mooring ropes was not effective.

- (3) It is somewhat likely that, although additional mooring ropes had been added under conditions in which external force was being applied by heavy weather, the use of multiple mooring ropes of different diameters and the fact that the Vessel was moored with ropes made slack contributed to the breaking of the mooring ropes.

- (1) For the use of mooring ropes, masters must appropriately conduct maintenance inspections, must not use ropes that have lost strength from degradation, and must not use ropes of different diameters together. Additionally, regarding the berth mooring method in heavy weather, masters must appropriately add mooring ropes by, for example, adding tension so that load is distributed evenly.
- (2) When heavy weather attributable to a typhoon or other phenomenon is predicted, masters must
  - 1) Strive to accurately ascertain and predict weather and sea conditions;
  - 2) Accurately ascertain port characteristics; and
  - 3) Based on 1) and 2) above, quickly execute necessary heavy-weather countermeasures, including considering evacuation.

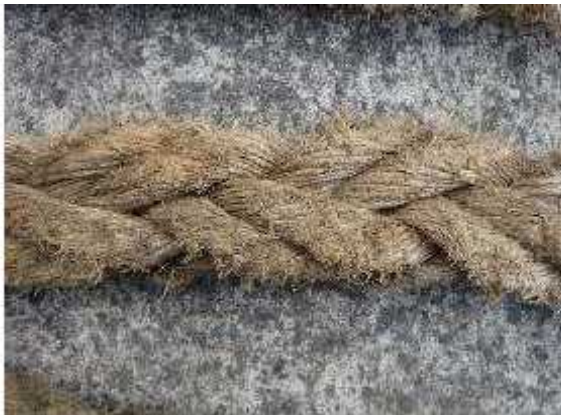
Photo 2.9-1 Fuzzing

- (5) Two ropes had traces of melting.
  - (6) Two ropes had breaks in the strands themselves.
- (See Photos 2.9-1, 2.9-2, 2.9-3, and 2.9-4)

- (1) Given that, based on the appearance inspection by the Manufacturer, fuzzing was observed in all lines and traces of melting and broken strands were seen in some ropes, and that some ropes had decreased strength with a breaking load confirmed to be at least 30% below the standard load in the tension test, it is probable that fatigue degradation and age degradation had occurred in the mooring ropes the Vessel used at the time of the accident.

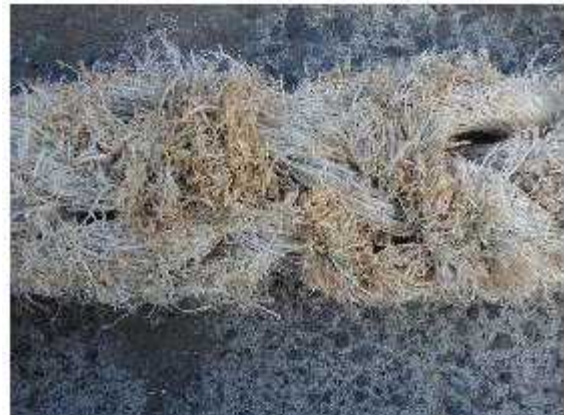
Photo 2.9-2 Inability to Distinguish Strand Shapes

- (1) All of the mooring ropes were synthetic fiber ropes (polypropylene).
- (2) The ropes' diameters were largely classified into the 50-mm level, 60-mm level, and 70-mm level. The classifications numbered four ropes, two ropes, and three ropes, respectively.
- (3) Fuzzing was observed in all of the mooring ropes.
- (4) Six ropes had fuzzing so advanced that the shapes of the strands<sup>\*13</sup> could not be distinguished.

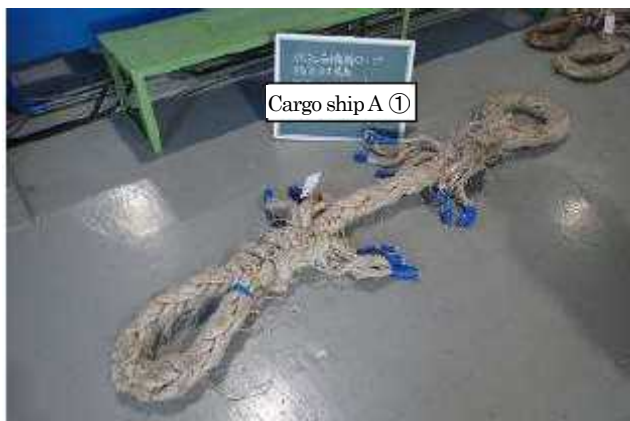
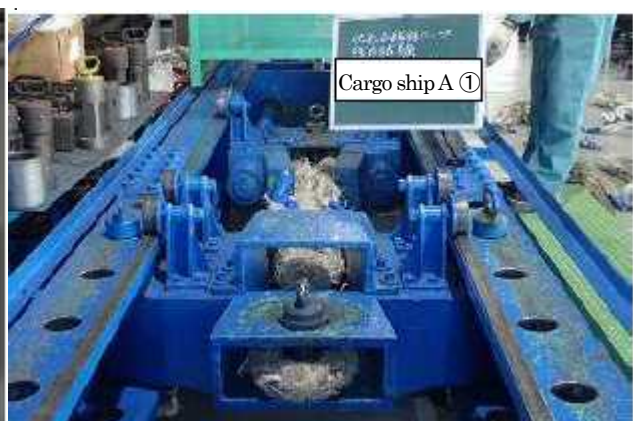
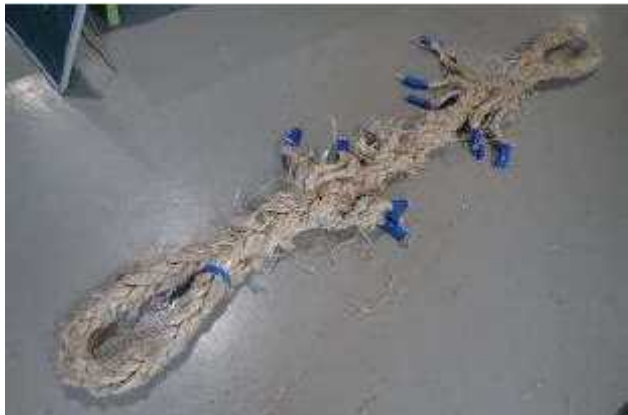
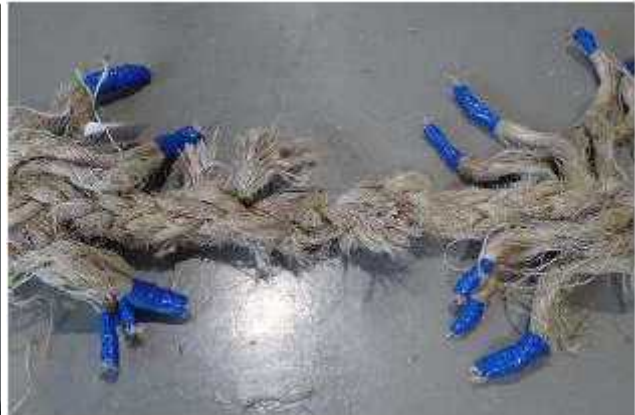
For each mooring rope, the Manufacturer took approximately six meters from a section as a test piece for tension testing, spliced eyes on both ends, conducted a rupture test using a tension tester, and then measured the remaining strength. (See Photos 2.9-5 to Photo 2.9-8)

- (1) The results of a comparison of the breaking load of individual ropes based on the tension test with the Manufacturer's standard (guaranteed breaking load at the time of manufacture and shipment) for the standard load corresponding to the determined diameter of those ropes are as shown in the Table 2.9 below.
- (2) Six ropes fell below a residual rate (breaking load/standard load) of 70% vis-à-vis the Manufacturer's standard, which is generally used as a rough guide for assessing the timing of a rope's retirement or replacement (red areas in the table).

- (1) It is probable that "fatigue degradation," whereby fatigue accumulates in a mooring rope when load is placed on it with each use and with repeated use, resulting in loss of the rope's original ability and quality, and "age degradation," whereby a mooring rope is gradually subjected to ultraviolet rays and other elements with the passage of time after its manufacture, resulting in loss of the rope's original ability and quality, occurred. It is probable that the mooring ropes' breaking strength (load) had fallen as a result of these
