**MARINE ACCIDENT
INVESTIGATION REPORT**

Vessel type and name: Container vessel NYK VENUS

Vessel type and name: Container vessel SITC OSAKA

Accident type: Collision

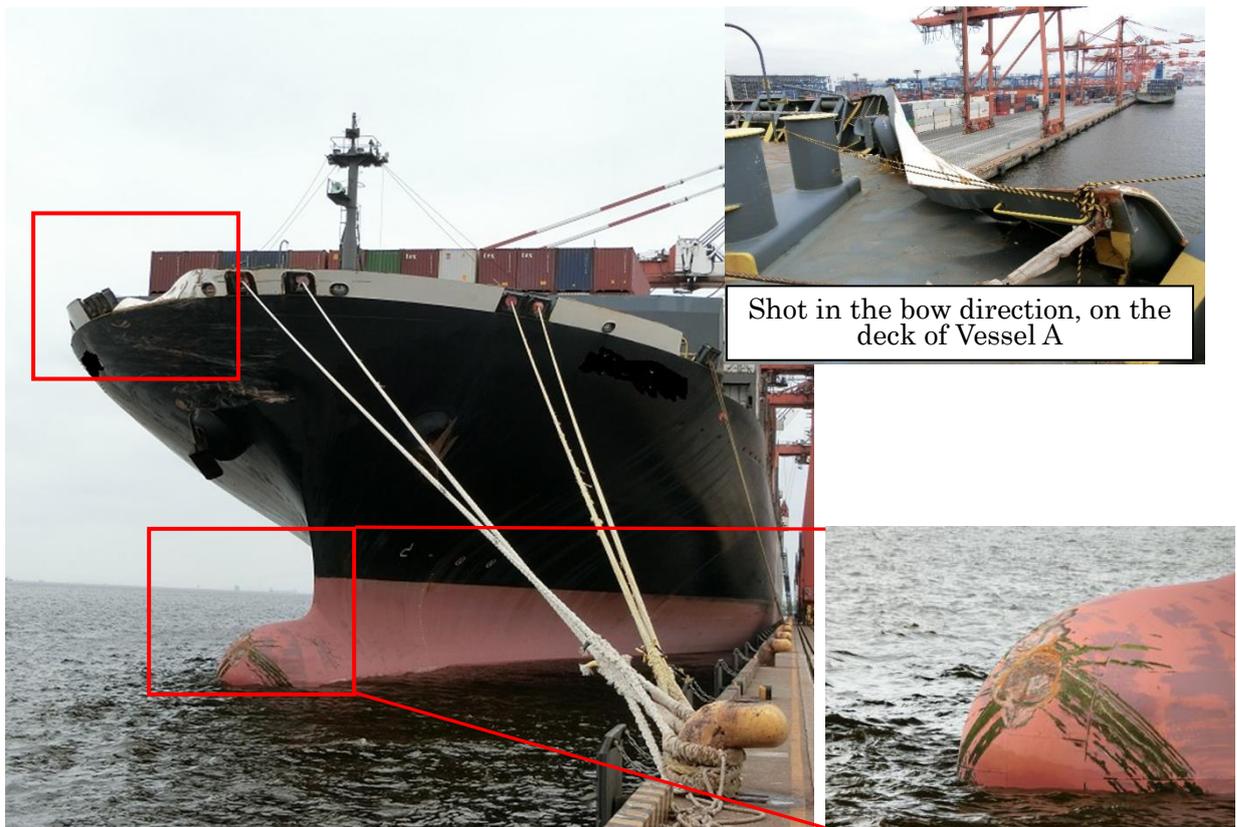
Photo 2.3-1 Damage status of Vessel A

(1) Vessel A got a bend damage in the bulwark and others of the starboard bow, abrasion on the shell plate of the starboard bow, and a concave damage in the bulbous bow.

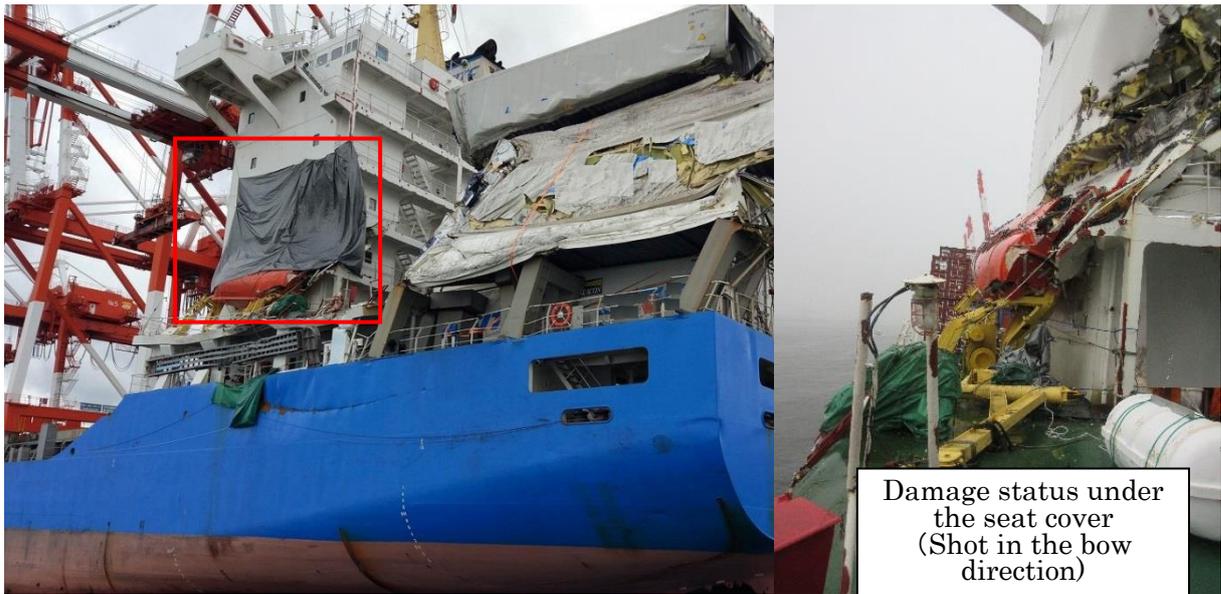
Photo 2.3-2 Damage status of Vessel B

(2) Vessel B was damaged in the accommodation spaces etc. on the port side stern, and according to the statement by the SITC SHIPS MANAGEMENT CO., LTD., the management company of Vessel B (hereinafter referred to as "Company B"), Vessel B occurred cracks in the port bottom shell.
