**MARINE INCIDENT
INVESTIGATION REPORT**

Vessel type and name: Container Ship WAN HAI 316

Incident type: Grounding

Location: 4B Anchorage, Nagoya Port, Aichi Prefecture

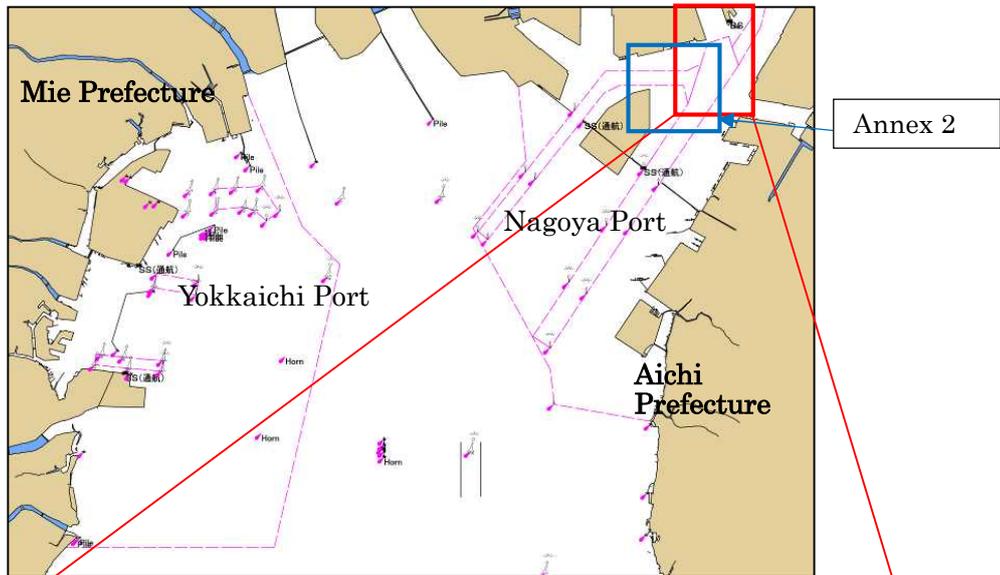
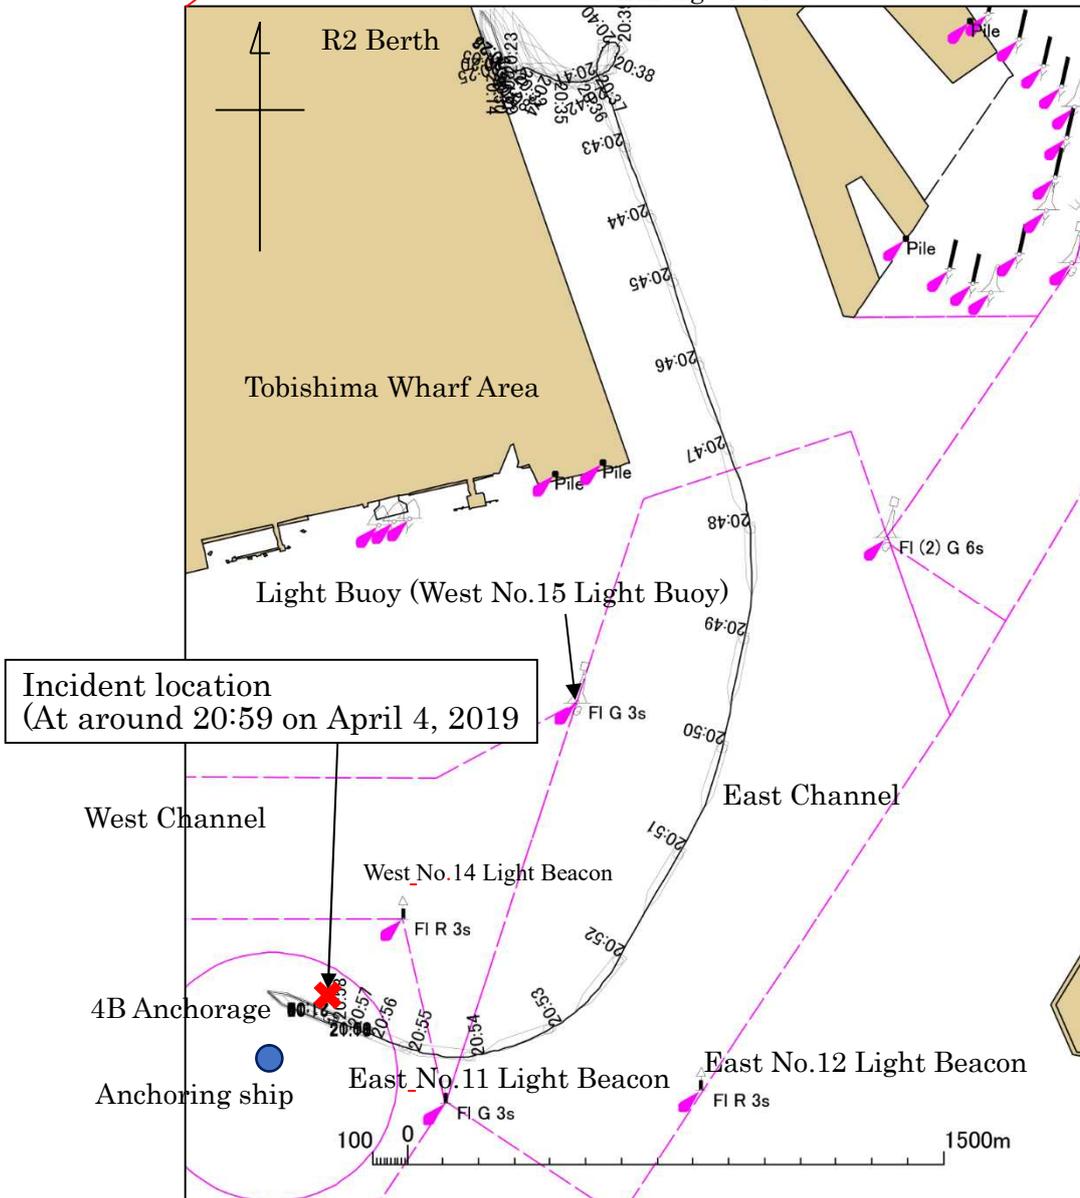
Annex 1 Estimated Navigation Route

It is considered probable that this incident occurred, while the Vessel was proceeding the south in the East Channel of Nagoya Port for Yokkaichi Port in the nighttime, a pilot trainee (hereinafter referred to as "Pilot A") was conducting pilotage operation as part of practical training for new pilot under guidance and evaluation of a supervising pilot (hereinafter referred to as "Pilot B"), Pilot A passed and continued the Vessel to proceed the south without noticing the Nagoya Port West Channel No.15 Light Buoy (hereinafter referred to as "the Light Buoy"), which was the bearing target to turn to the starboard for the West Channel of Nagoya Port, and then Pilot A instructed the rudder angle of starboard 15° without confirming the Vessel position due to being urged to the starboard turn by Pilot B when the Vessel was at the east offing of the West Channel No. 14 Light Beacon, Nagoya Port (hereinafter referred to as the "West 14 Light Beacon"), and furthermore Pilot B instructed the rudder angle of hard to starboard because, the Vessel was turning to the starboard and proceeded 4B Anchorage, with the result that the Vessel ran aground at 4B Anchorage.

It is considered probable that Pilot A passed the Light Buoy and continued to proceed the south without noticing the Light Buoy, because it might be that the speed of Vessel was a little higher at approximately 8 knot when he passed the southeast end of Tobishima Wharf and turned to the starboard, and moreover he paid attention to the East 12 Light Beacon as the next bearing target in situation of increasing the ship speed, and then after noticing the Vessel passing the Light Buoy, and subsequently he did not determine immediately whether he would be able to make the starboard turn in time for the West Channel or not.

It is considered probable that Pilot A instructed the rudder angle of starboard turn 15° without confirming the Vessel position due to urging to take the starboard turn by Pilot B, because he thought that the evaluation operation had been suspended and Pilot B had maneuvering command of the Vessel.
