RA2017-8-II

Railway Accident Investigation Report

Train Derailment Accident
between Kumamoto station and Kumamoto General Train Depot
of the Kyushu Shinkansen of the Kyushu Railway Company

Japan Transport Safety Board

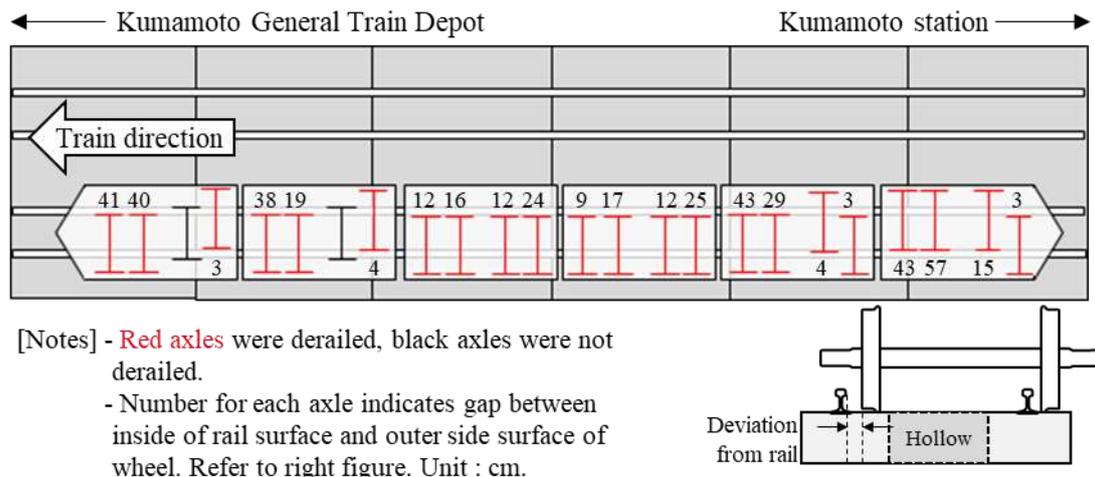
Figure 1. Status etc. of each axle after the occurrence of the accident

The front head of the accident train was halted at around 99,461 m and all axles, except for the 3rd axle in the 1st vehicle and the 3rd axle in the 2nd vehicle, had been derailed when the investigation of the accident site was implemented. The 6 axles had been derailed to right and the 16 axles had been derailed to left of the track, and the most deviated axle was the 2nd axle in the 6th vehicle, in which the axle box suspension device was damaged, and its left wheel had been derailed to inside gauge by 57 cm apart from left rail, as shown in Figure 1.

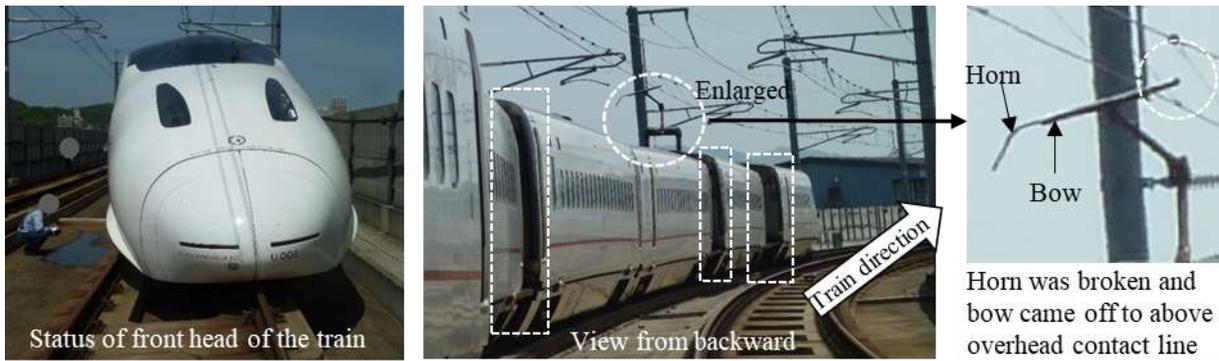
Figure 2. Status of the accident train at the investigation of the accident site.

When the investigation of the accident site was implemented, vehicles were displaced with each other in lateral direction, and the front head of the accident train deviated to left by about half of the gauge and center of the front head deviated to just above the left rail, as shown in Figure 2. The pantograph equipped on the 2nd vehicle had been in the lifted position, but its bow had come off to above the overhead contact line. The right horn of the pantograph, considered as to contact with hanger of the overhead contact line, was broken away, and the broken piece was found in beneath the Rendaiji No.1 viaduct, hereinafter referred to as "No.1 Rendaiji BL", around the border of Kagoshima main line and Kumamoto Vehicle Center, about 20 to 30 m apart from Tsuboigawa Bridge, hereinafter referred to as "Tsuboigawa B", in the direction to Kumamoto General Train Depot, according to the Company.

There was no trace considered as running on the slab track, in the tip of flanges of left and right wheels of the 3rd axles in the 1st and 2nd vehicles.

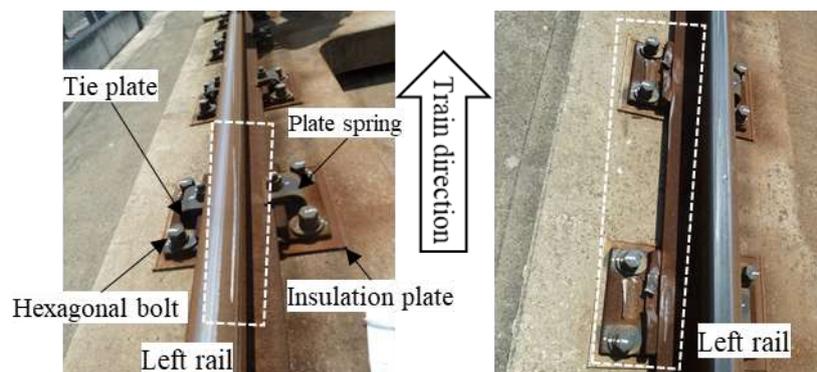
Figure 3. Traces of the derailment, around 99,157 m in left, and around 99,160 m in right

There was linear trace considered as caused by the wheel flanges running on the top surface of left rail in around 99,157 m, *hereinafter referred to as the "start point of the derailed trace"*, and there were damages considered as caused by the wheels running on the rail fastening devices and the bottom of rail in outside gauge of left rail in around 99,160 m, but there was no trace considered as wheel flanges climbed up rails. In addition, there was no trace considered as to relate with the derailment on the track in the direction to Kumamoto station from there. Traces of the derailment were shown in Figure 3. There was the black adhesion considered as the gear oil leaked from gear box of the driving device on the top surface of left rail in around 99,160 m. There were black adhesions, as same as described in the above, discretely on the rail and the frame shaped slab^{*8} from around 99,160 m in the direction to Kumamoto General Train Depot.

There were damages considered as being hit by the wheels or the underfloor equipment on the front wall of inside frame of the frame shaped slab, *hereinafter referred to as "the hollow in frame shaped slab"* refer to Figure 5, from around 99,200 m to the position where the accident train had stopped. The damaged level became severer gradually according to the movement of the train, but it became smaller gradually to the point where the accident train stopped. There were many black adhesions described in above and the traces etc. being scraped by the underfloor equipment and their cover plates, etc. of the vehicle on the top of rail, and many traces etc. considered as caused by the wheels passing on and the underfloor equipment of vehicles coming into contact with the rail fastening devices, bottom of rail and the frame shaped slab in the same section.

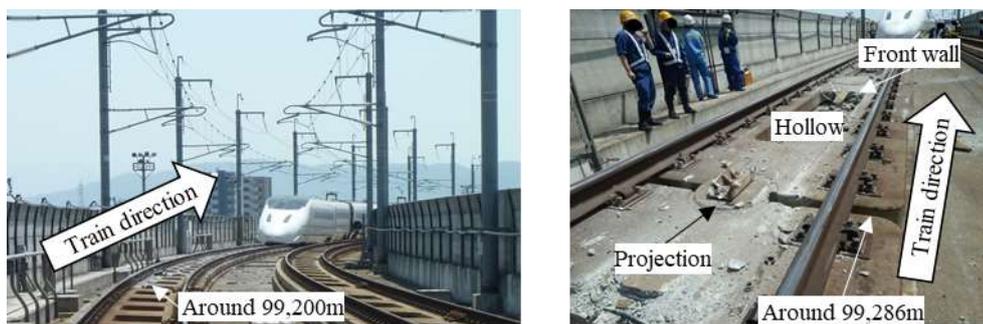
Figure 5. Damaged status of frame shaped slab.

The split damage etc. were found in the front wall and left and right walls in the hollows and side surfaces of the frame shaped slab in the inspection of the accident site. These damages existed in around 99,200 m to around 99,450 m, but remarkable damages existed from around 99,200 m to around 99,407 m. The damaged status of the frame shaped slab were shown in Figure 5.

Here, there were no angular rotation nor joint stagger on the track.

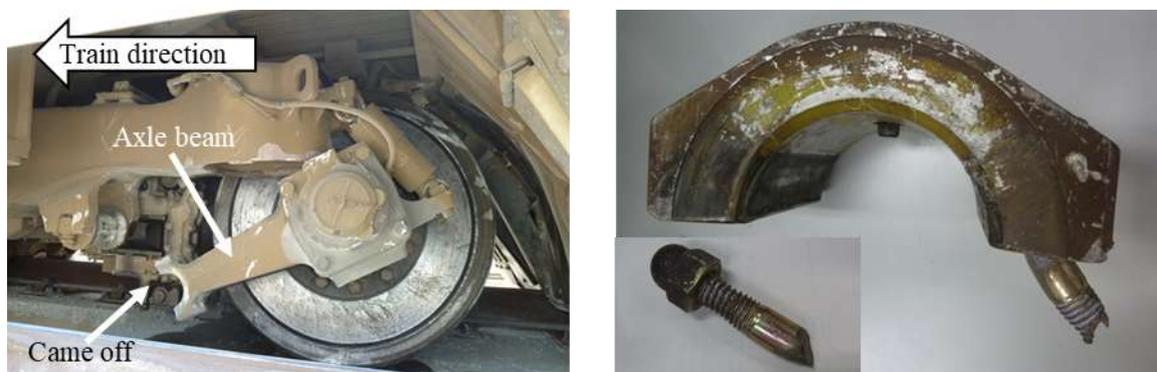
Figure 6. Damaged status of axle box suspension device, status at just after the accident in left, holding metal and snapped and broken bolt in right

Many damages were found in bogies, yaw damper between vehicles and underfloor equipment such as automatic leveling device, lower part of gear box, lower part of traction motor, cover plates, etc. Some air suspensions in the 5th and 6th vehicles were damaged. The fitting bolts snapped and broken, axle beam came off and axle spring fell away, in left axle box suspension device of the 2nd axle of the 6th vehicle. There was no beach mark etc. that is the trace caused by metal fatigue, in the broken surface of the fitting bolts.

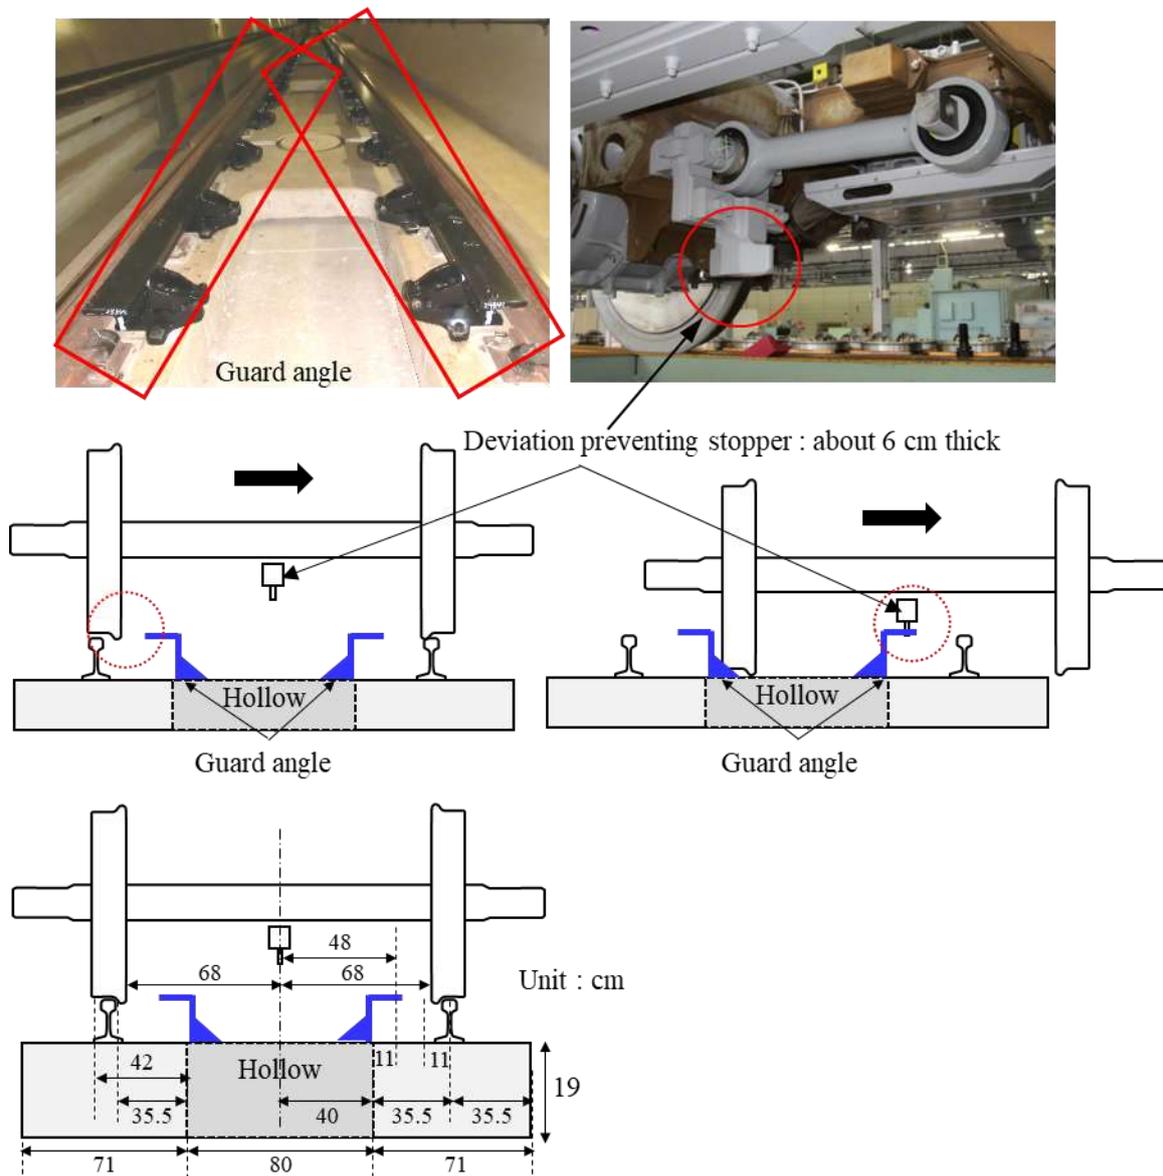
Figure 7. Positional relationship in lateral direction of guard angle, deviation preventing stopper and frame shaped slab

The Company has been promoted to equip guard angles on the track to prevent train derailment accident caused by earthquakes, and to equip the deviation preventing stoppers to vehicles to prevent running as being deviated widely from the track even if train was derailed, from 2012. The guard angles prevent derailment by being in contact with back surface of wheels, and the deviation preventing stopper prevent deviation by being in contact with the guard angle. The attached status of the guard angles and the deviation preventing stopper and the status of being in contact with each other are shown in Figure 7. Here, in Figure 7, the equipment mounted on bogie frame and underfloor equipment of vehicle were omitted to simplify the explanation.

On the other hand, the deviation preventing stoppers were equipped in the 13 train sets in total 20 train sets of the Shinkansen trains of the Company when the accident occurred. But the deviation preventing stoppers were not equipped to the accident train when the accident occurred, even though there was a plan to equip them in July 2016.

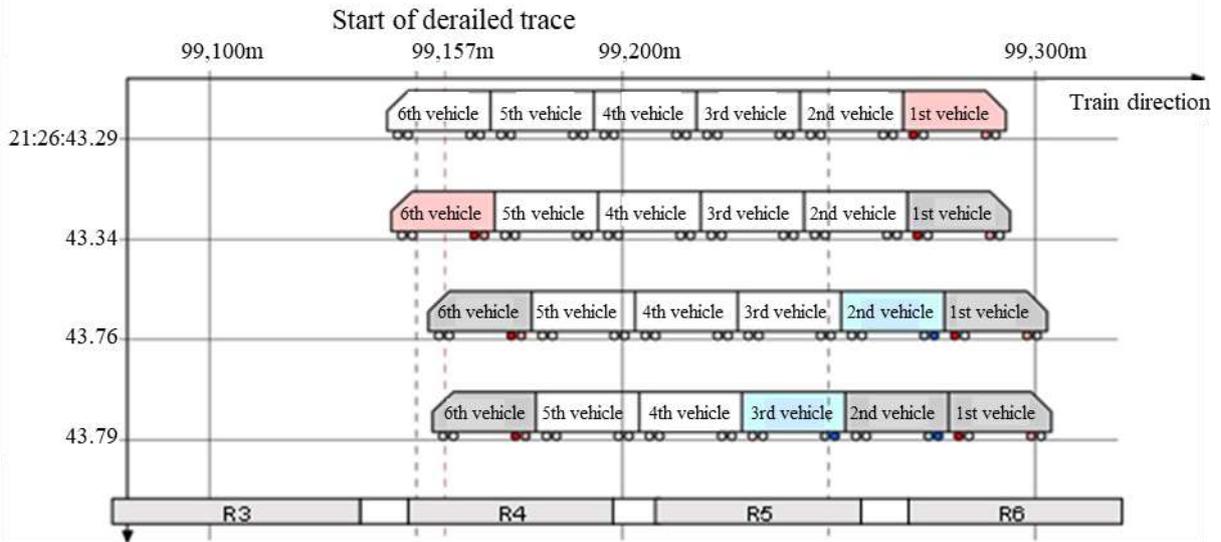
Figure 20. Position of vehicles and derailed axles when derailed

- : Derailed to right ○ : Climbed up to right when derailed
- : Derailed to left ○ : Climbed up to left when derailed
