~ Accident that the train derailed due to gauge widening by the decreased rail fastening force, because the sleepers, being judged as inferior, had not been treated as replaced, etc. ~

Railway operator : Keiyorinkai Co., Ltd.
 Accident type : Train derailment
 Date and time : At about 13:46, June 16, 2018
 Location : In the premises of Soga station, Rinkai Main Line, Chiba City, Chiba Prefecture

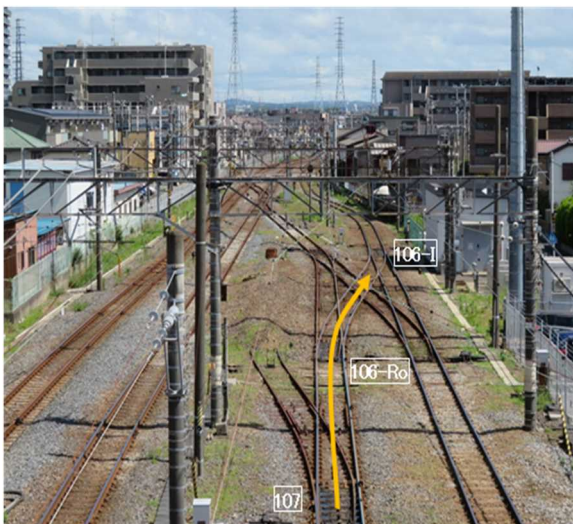
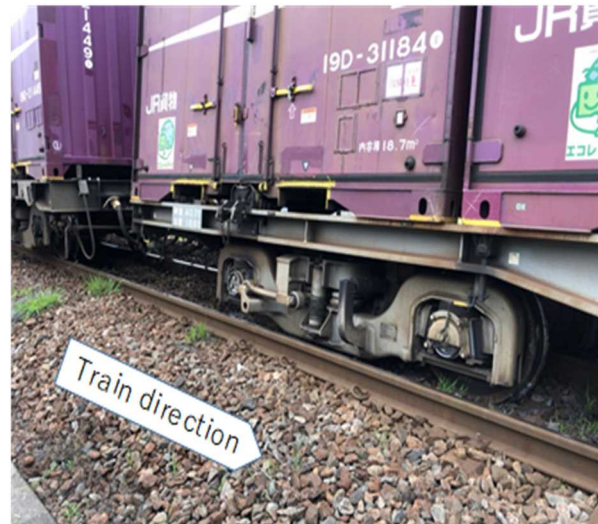
The 4th vehicle of the concerned train had derailed to left. All the right wheels of the 4th vehicle had derailed to inside gauge. All the left wheels of the 4th vehicle had derailed to left of the track, and the derailed left wheels were in the status as being buried partly in the crashed stones.

It is highly probable that the start point of the derailment of the concerned train was in around the center part of the lead area in the 106-B turnout.

It is probable that the gauge in around the 106-B turnout widened due to the decreased rail fastening force caused as the Japan Freight Railway Company, who was in charge of the management of track maintenance, had not implemented the measures such as the replacement of sleepers or the repairing work, etc., although the sleepers, which had been judged as inferior in the periodic inspection, existed continuously.

(1) It is desirable for Japan Freight Railway Company to enrich the contents of the education to improve the judging abilities for the place where the attention should be paid as the danger against the derailment to inside gauge caused by the gauge widening is specially increased, such as the place where corrosion of the sleepers, etc., exists continuously, in the educational training of the staffs engaged in the maintenance management and the repair planning of the track. In addition, the company should pay special attention to implement measures such as the replacement of the sleepers or the repair works in high priority in such places where special attention is required.

Furthermore, it is desirable for Japan Freight Railway Company to apply positively the measured results of the dynamic track irregularities obtained by the track inspection car provided from Keiyorinkai Co., Ltd., for the track management as to use for the judgement of the necessity and urgency for the repair works of the track, etc.
