"The level crossing accident caused by the collision of the train and a light automobile, occurred at the class 3 level crossing"

Railway operator : Willer Trains Inc.  
 Accident type : Level crossing accident  
 Date and time : About 14:53, January 29, 2020  
 Location : Kamiyukou level crossing, the class 3 level crossing equipped with road warning device but without crossing gate, at about 12,428 m from the origin in Nishimaizuru station, between Shinonome station and Tangokanzaki station, single track, Miyazu Line, Maizuru City, Kyoto Prefecture

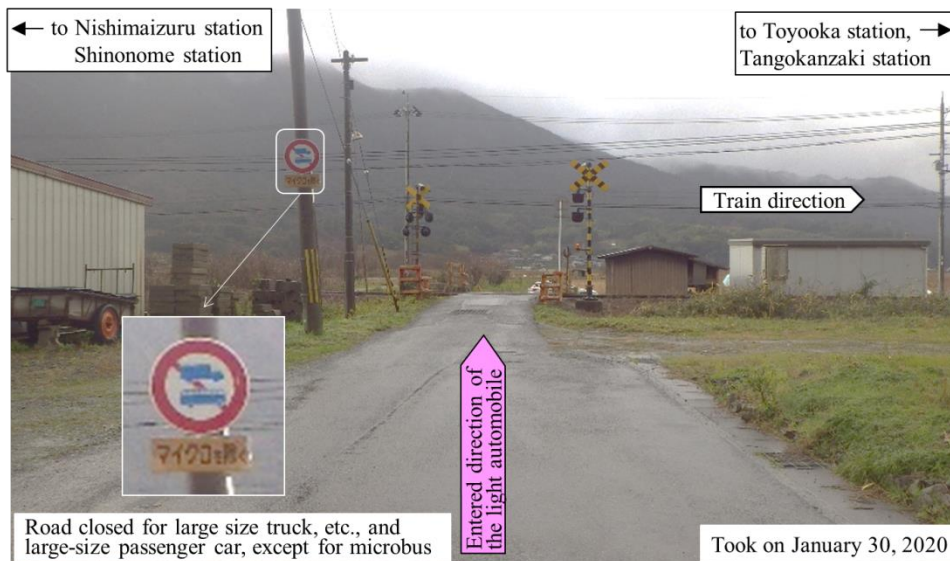
<Status of Kamiyukou level crossing viewed from the entered light automobile>

It is probable that the concerned accident was caused as that the light automobile entered Kamiyukou level crossing, the class 3 level crossing equipped with road warning device, from right in the situation that the road warning device was operating responded to the approaching train, and collided with the train.

It could not be determined the reason why the light automobile entered the concerned level crossing in the situation that road warning device was operating responded to the approaching train, because the driver of the light automobile was dead, although it is considered as the possibility that the driver of the light automobile did not notice the approaching train.

In order to aim improvement of the safety of the concerned level crossing, it is desirable for the concerned company, etc., to prepare the crossing gate for the concerned level crossing. In addition, it is desirable for the concerned company, etc., to make efforts to obtain comprehension and cooperation of the users of the level crossings and the regional residents, etc., toward the preparation of the crossing gate and to implement the safety measures such as to cut down trees and plants growing along the railway track to secure the perspective of the train, to improve the red flash lamps in order to improve visibility of the road warning device, to install the signboard for attention to call attention of the passersby of the level crossing, etc. In addition, it is desirable for the road administrator to implement the safety measures such as to prepare the stop line, etc.
