Railway operator : Tosaden Traffic Co., Ltd.

Serious incident type : Incorrect management of safety block, the railway serious incident related with the situation that train ran in the main track to operate in the safety section, before the completion of the procedures for safety system, prescribed in Clause 1, Article 2 of the Ordinance on Report on Tramway Accidents, etc.

Date and time : About 11:47, March 25, 2019

Location : Around 5,576 m from the origin in Harimayabashi stop, between Asakura stop and Yashiro stop, single track, Ino Line, Kochi City, Kochi Prefecture

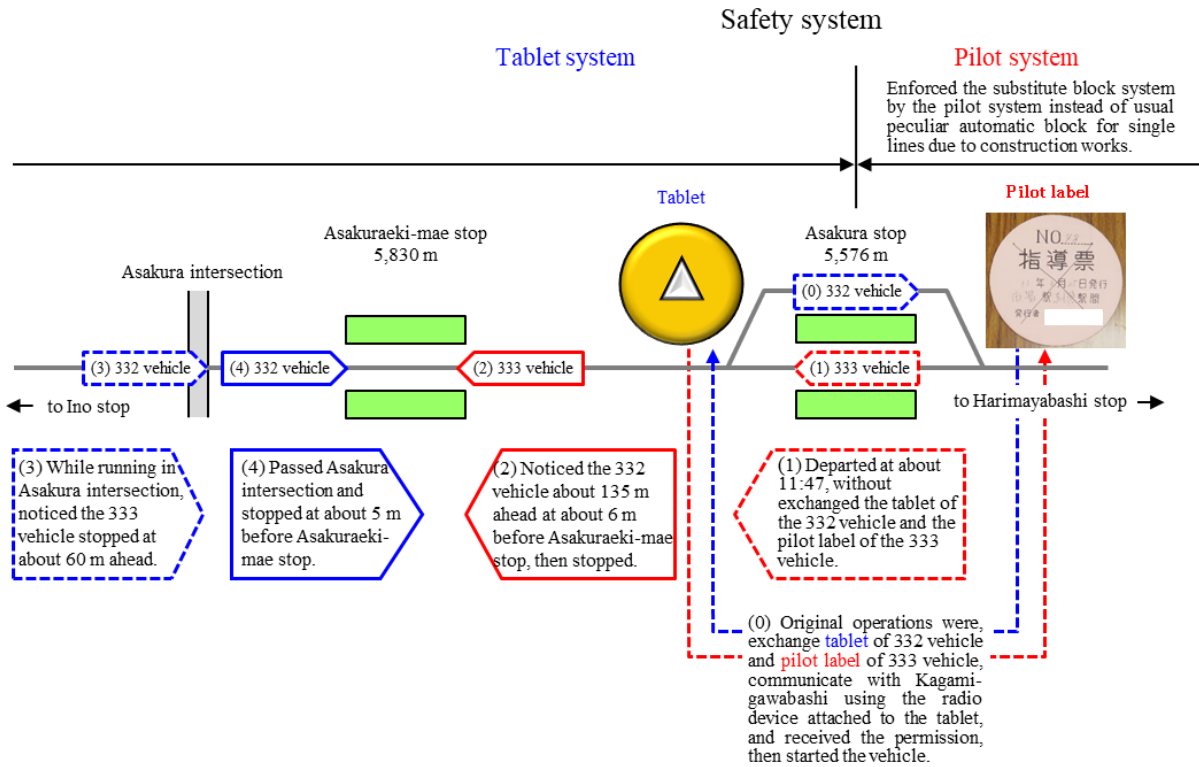
<MOTION OF THE CONCERNED VEHICLE AND THE FACING VEHICLE>

At about 11:47, on Monday, March 25, 2019, the driver of the outbound 333 vehicle, composed of one vehicle started from Monjudori stop bound for Ino stop, Ino Line of Tosaden Traffic Co., Ltd., operated the vehicle to depart from Asakura stop, located in the single track section, without carrying the tablet in the situation that vehicles should be operated in the tablet instrument block system instead of the pilot system that had been enforced temporary between Kagamigawabashi stop and Asakura stop.

After that, while the concerned driver moved the vehicle to about 6 m before Asakuraeki-mae stop, he found the facing outbound 332 vehicle, composed of one vehicle started from Ino stop bound for Monjudori stop, in ahead, then he stopped the 333 vehicle immediately.

On the other hand, the driver of the 332 vehicle, while running in Asakura intersection, located between Asakurajinja-mae stop and Asakuraeki-mae stop, noticed the 333 vehicle halting in ahead, then stopped the 332 vehicle at about 5 m before Asakuraeki-mae stop after passed the concerned intersection.

It is certain that the concerned serious incident occurred because the driver of the 333 vehicle started the 333 vehicle from Asakura stop, in the single track section between Asakura stop and Yashiro stop where the tablet instrument block system was enforcing, without carrying the tablet by himself and entered the safety section where the 332 vehicle was existed.

- (1) It is necessary to prepare the detailed manuals on the proper communication system, notification methods, confirming procedures, operating methods, etc., on the handling operations for the case that the safety system was changed to the pilot system.

- (2) It is necessary to implement the training and the education properly for the company staffs involved in the train operation, and to construct the system and the structure to confirm sufficiently that the educated contents had been understood, after prepared the previous item (1).
