Opinions on the improvement of safety of the freight train operation

On the improvement of running safety of the freight train (Tentative translation)

Summary

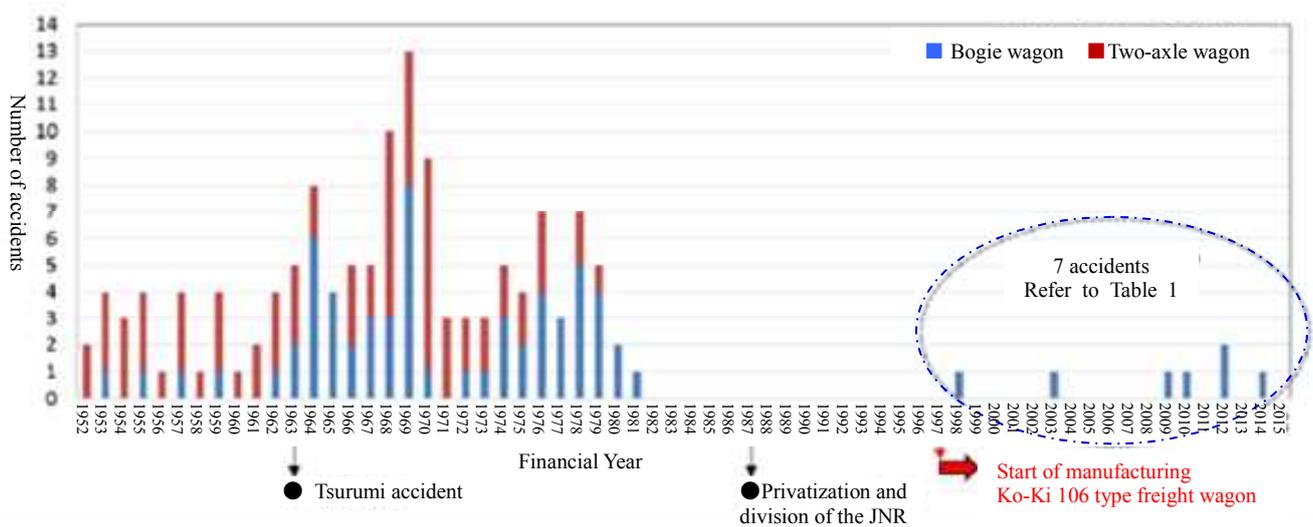
Figure 1 Changes of flange climb derailment and similar derailment accidents of freight wagon.

Figure 1 shows the data about flange climb derailment accidents and the similar accidents occurred after 1952[4]-[6]. The flange climb derailment accidents of freight wagons at main tracks had occurred frequently until around 1980, and probable causes of these accidents were determined as combination of various factors while the vehicles and the tracks were maintained within the criterion values for control, and so called as "multiple-factor derailments". The Tsurumi accident, occurred in Tokaido Main Line in November, 1963, was the multiple collision accident originated by derailment of freight wagon, and became to the disastrous accident killing 161 people. To respond this accident, Japan national railway, at that time, established the investigate committee to conduct a variety of examination including on-track tests, and implemented the measures to prevent multi-factor derailments from the view points of both vehicle and track[7], i.e., softened spring

constants of the secondary suspension of the TR-41 series bogie, remodeled to use with oil dampers, added the combination of alignment and cross-level to the items in the management of track irregularity, etc. As the results of implementation of these measures, there was no multiple-factor derailment accident after 1982, however, in recent years, the same sort of derailment accidents came to happen again.

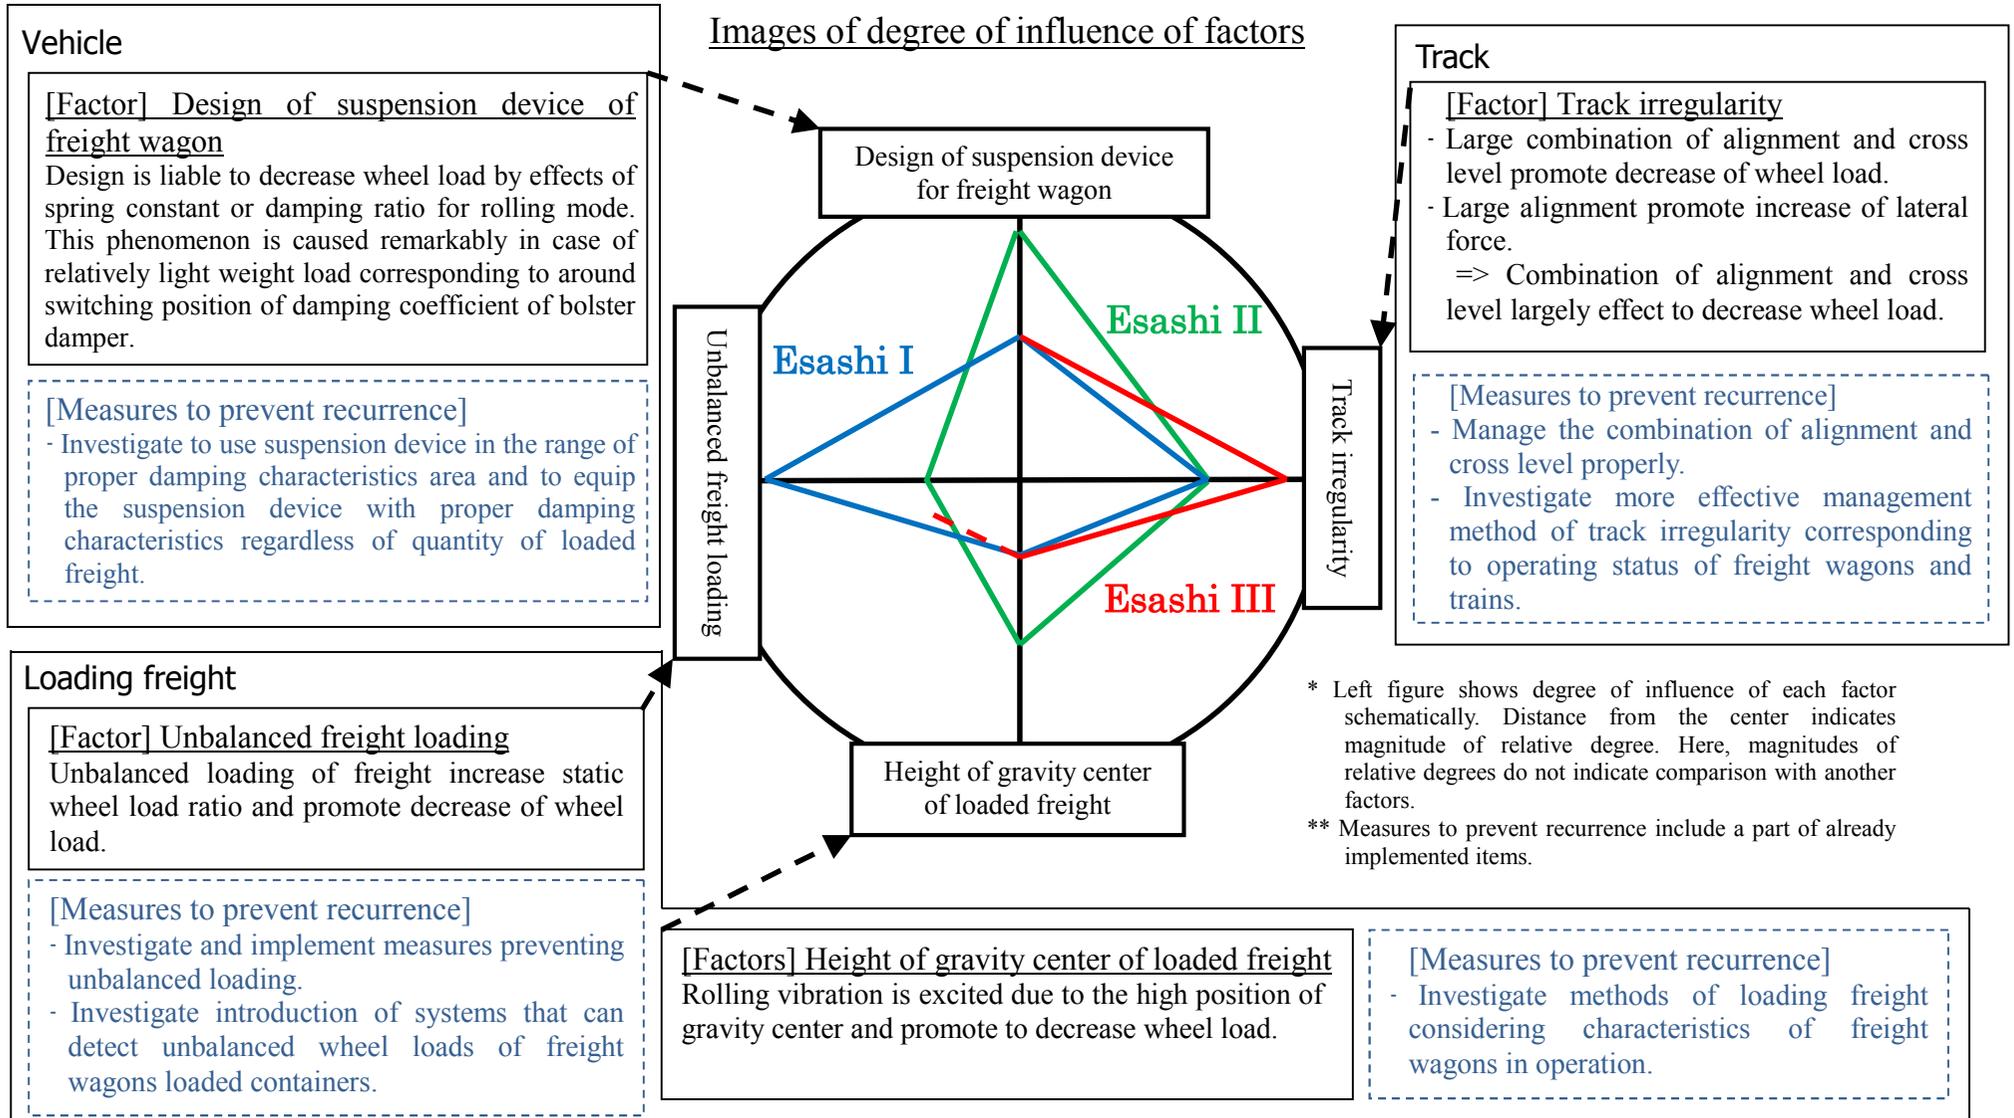
Attached diagram. Factors of the Esashi Line derailment accidents and their degrees of influence, etc.

- A series of the derailment accidents of freight trains occurred in Esashi Line have the common situation that the outer rail side wheels of the freight wagon in the freight train running in relatively sharp curve at near the limited speed, derailed by flange climbing.
- It is somewhat likely that these accidents were caused by the combination of the factors such as vehicles, track, and loading freight, etc., in the worse direction, while each factor would not cause the derailment.
- Here, degrees of influence of the factors to a series of derailment accidents differ as shown in the followings.
