AI2004-3

# AIRCRAFT INCIDENT INVESTIGATION REPORT

JAPAN AIR COMMUTER FLIGHT 031, NAMC YS-11A, JA8781  
PRIVATELY OWNED, CESSNA A185F, N185GW  
OVER THE SEA APPROX. 4NM SOUTH OF OKINOERABU ISLAND  
KAGOSHIMA, JAPAN  
AUGUST 9, 2003

MAY 28, 2004

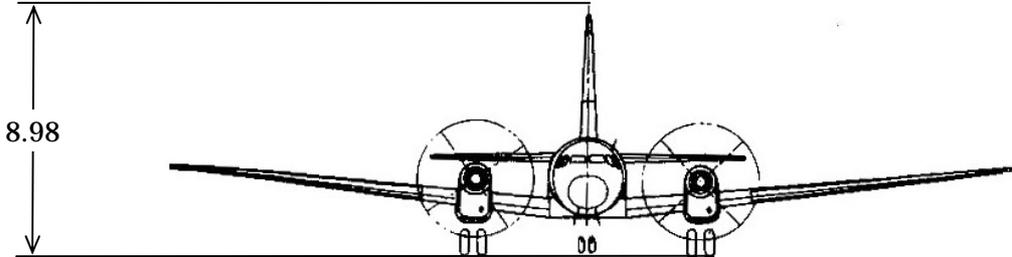
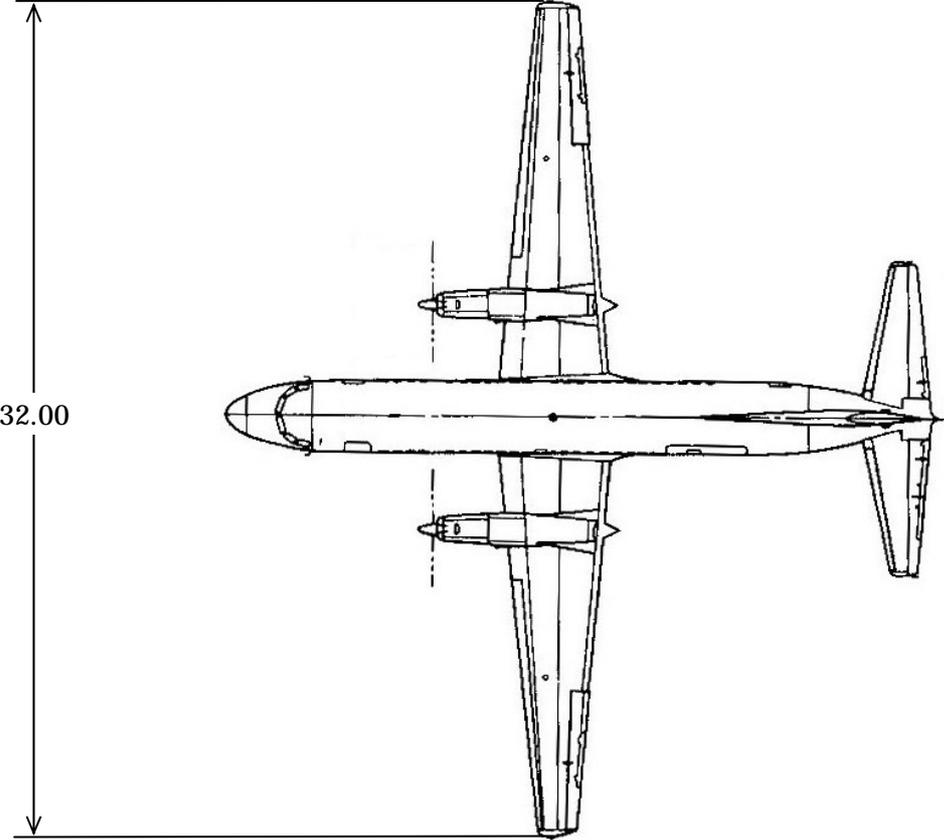
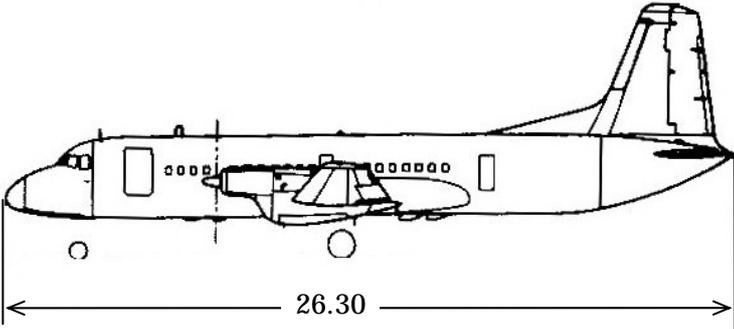
Figure 2: Three-angle view of NAMC YS-11A (Aircraft-A)

Unit: m

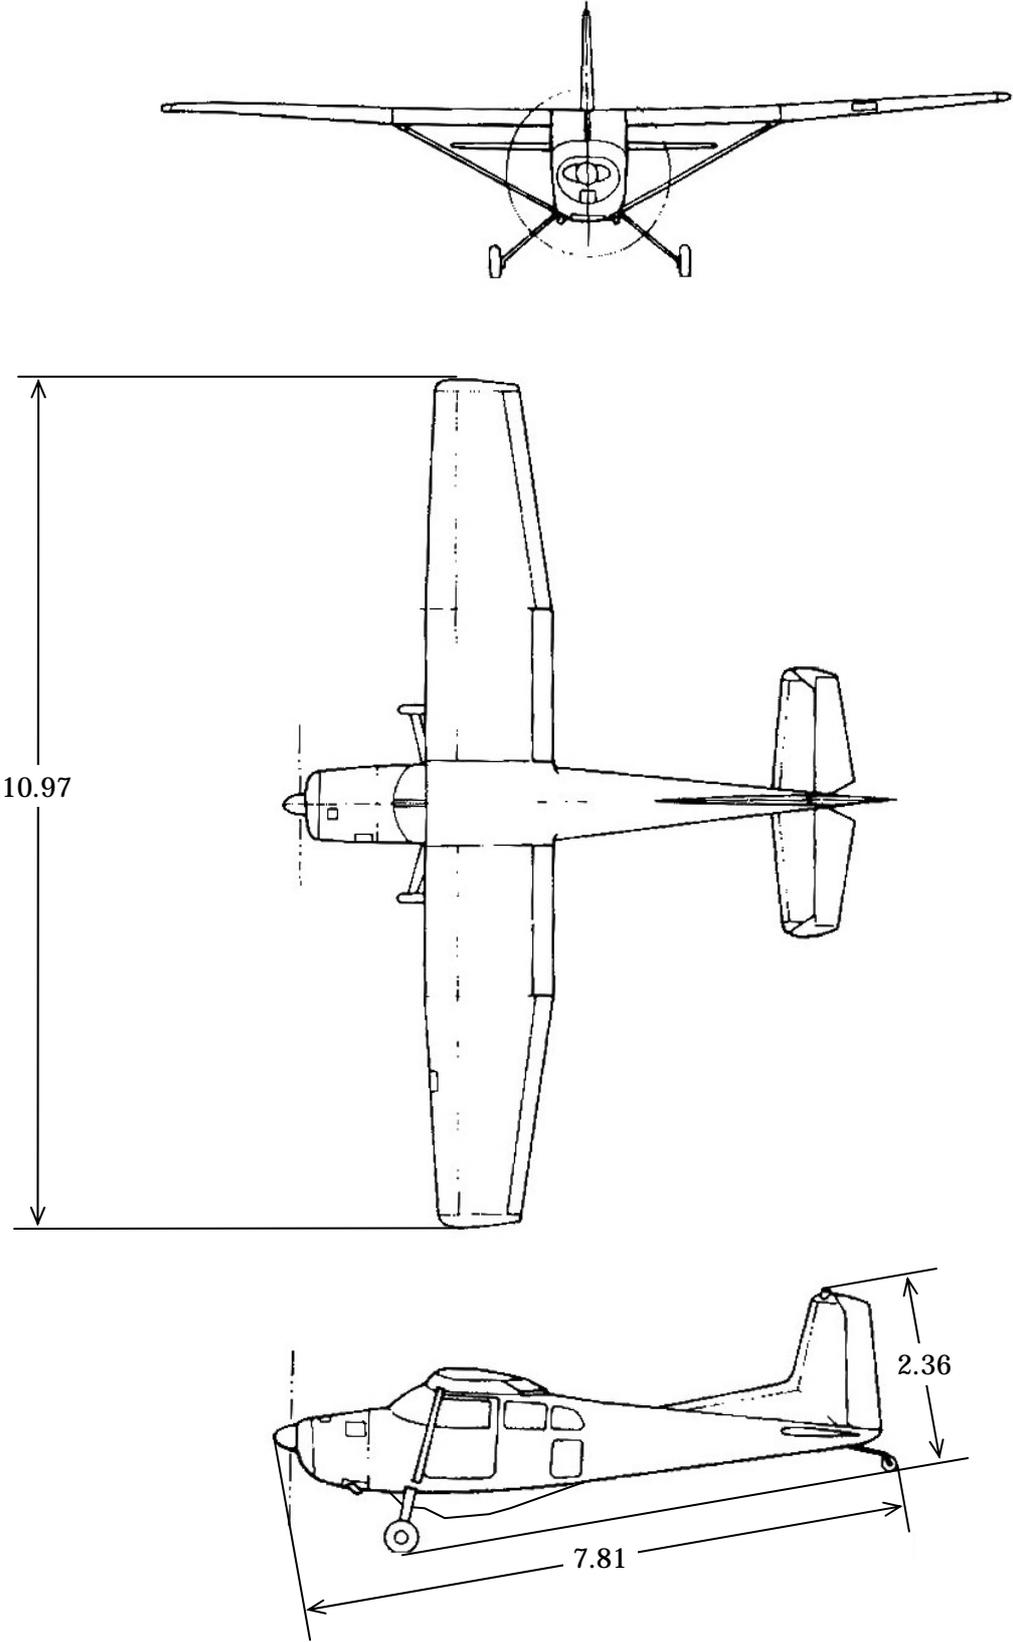
Figure 3: Three-angle view of Cessna A185F (Aircraft-B)

Unit: m

Aircraft-B was a high wing, single-engine fixed wing airplane.

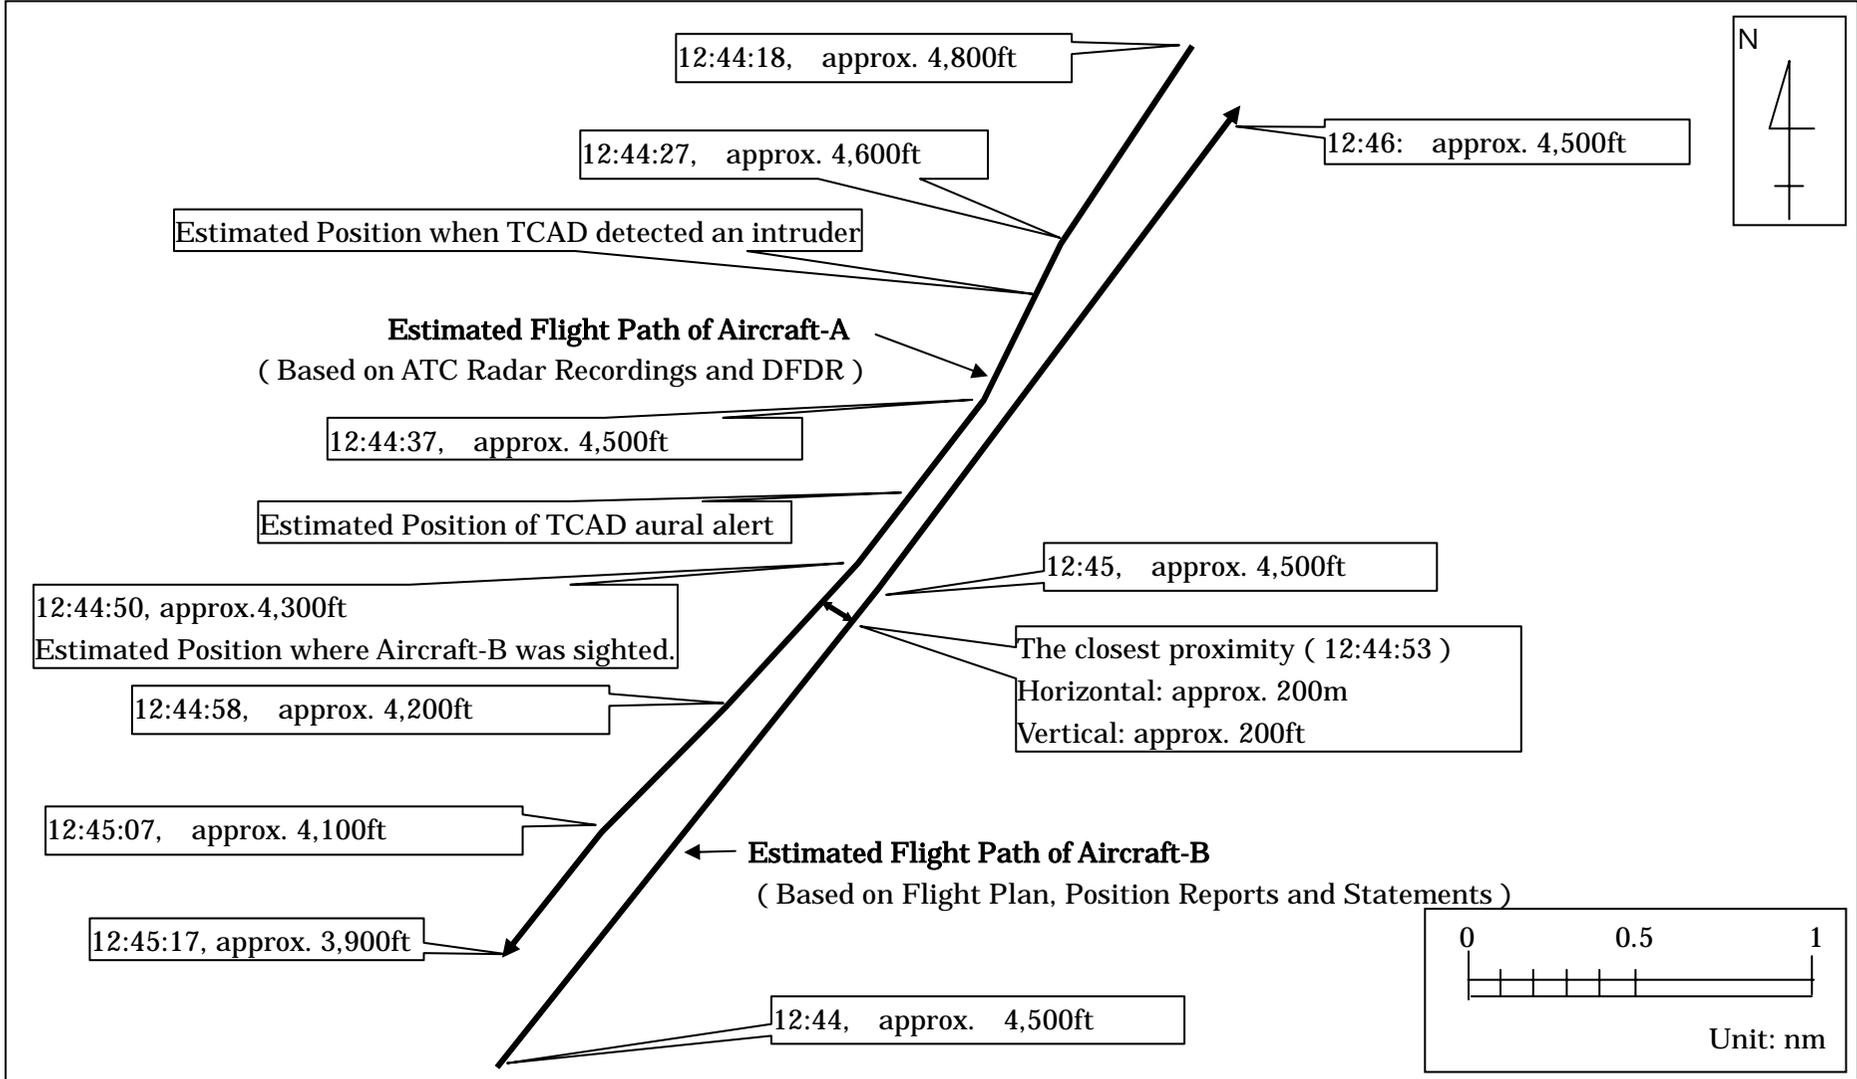
付図 4 Figure 4: Estimated Track Profiles at the Airprox

The position and the altitude of Aircraft-A were recorded at 10 second intervals in the ATC radar recordings. Based on these data, a track profile was plotted and the position and the altitude of Aircraft-A at the time of the incident were estimated at approximately 10-second intervals.

The position and altitude of Aircraft-B were not recorded in the ATC radar recordings. The track of Aircraft-B was plotted based on its flight plan, recordings of air-ground communications of position reports, and statements from persons concerned, and the position and altitude of Aircraft-B at the time of the incident were estimated at one minute intervals.

Considering the above, it is estimated that Aircraft-A was descending at an altitude of around 4,300ft, and that Aircraft-B was in level flight at around 4,500ft on a nearly parallel, reciprocal track to Aircraft-A, and that the aircraft approached each other head-on and passed at around 1244:53 around 10nm southwest of Erabu VORTAC (around 4nm south of Okinoerabu island), with separation approximately 200m horizontally and 200ft vertically at the point of closest proximity.

Although Aircraft-A's flight crews are considered to have felt in danger when Aircraft-A's TCAD issued an aural alert due to the approaching Aircraft-B, considering the directions of flight and relative positions of the aircraft at the time of closest proximity - both aircraft were flying on nearly parallel tracks with a horizontal offset of around 200m, and Aircraft-A was around 200ft lower than Aircraft-B and descending - it is estimated that the aircraft had not been on a collision course. It is thought the closest

separation between the aircraft did not constitute a risk of collision, and it is considered that there was no possibility of a collision.

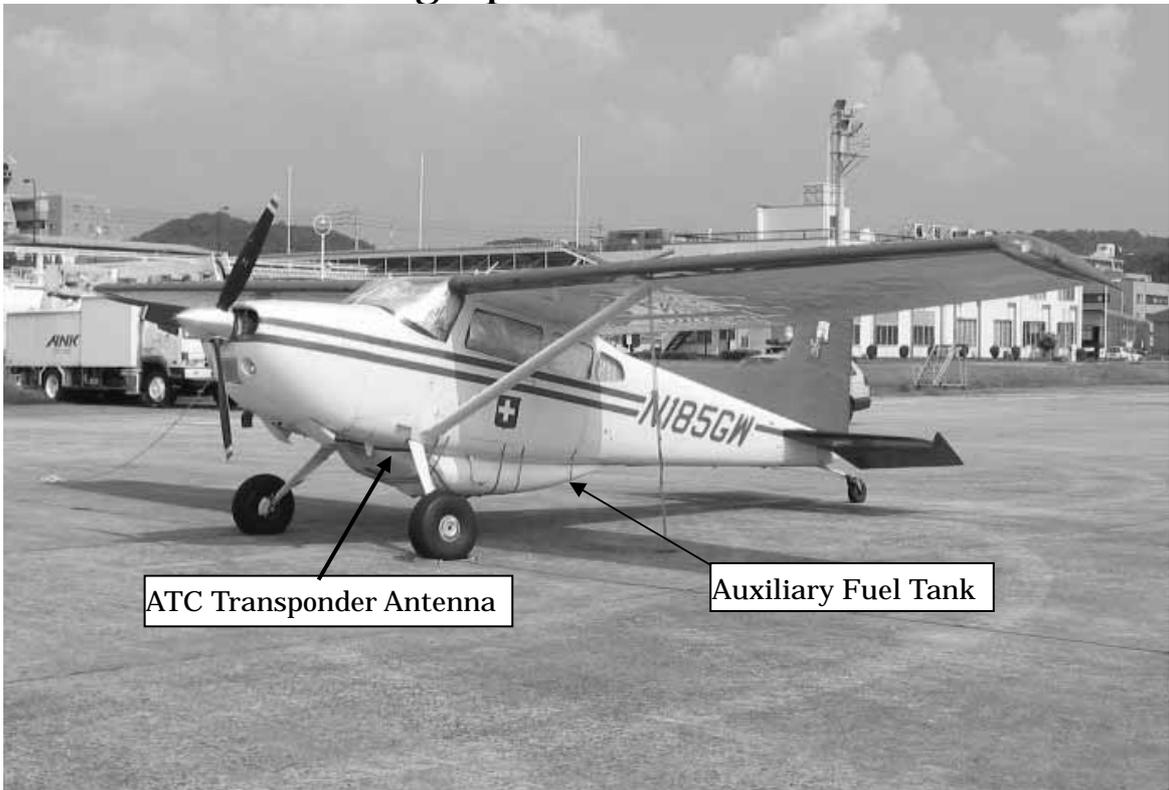
Photograph-2: Aircraft-B

The fuselage of Aircraft-B was painted white with a red stripe running from the nose to the empennage on both sides of the fuselage, and the registration number was written in red on both sides of the empennage. The upper surfaces of the wings were decorated with red and white radial patterns, the wing leading edges were painted red, and the lower surfaces of the wings were painted white. The vertical stabilizer was decorated with patterns in yellow, white, etc. on a red background, and the horizontal stabilizer was painted red.

It was found that the characteristics (color and shape) of the other aircraft described in the near collision report submitted by the PIC of Aircraft-A closely matched the color feature and the shape of Aircraft-B as described in section 2.12. Further, apart from Aircraft-A and Aircraft-B, no other aircraft submitted a flight plan which corresponded to the time and location of the incident in the near collision report submitted by the PIC of Aircraft-A.
