# MAIA DIGEST

## Marine Accidents in Kanmon Kaikyo (Strait)

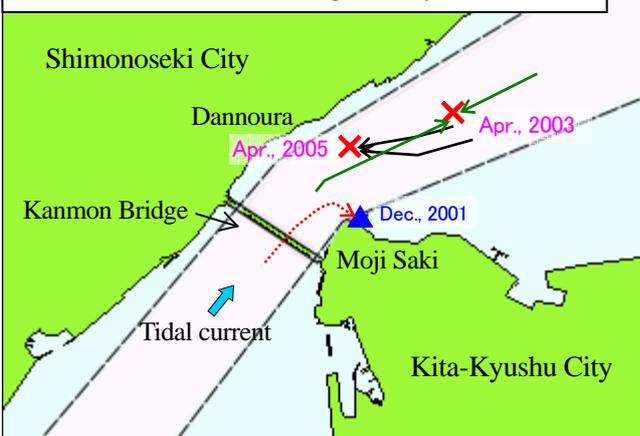
Locations of accidents during easterly tidal current

Of the 20 vessels involved in collisions, 12 were foreign-flag vessels!

✕ Collision involving a foreign-flag vessel  
✕ Collision involving Japanese vessels only  
▲ Grounding of a Japanese vessel

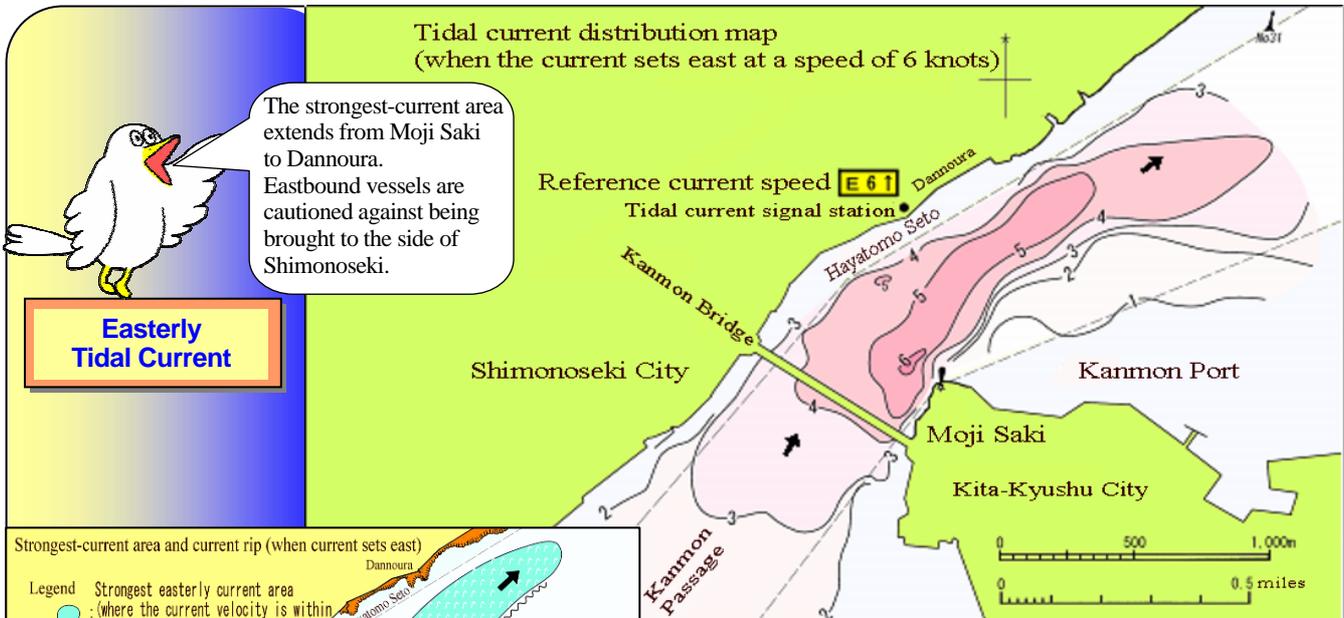
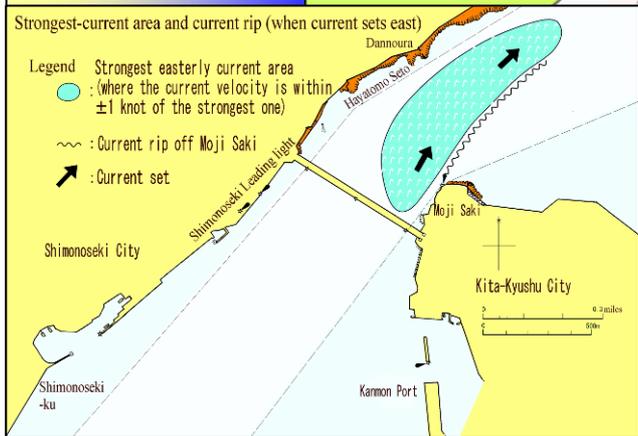
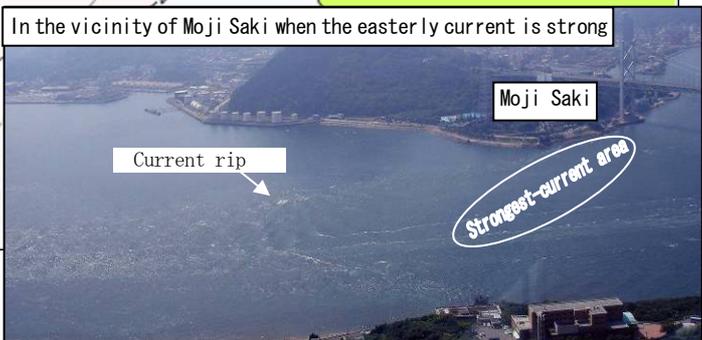
**The area with the strongest tidal current (strongest-current area) in the vicinity of Moji Saki stretches from the north to the west (close to the center of the passage) of a current rip which extends from off Moji Saki.**

- During easterly tidal current: Area 200 to 300 meters wide and about 1,200 meters long; it extends northeastward, from the vicinity of Moji Saki, along the Kanmon Passage, but slightly closer to Shimonoseki.
- During westerly tidal current: Area 150 to 300 meters wide and about 2,000 meters long; it extends southwestward, from the vicinity of Moji Saki, along the Kanmon Passage, but slightly closer to Shimonoseki.

(Source: the Hydrographic and Oceanographic Department, 7th Regional Coast Guard Headquarters; see the next page)

Eastbound vessels are required to exercise caution as they may be driven toward the side of Shimonoseki both during easterly and westerly tidal current!

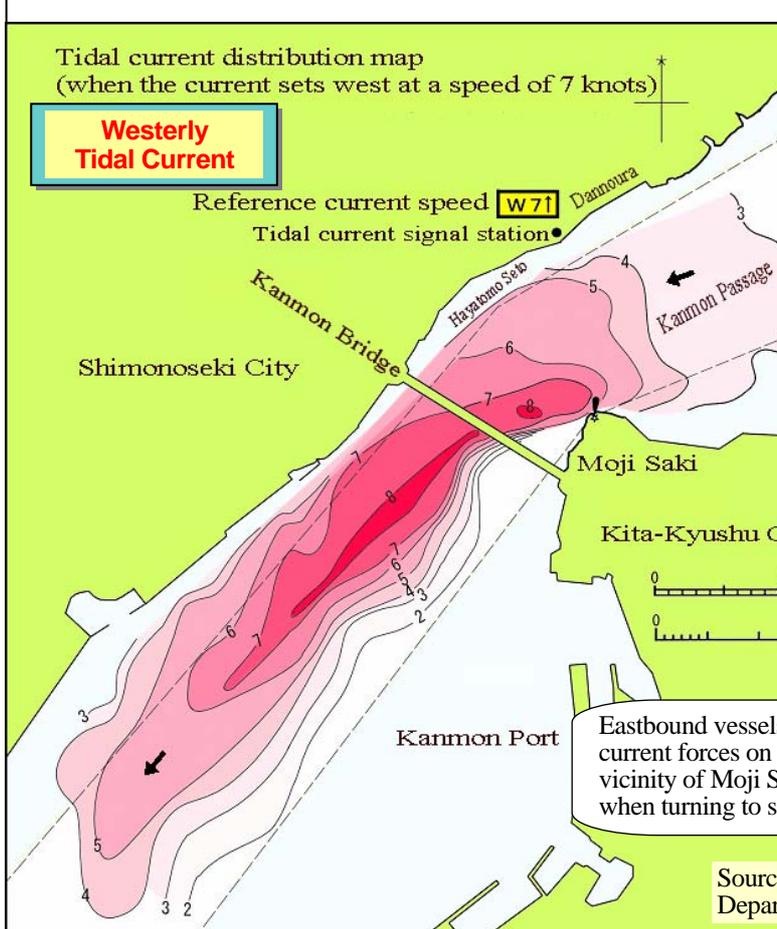
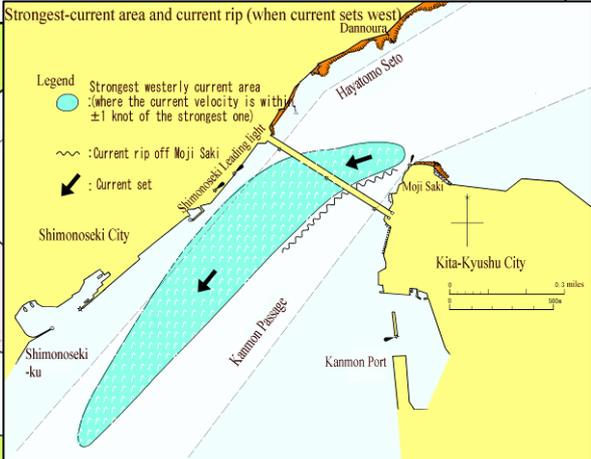
Source: the Hydrographic and Oceanographic Department, 7th Regional Coast Guard Headquarters

Eastbound vessels are subject to strong tidal current forces on the starboard bow, in the vicinity of Moji Saki, and caution is required when turning to starboard!

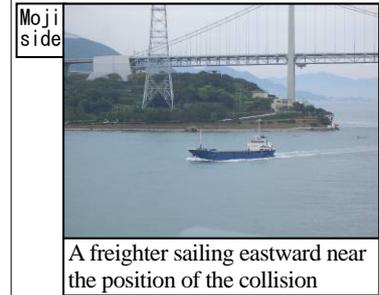
**(Case Study 1) A foreign-flag vessel collided with a tanker, in an overtaking situation, off Moji Saki where a west current flowed at a speed of 3.6 knots**

The Japanese tanker 'K' was sailing northeastward under the conn of the master, in the manual steering mode, on the starboard side of the passage, in strong tidal current. The master noticed the Malaysian-flag freighter 'B' approaching from his starboard quarter. However, presuming that the freighter would not overtake his own tanker, he did not monitor the movement of the freighter. Meanwhile, the freighter 'B' was sailing northeastward, under the conn of the master, in manual steering mode, close to the outer limit on the starboard side of the passage, where the tidal current was relatively weak. The master of the freighter 'B' judged that, even had his vessel drawn nearer to the tanker—which was sailing ahead of him—in the vicinity of Moji Saki, he would be able to overtake her safely, because the tanker would make a gradual starboard turn along the bend of the passage. Therefore, he continued to overtake the tanker without sounding overtaking signals. The freighter 'B' steered to port, 2 minutes before the collision, so as to keep away from Moji Saki and, then, steered to starboard after passing under the Kanmon Bridge. However, the freighter was not able to swing to starboard—because she was overcome by the strong westerly tidal current coming from his starboard bow—resulting in a collision.

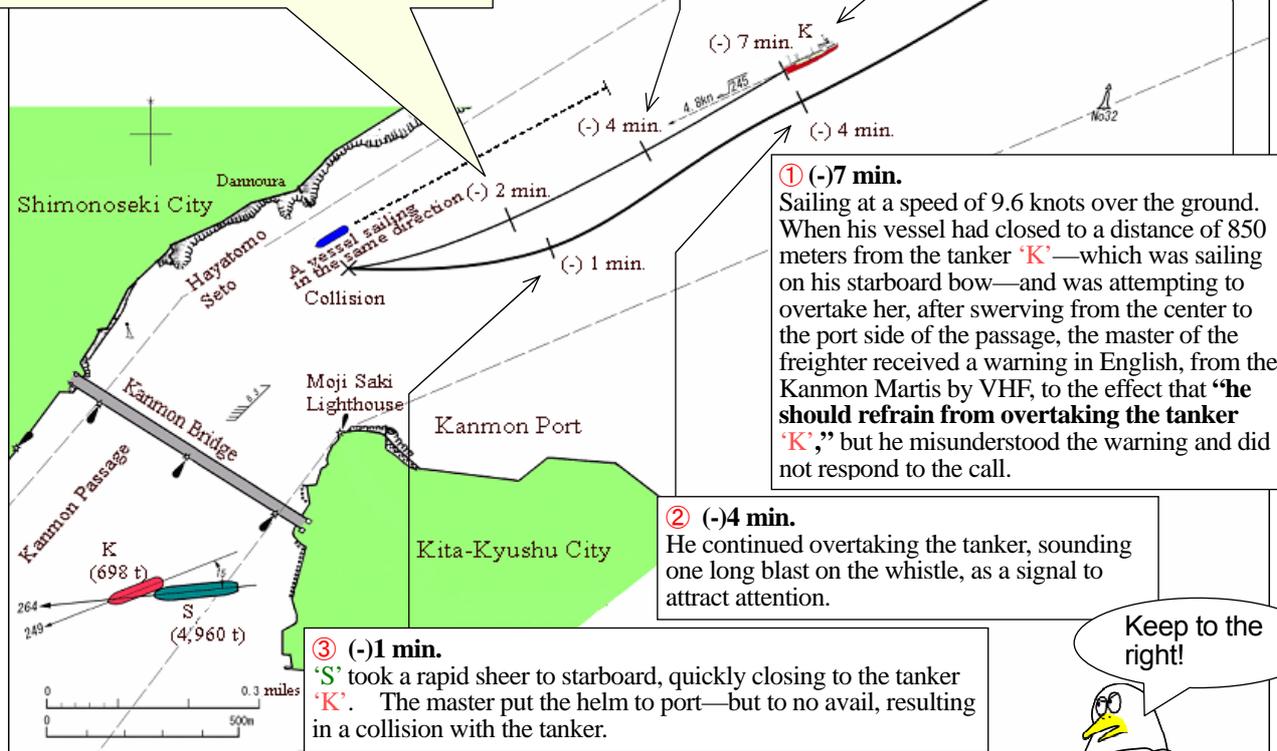
(Case Study 2) In Hayatomo Seto, during easterly tidal current of 6 knots, a foreign freighter collided with a Japanese tanker as the freighter tried to overtake the tanker from the port side of the passage

The Panamanian-flag freighter 'S' was sailing southwestward in the center of the Kanmon Passage, at the entrance to Hayatomo Seto, with the intention to overtake the Japanese tanker 'K', when Kanmon Kaikyo Traffic Advisory Service Center (the Kanmon Martis) gave a warning to the freighter by VHF, saying, "Never overtake the tanker 'K'." The freighter, however, did not respond to this call and continued overtaking the tanker, by proceeding to the port side of the passage. At about the same time, the freighter noticed the lights of two eastbound vessels and attempted to return slightly to her starboard side, but she took a rapid sheer toward the side of Shimonoseki, resulting in a collision with the tanker 'K'.

The master of the tanker overheard the Kanmon Martis tells the freighter 'S', sailing behind him, not to overtake his tanker. On the radar screen, set on the 1.5 miles range scale, he saw the echo of the freighter 2° on his port quarter, 850 meters off. Shortly after, he was advised by the Kanmon Martis over the VHF telephone to pay attention to the freighter 'S'.

A small vessel, sailing in the same direction on his starboard side, quickly lost speed over the ground, forcing 'K' to sail in parallel with her. Therefore, he increased his speed. At the same time, he recognized the freighter 'S' was nearing rapidly in an overtaking situation, while sounding one long blast on the whistle. Because the Kanmon Martis had given a warning against him to exercise caution on freighter 'S', he did not sound a warning signal believing that the freighter would reduce her speed so as to sail behind him.

Although he recognized that the freighter 'S' had begun to take a sharp sheer to the starboard side, he was unable to take any action and collided with the freighter.

Sailing at a speed of 9.6 knots over the ground. When his vessel had closed to a distance of 850 meters from the tanker 'K'—which was sailing on his starboard bow—and was attempting to overtake her, after swerving from the center to the port side of the passage, the master of the freighter received a warning in English, from the Kanmon Martis by VHF, to the effect that "he should refrain from overtaking the tanker 'K'," but he misunderstood the warning and did not respond to the call.

He continued overtaking the tanker, sounding one long blast on the whistle, as a signal to attract attention.

'S' took a rapid sheer to starboard, quickly closing to the tanker 'K'. The master put the helm to port—but to no avail, resulting in a collision with the tanker.

In the Kanmon Passage, keep to the starboard side of the passage!  
In the vicinity of Moji Saki, never make a risky overtaking attempt!

- When sailing along the Kanmon Passage and Kanmon Passage 2, vessels are required to sail on the starboard side of the passage as far as is safe and practicable.
- In the Kanmon Passage, vessels are prohibited from making risky overtaking maneuvers or sailing parallel to another vessel. As demonstrated by this case, it is important to refrain from overtaking another vessel in narrow Hayatomo Seto with its tidal current.
- **When sailing in Hayatomo Seto, mariners are required not to feel pressed, hurry, or fight the current, but keep a sufficient distance to another vessel ahead.**

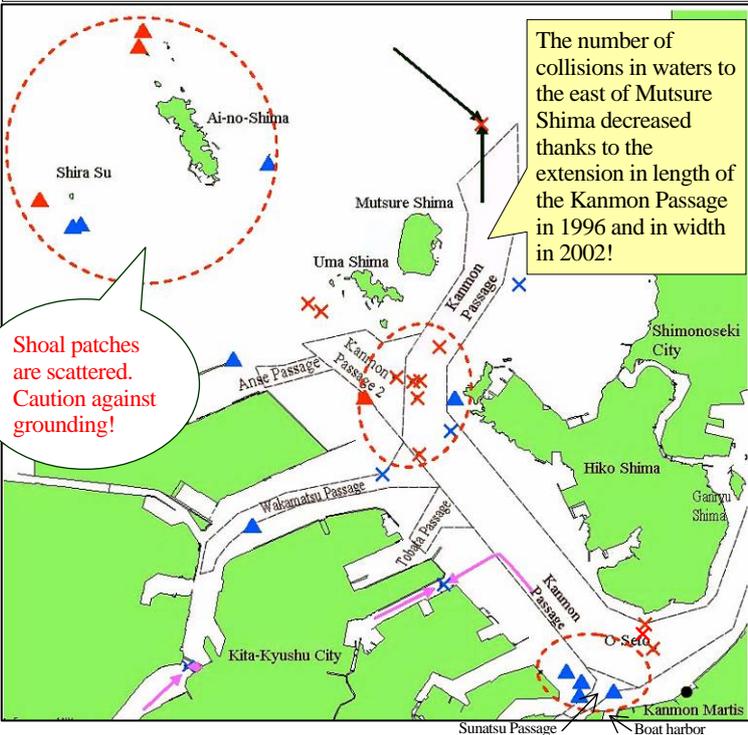
Collisions and groundings for which judgments were delivered over a period of 2002 to 2006 (marine accidents involving passenger ships, freighters and oil tankers)

Among the marine accidents (collisions and groundings), involving passenger ships, freighters and oil tankers, for which judgments were delivered by the relevant marine accident inquiry agencies over a period of five years from 2002 to 2006, 16 collisions (32 vessels) and 14 groundings occurred in the Kanmon Passage and its adjacent waters, lying to the west of the longitude of Ganryu Shima.

By the location of the accident within the area, 2 collisions occurred in O seto; 4 groundings in waters adjacent to the Sunatsu Passage; 7 collisions and 2 groundings in the vicinity of the junction of the Kanmon Passage and Kanmon Passage 2; 6 groundings around Ai-no-Shima and Shirasu; and 7 collisions and 2 groundings in other waters.

**Of the 16 collisions, foreign-flag vessels were involved in 11 cases!  
Accidents frequently occur in junctions of passages at night.**

- ✗ Collision involving a foreign-flag vessel (11 cases)
- ✕ Collision involving Japanese vessels only (5 cases)
- ▲ Grounding of a foreign-flag vessel (4 cases)
- ▲ Grounding of a Japanese vessel (10 cases)

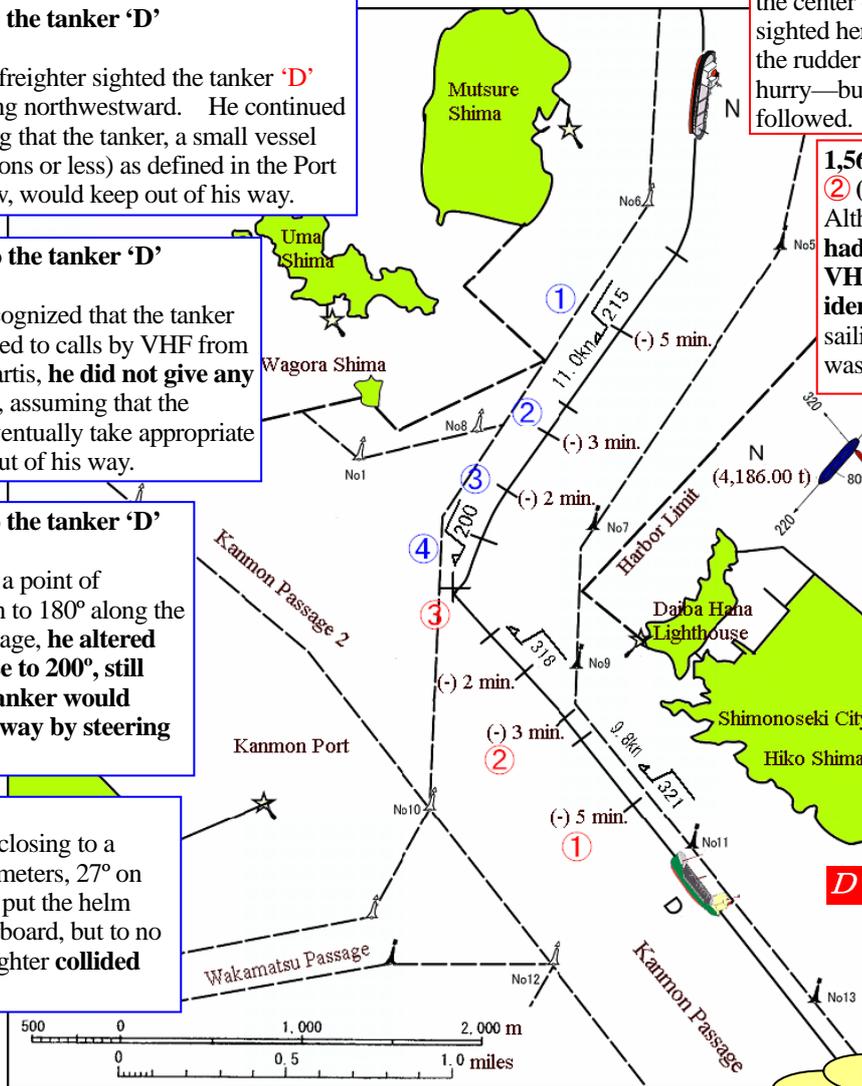
**(Case Study 3) A small Japanese oil tanker, which was a give-way vessel, collided with a foreign-flag freighter sailing southward along the Kanmon Passage**

While sailing northwestward along the Kanmon Passage, the Japanese oil tanker 'D' detected the Panamanian freighter 'N' by radar. However, the tanker did not monitor the movement of the freighter nor did she heed the information about the freighter 'N' that the Kanmon Martis gave several times to the tanker by VHF.

On the other hand, when the freighter 'N' made a position report to the Kanmon Martis by VHF, upon entering the Kanmon Passage, she received information to the effect that she might approach a small westbound vessel. However, assuming that the westbound tanker would keep out of the way of the own vessel, the freighter continued sailing, without sounding warning signals, and they collided with each other.

The pilot of the freighter sighted the tanker 'D' which was sailing northwestward. He continued sailing, assuming that the tanker, a small vessel (i.e., 300 gross tons or less) as defined in the Port Regulations Law, would keep out of his way.

Although he recognized that the tanker had not responded to calls by VHF from the Kanmon Martis, **he did not give any warning signal**, assuming that the tanker would eventually take appropriate action to keep out of his way.

Having reached a point of course-alteration to 180° along the bend of the passage, **he altered his vessel course to 200°**, still assuming the tanker would keep out of his way by steering to starboard.

With the tanker closing to a distance of 270 meters, 27° on his port bow, he put the helm hard over to starboard, but to no avail. The freighter **collided** with the tanker.

After observing the freighter closing to the center of the radar screen, he visually sighted her in close proximity. He put the rudder hard over to starboard in a hurry—but in vain. A **collision** followed.

Although the Kanmon Martis had been calling the tanker by VHF, without knowing her identity, the boatswain continued sailing, unaware that the message was addressed to his vessel.

The boatswain detected the freighter 'N' by radar. **He continued sailing, without monitoring the movement of the freighter, as he thought lightly that, because of his slow speed against the adverse tidal current, the freighter would pass ahead safely.**

In Kanmon Kaikyo, the master should take the conn!!

Does the other vessel have the intention to keep out of my way or does she not?  
Then, I will sound a warning signal !

In the highly dangerous environs of Kanmon Kaikyo, a vessel that does not keep a listening watch on VHF may adversely affect many of the other vessels around her.  
If you have not turned up the VHF telephone to an audible level, it is as if the telephone is inoperative. **You are required to ensure that you keep a listening watch**, by checking the installed location and sound volume of the VHF.

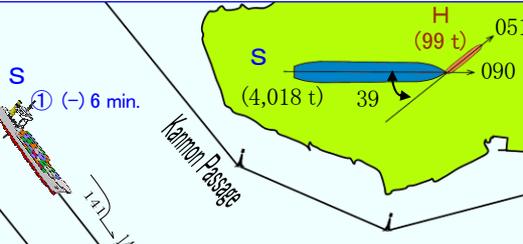
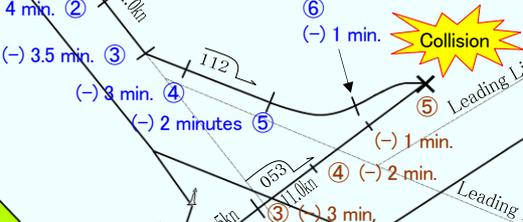
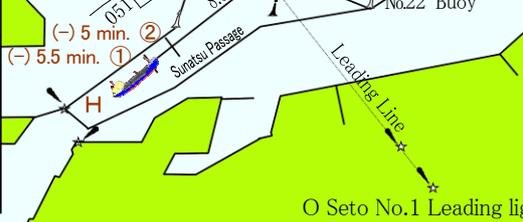
**(Case Study 4) A domestic tanker sailing out of the Sunatsu Passage collided with a foreign-flag freighter sailing southeastward along the Kanmon Passage**

The tanker 'H', engaged in domestic trade for the carriage of fuel oil, which was not required to be furnished with international code flags, had the possibility, in the process of sailing out of the Sunatsu Passage, to encounter the Panamanian freighter 'S', which was sailing along the Kanmon Passage, but decided to cross the latter passage. On the other hand, the freighter, which was sailing southeastward along the Kanmon Passage, recognized the tanker entering the Kanmon Passage from the Sunatsu Passage. She continued sailing, while monitoring the movement of the tanker. Although the tanker did not show any signs of keeping out of her way, the freighter continued sailing, without sounding warning signals, and collided with the tanker.

**③ (-)3.5 min.**  
Assuming the tanker, which was not displaying a destination signal, to be a vessel sailing in the same direction as his own, he put the rudder to port, slightly earlier than otherwise, to steer 112° along the orientation of O Seto No. 2 Leading light.

**② (-)4 min.**  
The master initially sighted the tanker 'H' 18° on his starboard bow, 1,310 meters off, sailing out of the Sunatsu Passage. He continued sailing, while monitoring the movement of the tanker.

**① (-)6 min.**  
Sailing on a course of 141°, at a speed of 14 knots.

**④ (-)3 min.**  
Although the tanker had continued closing, showing no sign of changing her course, he continued sailing, without sounding warning signals, on the assumption that the tanker would eventually alter to starboard, sooner or later, along the course of the Kanmon Passage.

**⑤ Immediately before the collision**  
Upon receipt of a report from the chief engineer (who happened to be having a meal in the wheelhouse) regarding the closing of the freighter, the master put the helm to starboard, but it was too late to avoid a collision.

**⑤ (-)2 min.**  
The tanker had closed in further, without changing her course, but he was prevented from making a large-angle course alteration to port, by an oncoming vessel on her port bow. He was therefore able to make only small change in course.

**④ (-)2 min.**  
Course of 053° at a speed over the ground of 11.0 knots, with an easterly tidal current. He continued sailing, while watching two oncoming vessels from ahead, but did not realize there was a risk of collision with the freighter.

**⑥ (-)1 min.**  
He slackened her speed to 'half ahead', 'slow ahead' and, immediately before the collision, put the helm hard over to starboard and the engine to 'dead slow', but to no avail. 'S' collided with the tanker while she was still making a starboard turn.

**③ (-)3 min.**  
Although he had observed the freighter 78° on his port bow, 770 meters off, upon entering the Kanmon Passage, he decided to reach the north side of the passage by crossing ahead of the freighter, in order to avoid interfering with the unit of the towing boat on his starboard bow. For this reason, he did not keep out of the way of the freighter.

He did not want to sail on the starboard side of the passage because a few months earlier, he had witnessed a grounding of a domestic trade vessel outside of the starboard boundary of the passage.  
He did not want to approach the tugboat towing a large barge on the starboard side.  
He ordinarily sailed outside the passage except when crossing it. He did not like being overtaken when sailing inside the passage.  
He assumed that the freighter would make a course alteration much later along the leading lines.

**② (-)5 min.**  
He first sighted a unit of towing boat and a tow 5° on his starboard bow, 700 meters off, and the freighter 'S' 70° on his port bow, 1,680 meters off.

**① (-)5.5 min.**  
The tanker 'H' steamed on a course of 051° with 8.5 knots, heading to No. 23 Buoy, with the intention to cross the Kanmon Passage to her destination in Shimonoseki-ku. The master was standing a single-handed navigation watch while being engaged in manual steering himself.

Vessels sailing along the Kanmon Passage have right of way over other vessels!  
(Specified sailing rules)  
(Regulations for the Enforcement of the Port Regulations Law, Article 39, Paragraph 1, Subparagraph 7)

In Kanmon Port, in the event of a risk of encounter between a vessel sailing along the Kanmon Passage and another one sailing along another passage, such other vessel sailing along the other passage shall keep out of the vessel sailing along the Kanmon Passage.  
The vessel intending to enter the Kanmon Passage from another passage should do so after ensuring that she has kept out of the way of other vessels sailing along the Kanmon Passage, by, e.g., slackening her speed in ample time.

It is apparent where your vessel is destined if you display a destination signal. If you display a second substitute and 'S', vertically, in this order, you are headed for Shimonoseki-ku!
