**[Issues accompanying the aging of infrastructure]**

<Examples of road aging>

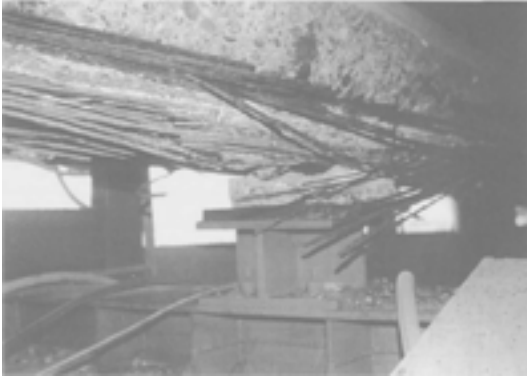
Rupture of PC tendon in a main girder caused by salt damage

Notes: PC tendon: Steel used for introducing compressive force (prestress) to concrete

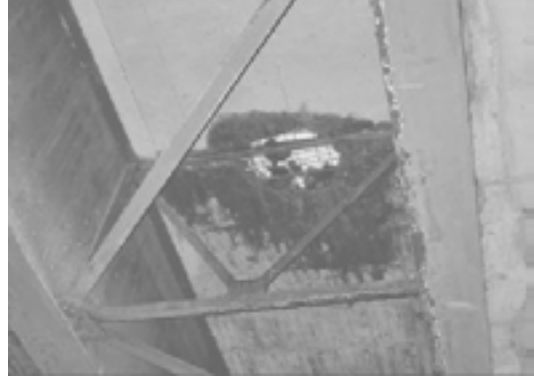
An reinforced concrete slab that has fallen out due to fatigue

Reinforced concrete slab: Floor made of reinforced concrete that directly supports vehicles
