Digest of the Analysis of Railway Accidents

The level crossing without crossing gate is dangerous

Urgent measures required to abolish or to prepare crossing gate, road warning device

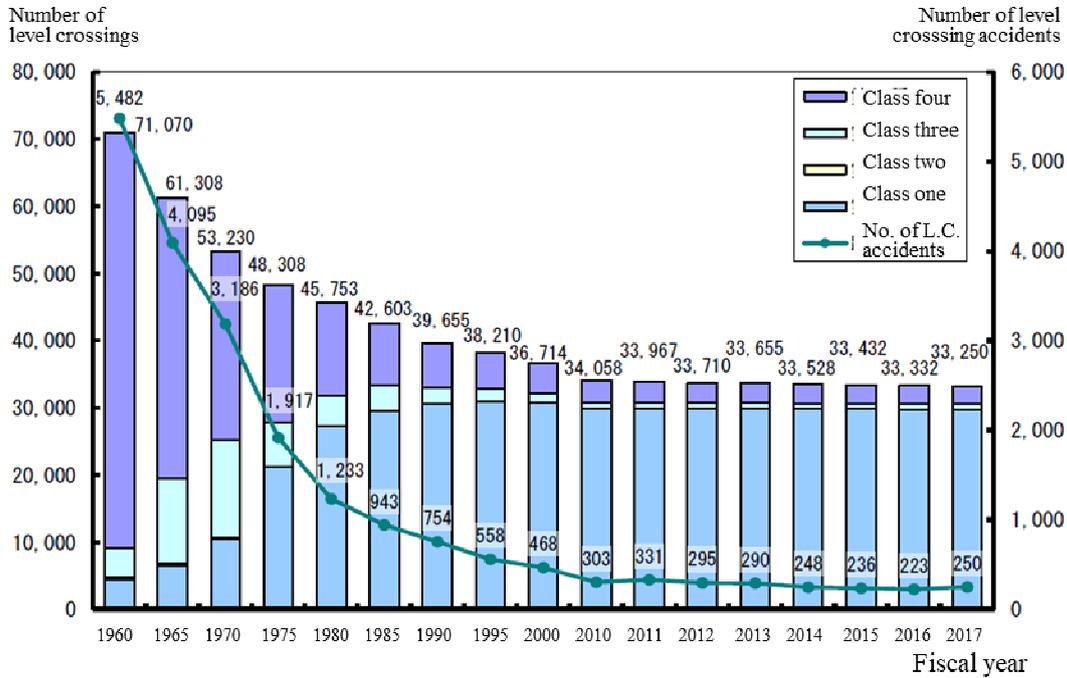
Figure 1. Changes of number of level crossings and level crossing accidents

- Total number of level crossings had been reduced by the change to overhead crossing or the integration and abolishment, and the preparation of level crossing protection device such as the improvement to class one level crossing equipped with crossing gate and road warning device, but did not so change in the recent years. Refer to Figure 1.

* Horizontal axis expressed every 5 years between 1960 and 2010 and every one year after that.
 Quoted from "Information on the safety of railway and tramway transportation" Railway Bureau, MLIT.

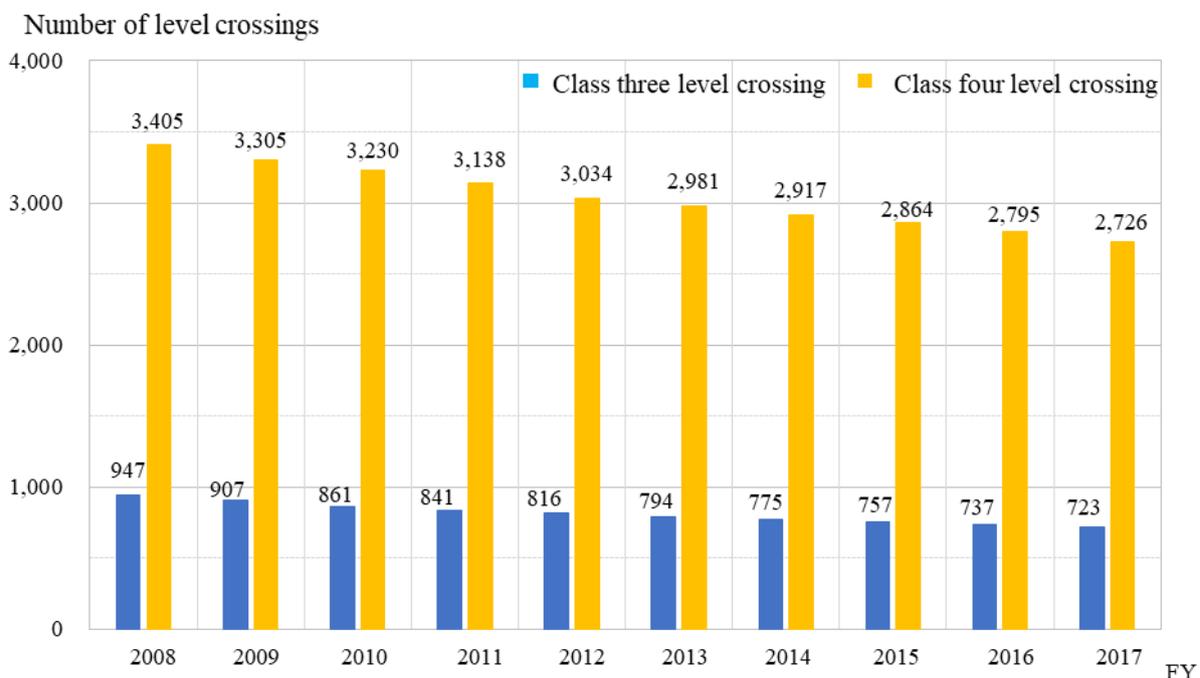
Figure 2. Changes of numbers of class three and class four level crossings

□ The change of numbers of class three level crossing, without crossing gate and with road warning device, and class four level crossing, without crossing gate nor road warning device, from 2008 FY to 2017 FY, was that the reducing ratio of level crossing was slowing down, and 723 class three level crossings and 2,726 class four level crossings still existed at the end of 2017 FY. Refer to Figure 2.

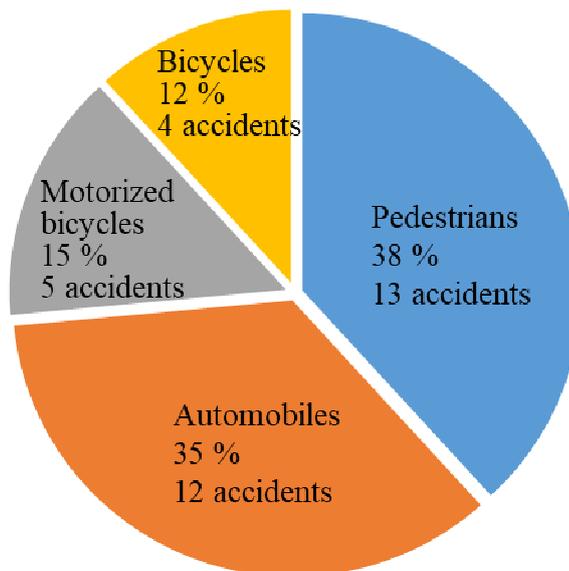
Figure 3. Details of passersby of level crossing

The most was pedestrian, 13 accidents, 38 %, the second most was automobiles, 12 accidents, 35 %.

* "Automobile" include the light motor vehicle and small sized special vehicle, i.e., tractor for agriculture.

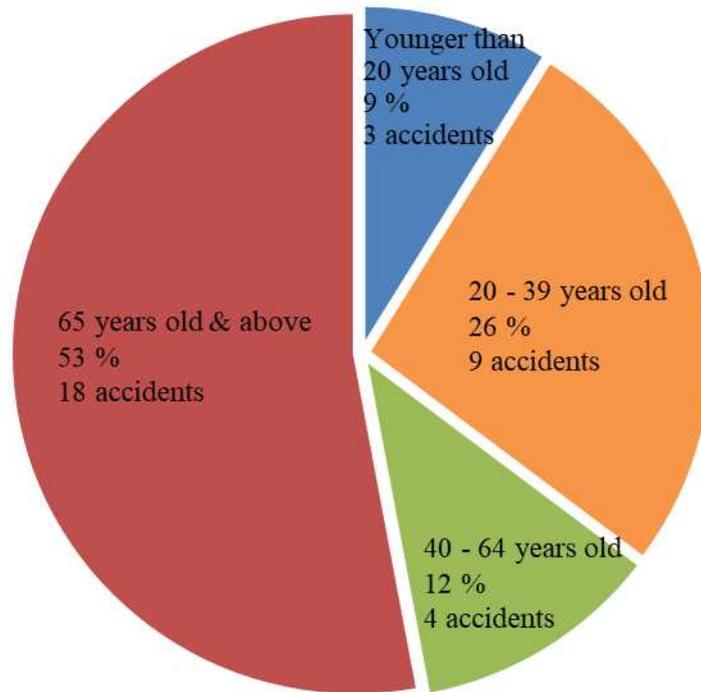
Figure 4. Classification by the age of passersby of level crossing

The ratio of aged person, 65 years old or above, was 18 accidents, 53 %, *i.e.*, occupied over half.

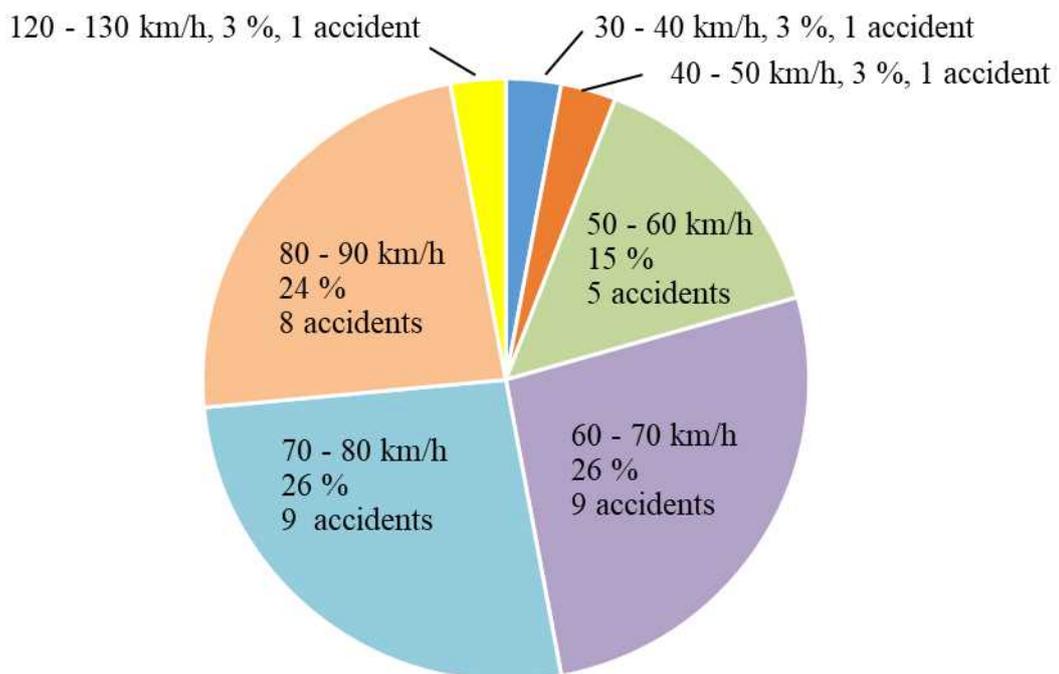
Figure 5. Velocity of the train when the passerby was found

The ratio of 60 km/h or above was 79 %, 27 accidents, *i.e.*, velocity of train is high.

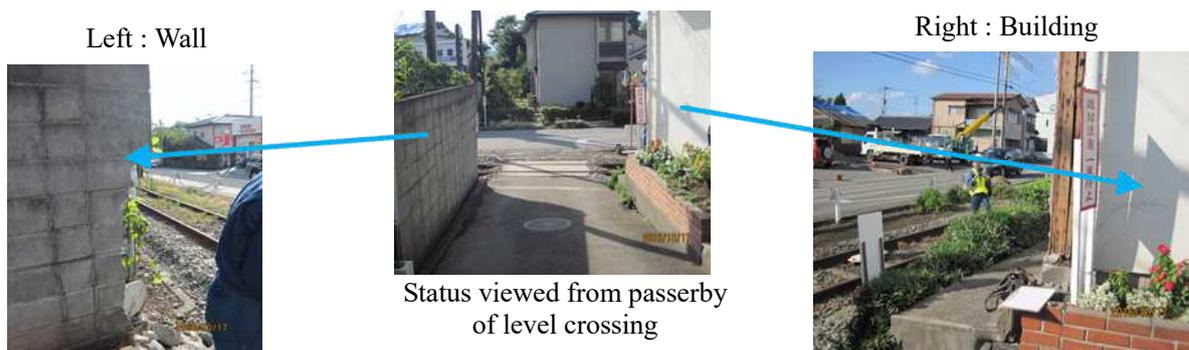
Example that the visibility of level crossing is obstructed by the neighboring buildings or fences

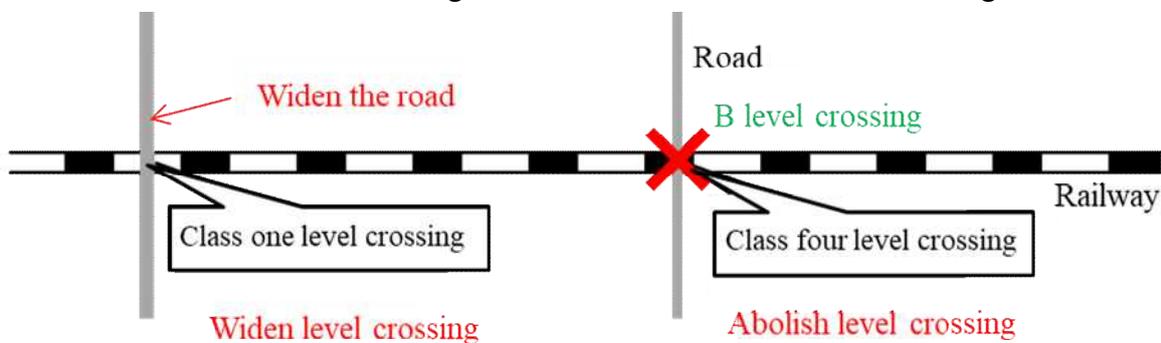
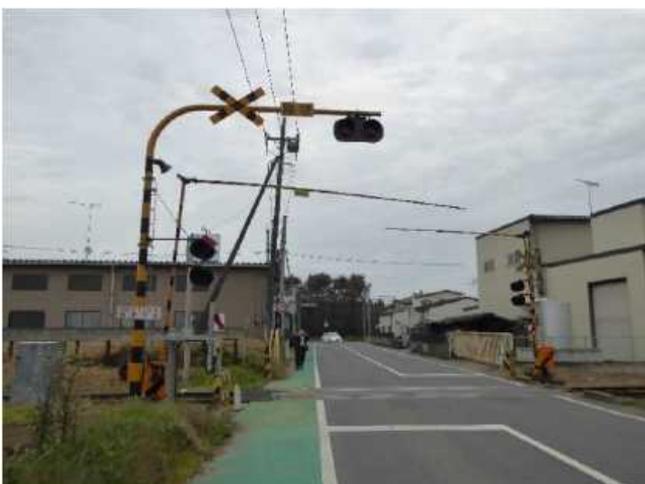
Responded to the occurrence of the accident with fatality, the relevant parties such as the local government, the police, the school, etc., studied on the abolishment of the B level crossing, but expressed disapproval for the abolishment because the present status of the neighboring class one level crossing and the connected road was narrow and dangerous, therefore, the relevant parties decided to abolish the B level crossing after widened, i.e., prepared walkway, the neighboring level crossing. The local government prepared the revised budget to widen the neighboring level crossing, implemented to widen the level crossing, after that, abolished the B level crossing.

- Widen the level crossing
- Widen the road
- Preparation of walkway, green part
- Relocation of the road warning device and change to the overhang type
- Improved the utility of pedestrian, and visibility of level crossing !

- Improved safety of the neighboring level crossing, i.e., prepared walkway and widen the level crossing road, then guided the users of level crossing -

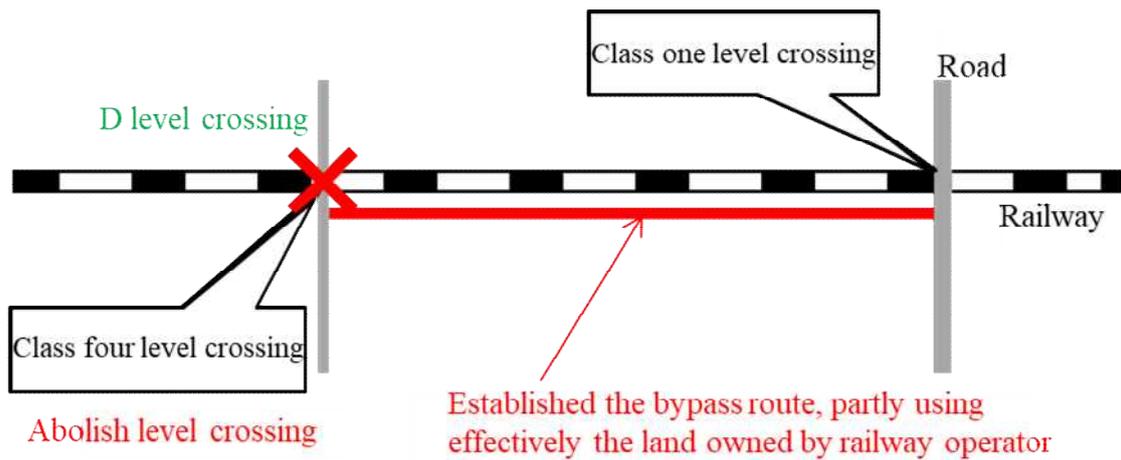
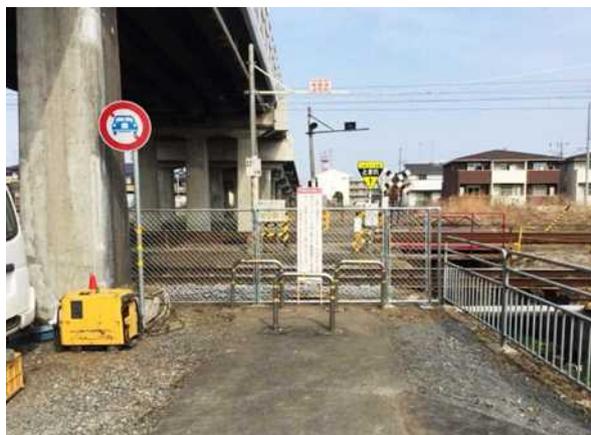
Abolished class four level crossing
Crossed three routes of three railway operators

In parallel to the above measures, the document to ask cooperation for the abolishment of the level crossing were distributed to the local residents via the resident's association. After the local government completed the preparation of the bypass route, the D level crossing was abolished.

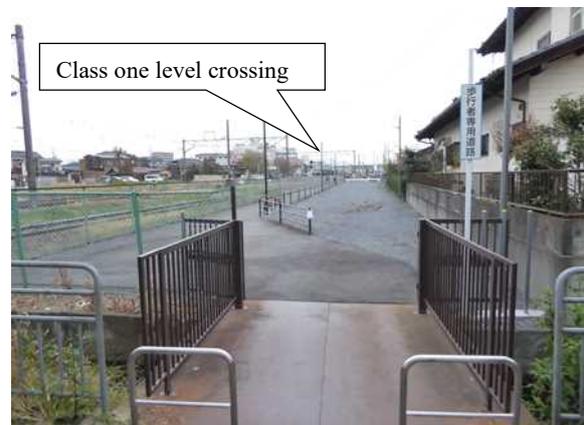
Bypass viewed from the site of class four level crossing
Rent the leased land of railway operator

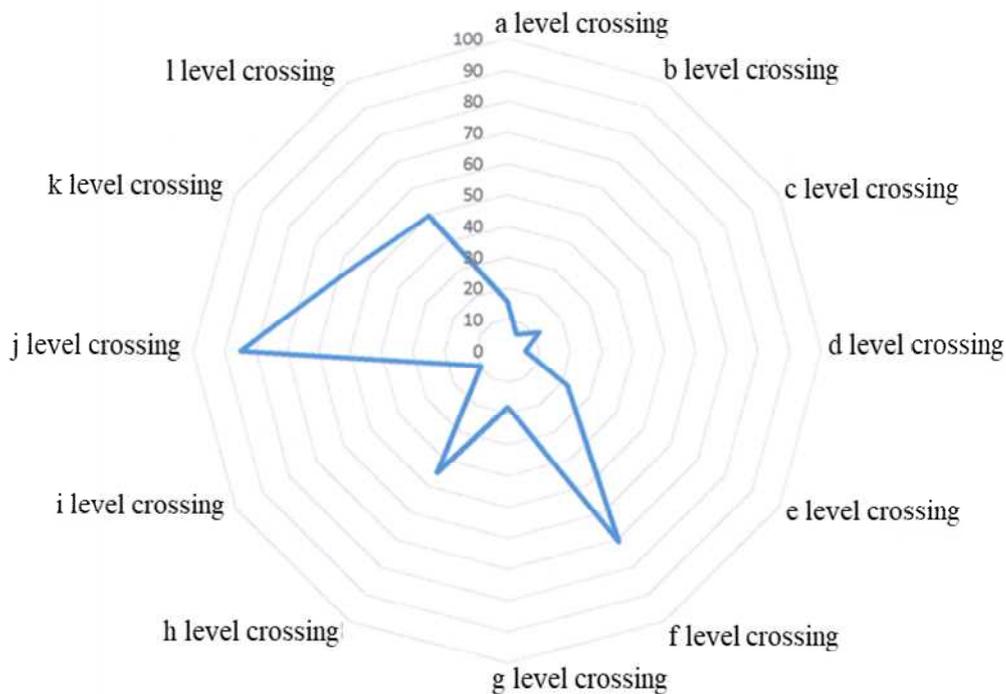
Radar chart on the degree of danger of level crossings, image

The following figure shows the risks to cause accident, based on the status of the occurred accidents, the traffic volume and installed status of level crossing protection devices in individual level crossing, which are converted to the numerical values, indicated in the radar chart and put in order by the level of risks.

Degree of safety	
Obstruction warning signal	-5
Obstruction detecting device	-10
Overhang type warning device	-10
Omnidirectional warning light	-5
Class four warning sign	-5
Hanging belts	-5
Color pavement	-10
Others	-3

Degree of danger	
Contacted accidents in the past 5 years	20
Just before crossing, in the past 5 years	5
Fallen barrier trap, in the past 5 years	5
Class four level crossing	50
Complex shaped level crossing	10
Traffic volume/100, maximum 30	30

The risks to cause accident were converted to the points based on the degree of safety, *i.e.*, prepared status of safety facilities, etc., and the degree of danger, *i.e.*, the occurred status of accident, visibility, traffic volume, etc., and reviewed by the total point.

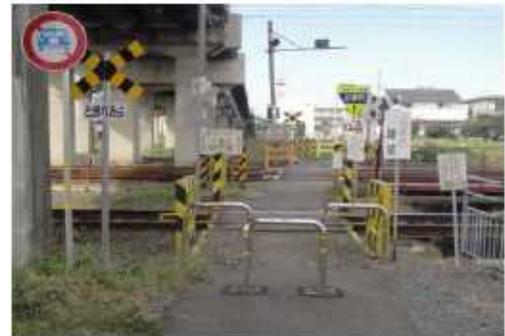
Example of installation of the fence to stop passersby riding bicycles

- Measures to control passersby of level crossing
 - Installation of piles to stop passage by automobiles
 - Installation of fences to stop passersby riding bicycles
- Measures to notice the approaching train easily
 - Weeding, constructing weed-killer earth, weed-killer seat in around the level crossing
 - Installation of the whistle sounding sign
- Measures to call attention of passersby by making the existence of level crossing more clearer
 - Installation of level crossing caution fence, caution sign board
 - Indication on the road
 - Indication of the once stop position on the road surface
 - Stop sign, which is the indication to promote the once stop to passersby, and secure the visibility by the flashing LED at night
 - Installation of lighting facility of level crossing

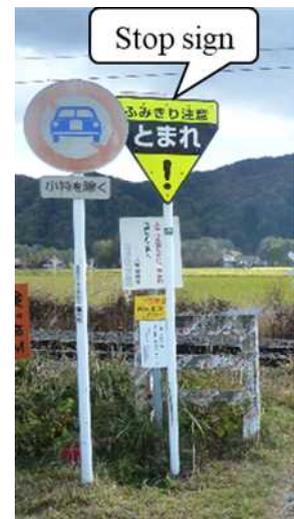
Installed example of the stop sign

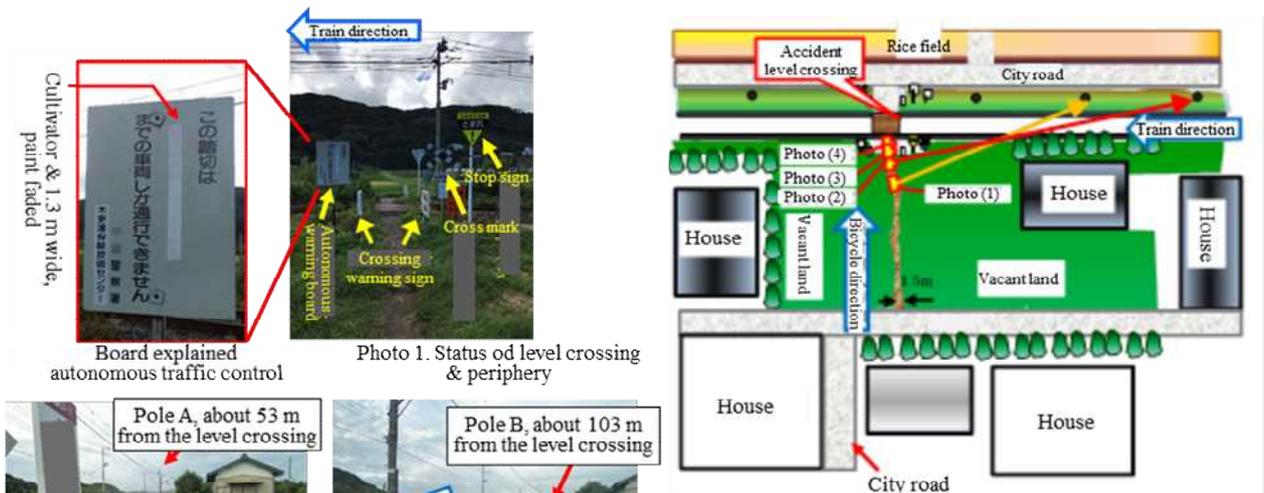
Figure. Status of level crossing & periphery

Probable causes : It is highly probable that the accident occurred as the train collided with a motorized bicycle, because the motorized bicycle entered class four level crossing without crossing gate nor road warning device, in the situation that the train was approaching . As it is somewhat likely that the motorized bicycle entered the level crossing where the train was approaching, related with the restricted visibility of the track by houses, hedges and overgrown weeds, but it could not be determined the precise situations because the driver of the motorized bicycle was dead.

The sight distance of the train was about 103 m from the central position of the level crossing caution fences, *i.e.*, center of the level crossing fence apart about 2.0 m from left rail, restricted by houses, hedges and overgrown weeds, and it takes about 4 seconds when train runs this distance at the velocity of about 95 km/h. It is somewhat likely that the passerby started to cross level crossing after confirmed that there was no train in the visible distance, cannot finish crossing the level crossing in this time.

It is expected for the railway operator to secure always the maximum sighting distance as possible, by implementing properly the weeding in the periphery so as to increase sighting distance even a little for the passersby of the accident level crossing, because the safety of class four level crossing is secured by the precondition that the passersby can confirm the safety in left and right directions sufficiently.

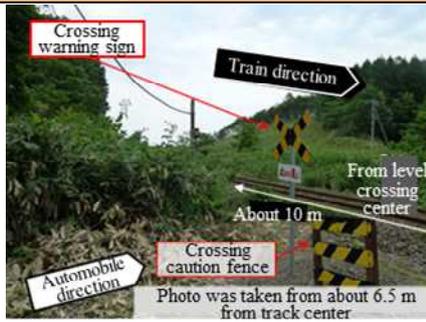
Photo 1. Sight of train viewed from the driver of bicycle

It is somewhat likely that the automobile entered to the level crossing in the situation that the train was approaching related to that the driver seated in the automobile was hard to see the approaching train. However it could not be determined precise situations because the driver of the automobile was dead.

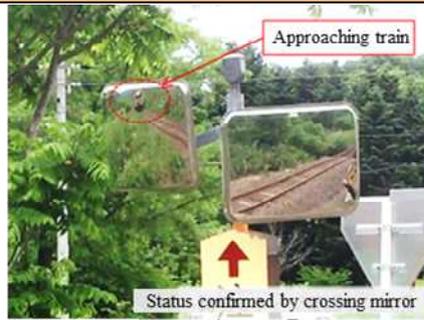
Confirmed by the train operated at the same time as the accident train in the next day of this accident.

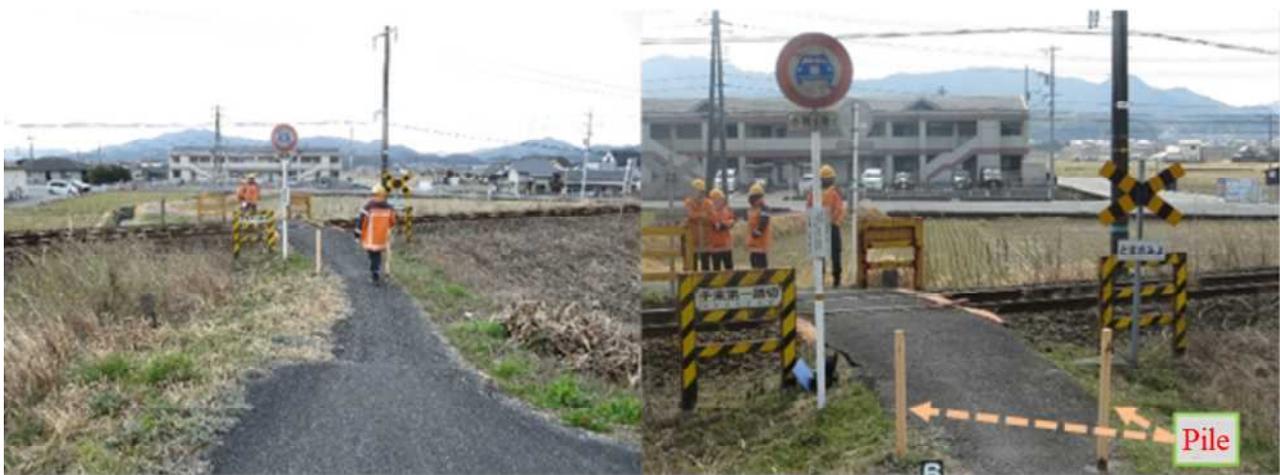
Photo 1. Status of level crossing viewed from the entered bicycle

Probable causes : It is highly probable that the accident occurred as the train collided with a passerby riding bicycle, because the passerby riding bicycle entered the level crossing in the situation that the train was approaching to class four level crossing without crossing gate nor road warning device.

It is probable that the passerby did not stop just before the level crossing in the situation that the train was approaching, and entered the level crossing without confirming the approaching train well. However, it could not be determined the reason why the passerby entered the level crossing, because the passerby was dead.

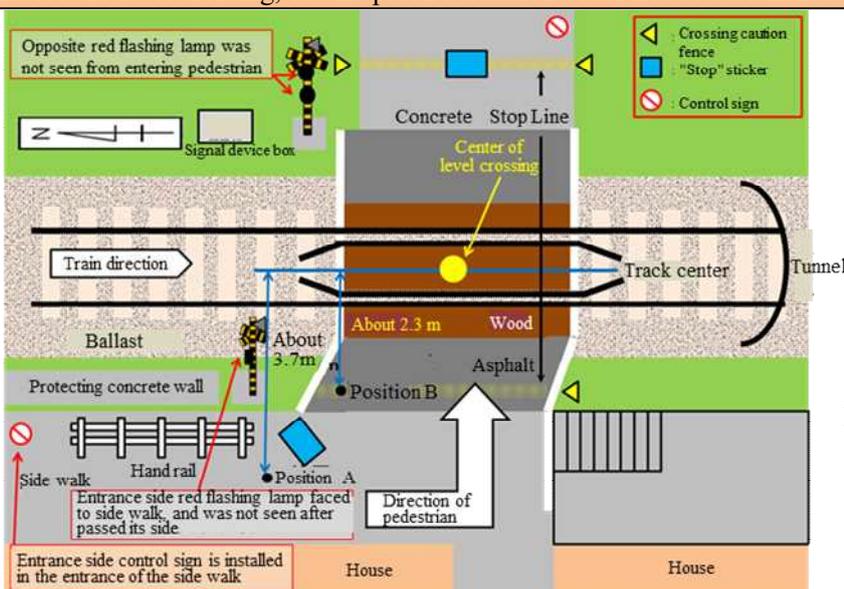
Figure. Status of level crossing and periphery and layout of level crossing protection devices, etc.

Probable causes : It is probable that the accident occurred as the train contacted with a pedestrian because the pedestrian entered class three level crossing equipped with road warning device, in the situation that the road warning device was operating according to the approaching train.

It is somewhat likely that the pedestrian entered the level crossing in the situation that the road warning device was operating responded to approaching train, related with the situation that the pedestrian had been lost hearing sense. Also, it is somewhat likely that the pedestrian could not recognize red flashing lights when the pedestrian entered the level crossing, but the precise situation could not be determined because the pedestrian was dead.
