**AIRCRAFT SERIOUS INCIDENT
INVESTIGATION REPORT**

NAKANIHON AIR SERVICE CO., LTD.

DIAMOND AIR SERVICE, INC.

- 1. NAKANIHON AIR SERVICE CO., LTD., BELL 206B
(ROTORCRAFT), JA9745**
- 2. DIAMOND AIR SERVICE, INC. MITSUBUSHI MU-300, JA30DA
AIRCRAFT PROXIMITY
OVER NAGOYA CITY AICHI PREFECTURE
JAPAN AT AROUND 11:22 JST, OCTOBER 10, 2012**

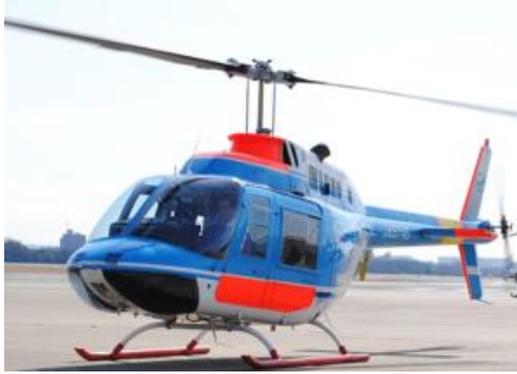
JA9745 (Bell 206B)
Over-all length 11.92 m Width 2.07 m
Height 3.26 m
Main/tail rotor diameters 10.15 m/1.65 m

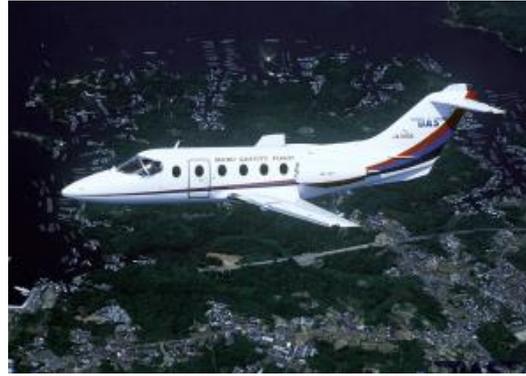
JA30DA (Mitsubishi MU-300)
Over-all length 14.75 m Wing span 13.29 m
Height 4.24 m

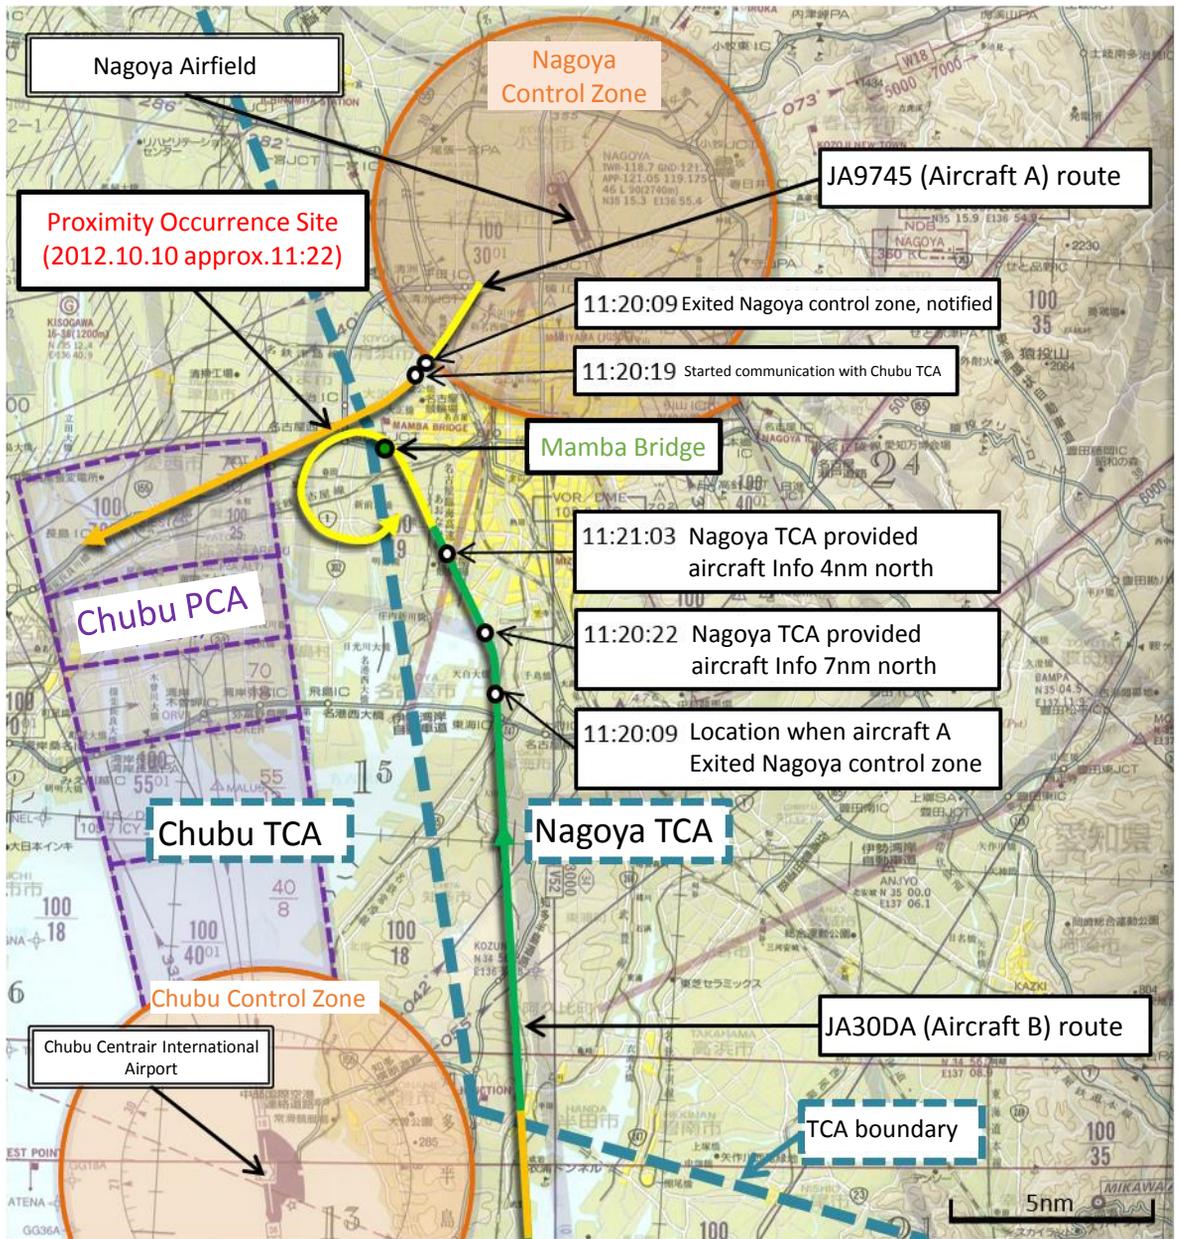
Figure 1. Estimated Flight Route

History of the flight both Aircraft A and Aircraft B (hereinafter referred to as “Both Aircraft”) before and after the incident occurred is as follows: (See Figure 1 – Estimated Flight Routes.)

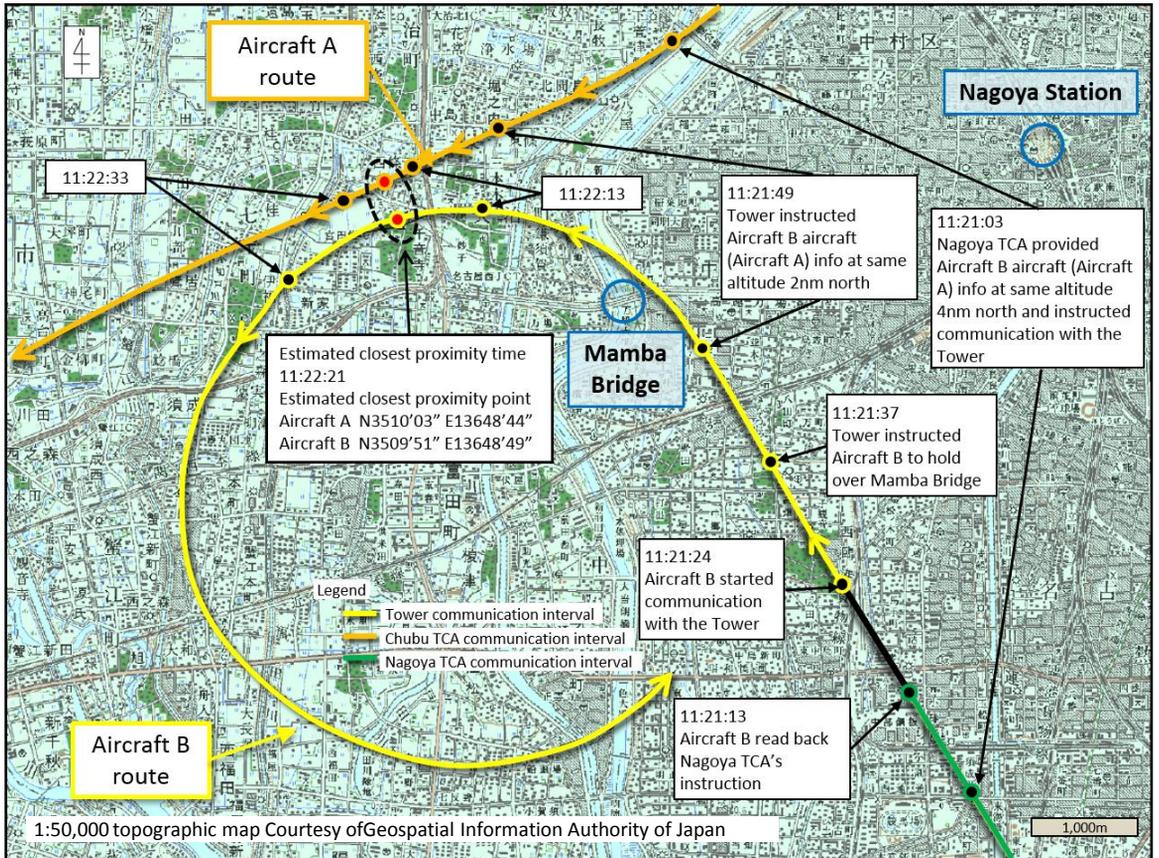
Figure 2. Proximity Status Chart

According to the descriptions in 2.1.3 (1), (2) and Figure 2, Aircraft B approached Aircraft A from the left rear side outside the view of Aircraft A, then overtook Aircraft A on the left side. When the Trainee A on Aircraft A was aware, Aircraft B already overtook Aircraft A on the side ahead of Aircraft A and turned away from the path of Aircraft A. Therefore, it is probable that the proximity condition was resolved irrespective of the avoidance maneuver by Aircraft A.

According to the approaching conditions in 2.1.1, Figures 2 and 3 as well as 2.1.3 (1) and (2), Aircraft B overtook Aircraft A almost at the same altitude, and it is highly probable that Aircraft A did not find Aircraft B until it came closest and Aircraft B did not find Aircraft A during the flight. From these, it is highly probable that Aircraft A did not have time allowed for avoidance maneuver and Aircraft B did not perform the avoidance maneuver.

From the descriptions of 2.1.3 (3) and 2.1.3 (4) and Figure 2, it is somewhat likely that the followings may have caused for PIC and FO of Aircraft B unable to visually recognize Aircraft A when Aircraft B approached Aircraft A and overtook Aircraft A 390 m in the left side.
