"The accident with human death caused by the collision between the train and the motorized bicycle, occurred at the class 4 level crossing"

Railway operator : West Japan Railway Company
 Accident type : Level crossing accident
 Date and time : About 15: 30, January 31, 2020
 Location : Niiya No.3 level crossing, the class 4 level crossing without crossing gate nor road warning device, at about 13,766 m from the origin in Yonago station, between Takamatsucho station and Nakahama station, single track, Sakai Line, Sakaiminato City, Tottori Prefecture

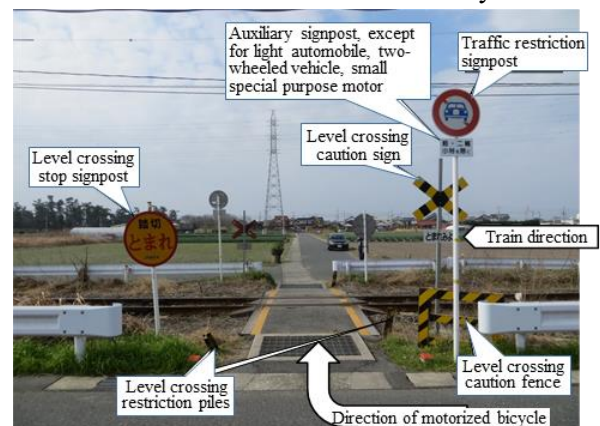
<Status of Niiya No.3 level crossing viewed from the entered side of the motorized bicycle>

It is certain that the concerned accident was caused as that the train collided with the motorized bicycle because the motorized vehicle entered Niiya No.3 level crossing, the class 4 level crossing without crossing gate nor road warning device, in the situation that the train was approaching.

Furthermore, until to implement these measures, it is desirable to study the measures such as to add the signboard for attention against the persons who enter the concerned level crossing from the city road Nakahama 188, to paint the stop line for level crossing, etc., in addition, to let known well to stop once at just before the level crossing and confirm the safety.

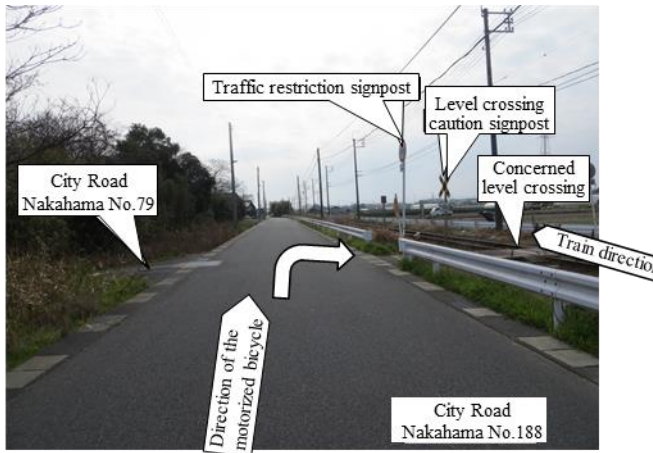
<Status of Niiya No.3 level crossing viewed from city road before the motorized vehicle had entered>

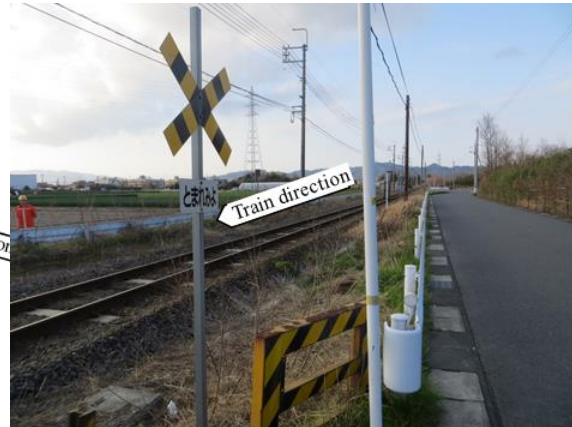
<Perspective of the train viewed from the entered motorized vehicle>

It could not be determined the details why the motorized bicycle entered the concerned level crossing in the situation that the train was approaching, because the driver of the motorized bicycle was dead, although it is somewhat likely that the driver of the motorized bicycle entered the concerned level crossing without noticed the approaching train.
