Demonstration test of a newly developed corrosion-resistant concrete manhole in Vietnam, which was adopted in the WOW TO JAPAN (Wonder Of Wastewater Technology Of JAPAN) project by MLIT.

- Hazama Ando corp.
- Global Works Co.,Ltd
- Tokyo City University

Demonstration period : 2021.11.16~2022.5.31

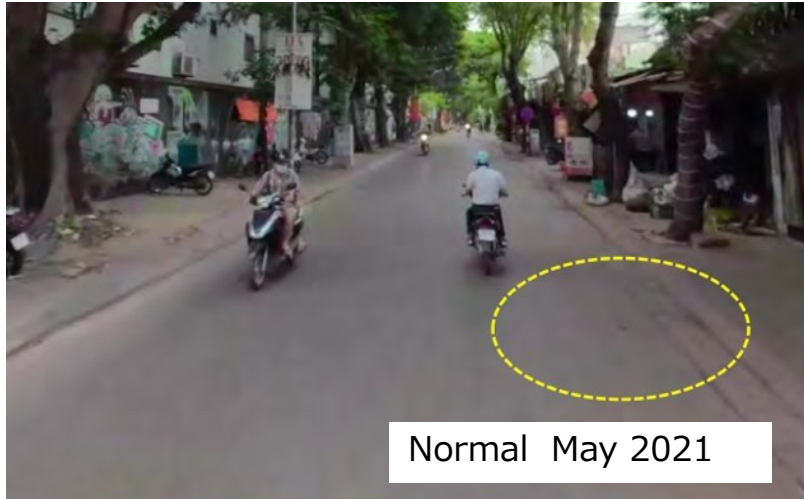
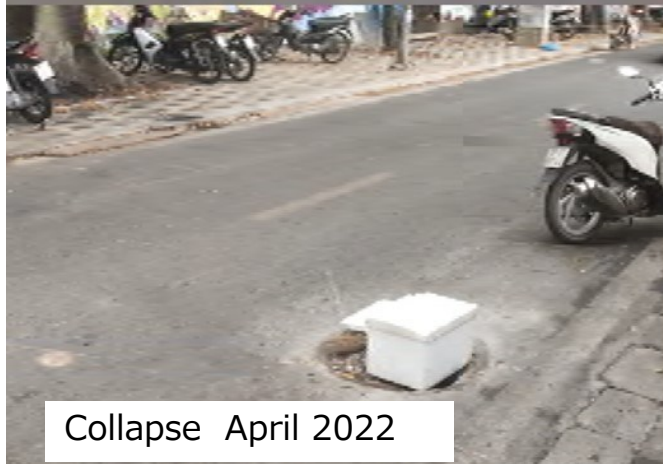
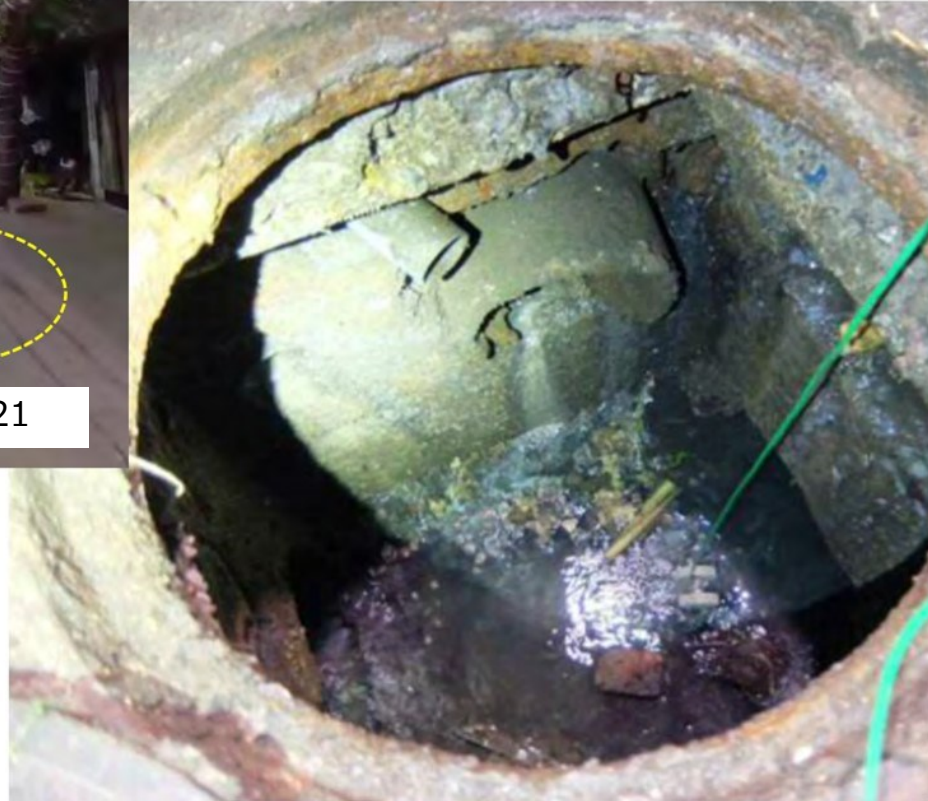
# Corrosion of concrete sewage pipe in Vietnam

Corroded manholes before replacement

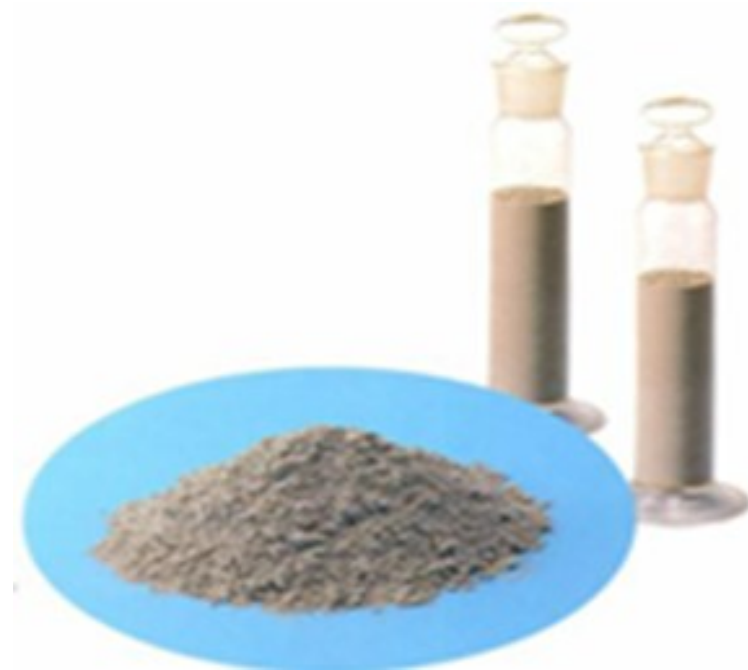
# Antimicrobial agent to inhibit $\text{H}_2\text{SO}_4$ Production

Agent S: Metal- Metallic oxide

Agent C: Organic acid metallic salt + Metallic Oxide

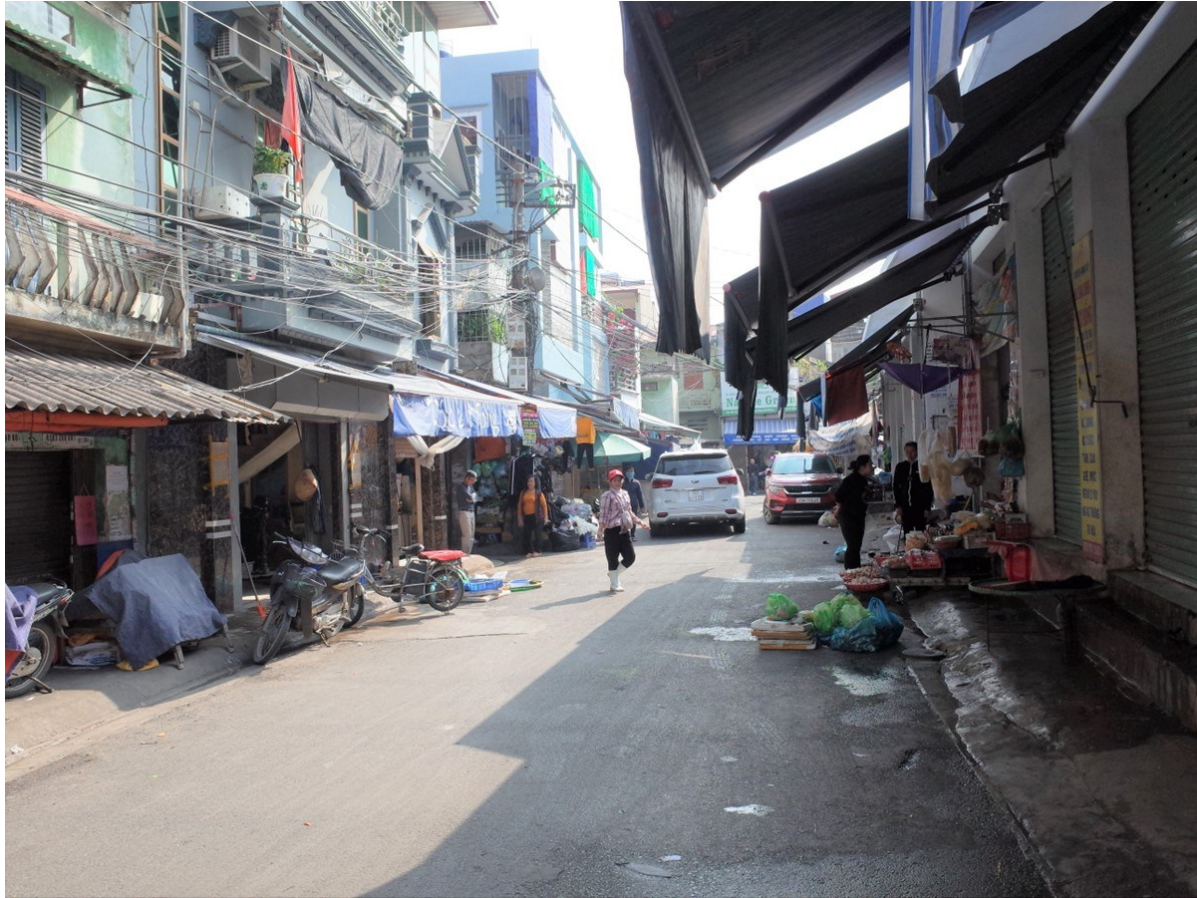
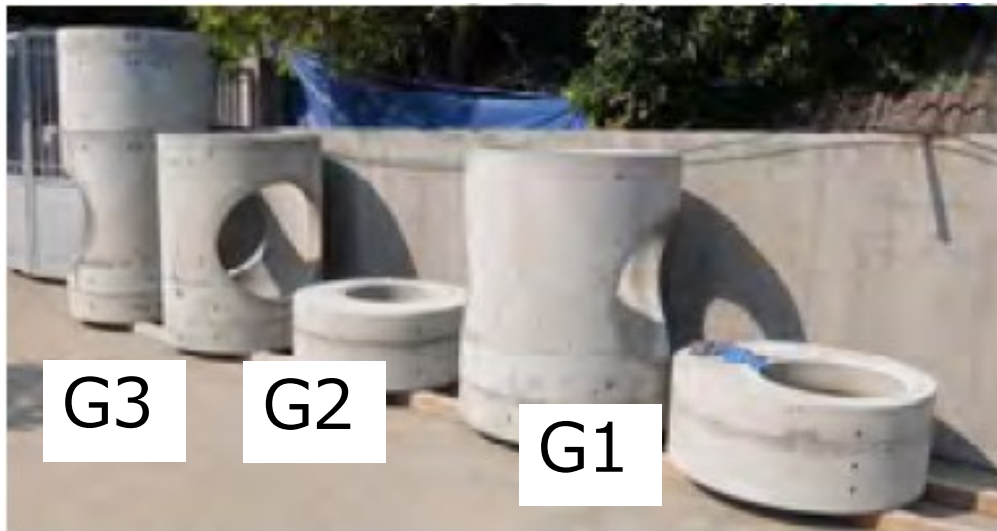
# Field Test in Hai Phong -Food Market-

3 manholes were installed inside the market place  
on 27-29 Dec 2021

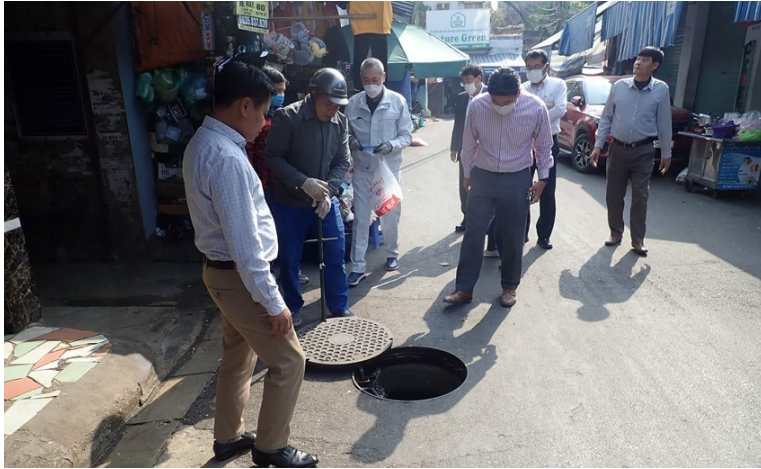
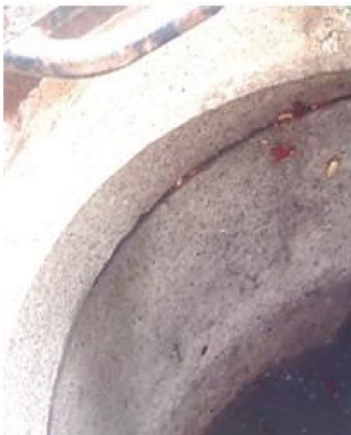
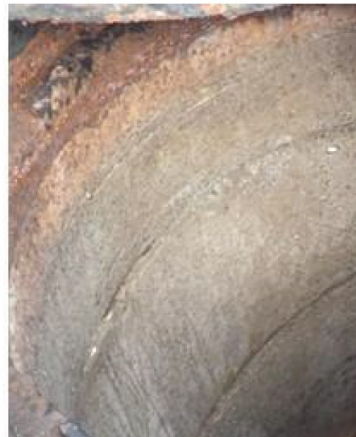
# Microbial community on the manhole wall

Microbial community from 1 to 4 years after the installation

G1:Normal

G2:Agent S
