1. Damages caused by the Great East Japan Earthquake

2. MLIT's emergency response to the Great East Japan Earthquake

3. Recent policy changes regarding tsunami disaster countermeasures

Overview of Earthquake & Tsunami

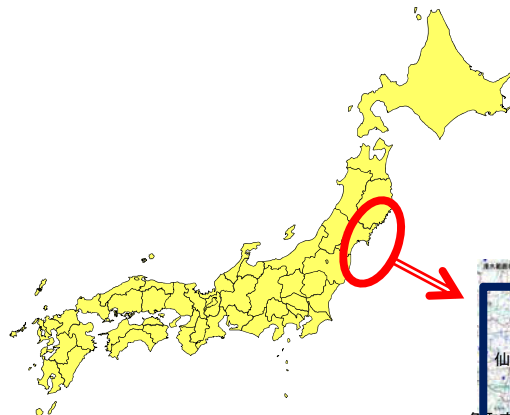
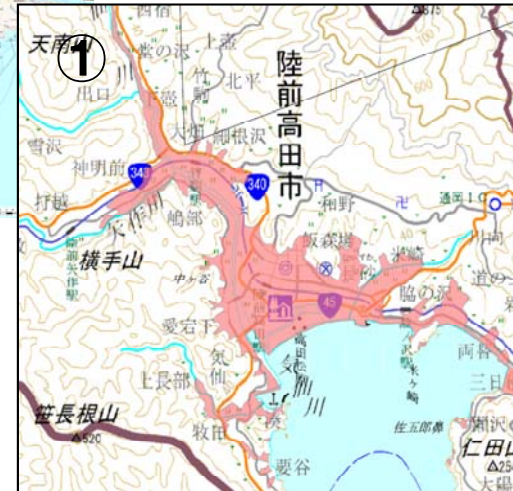
Damages caused by Tsunami (1/2)

- 535km² of land was inundated by tsunami in Tohoku and Kanto region. Approx. 10% (119km²※1) of urban area was inundated.
- Approx. 129,000 buildings were destroyed, fatalities were around 15,850 and missing persons were around 3,282. ※2

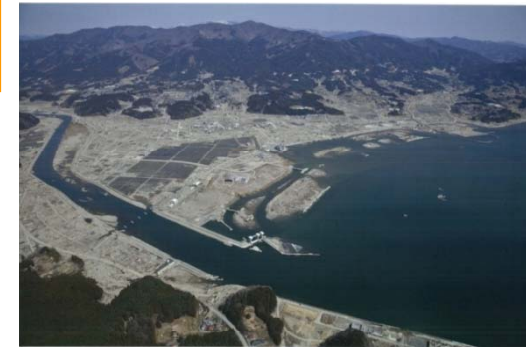
Looking at Rikuzentakata from the sea side (After tsunami)

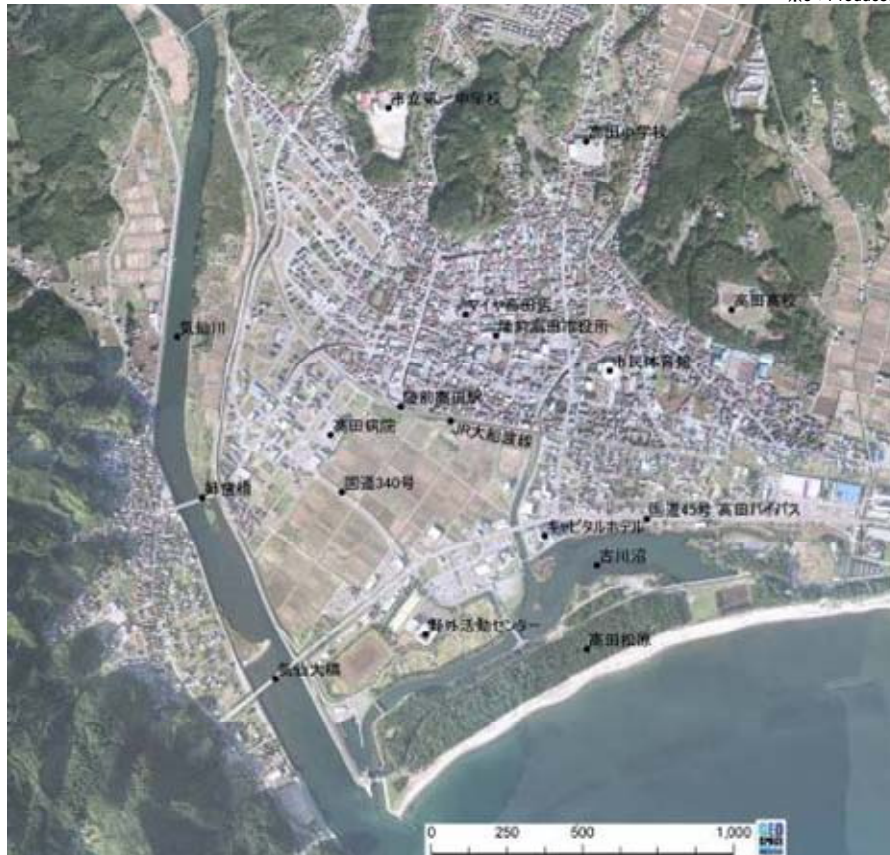
Before tsunami (Oct. 18 and 29, 2010)

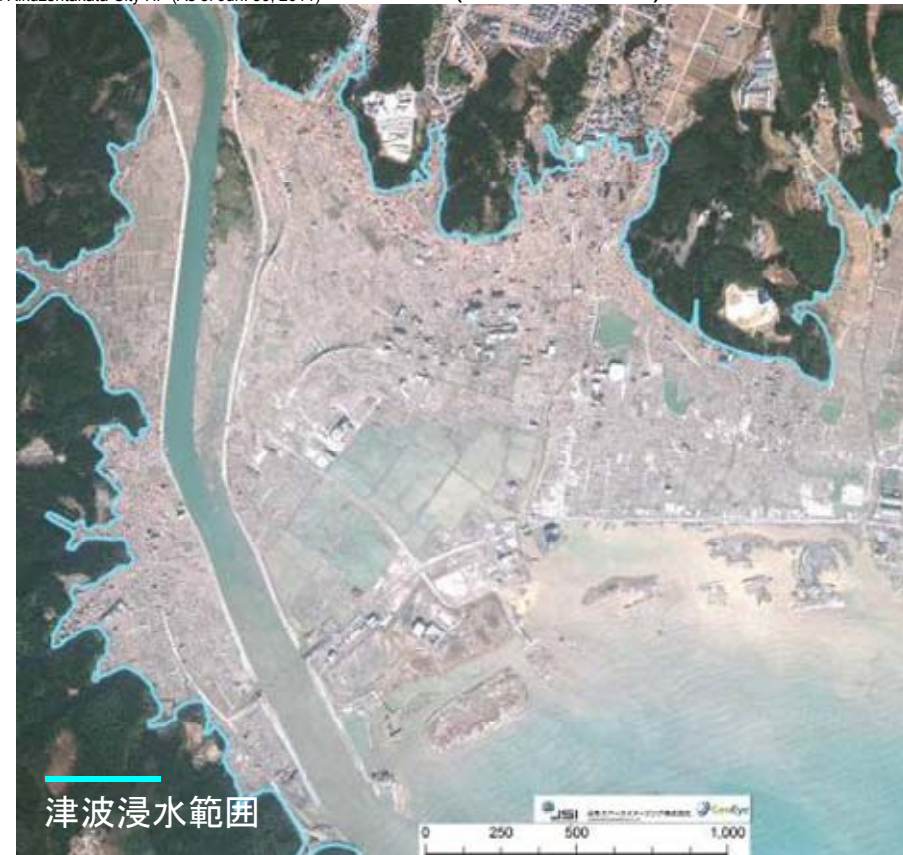
After tsunami (Mar. 13, 2011)

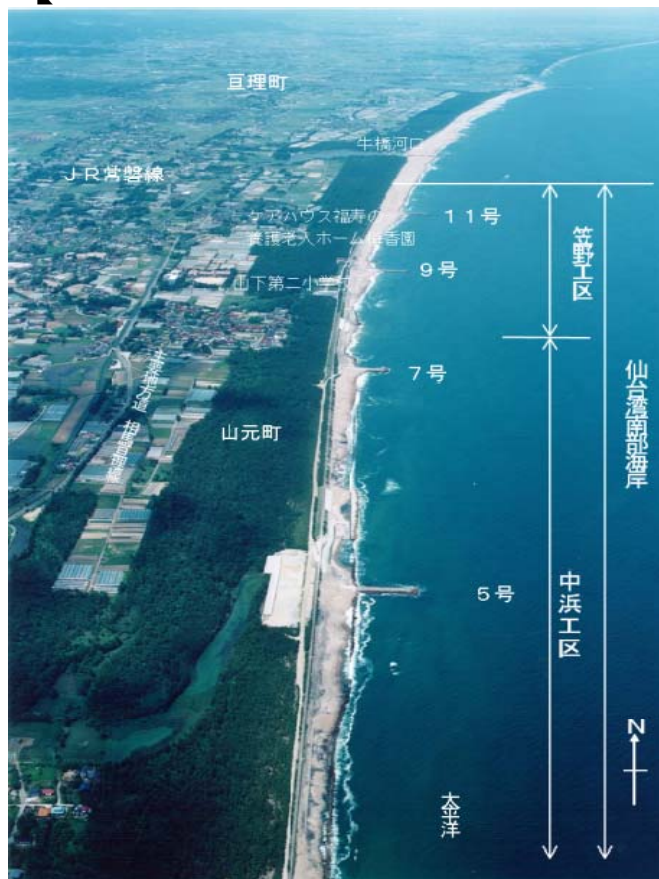
【Sendai Gulf Southern Coast】

- Along the 1,700km coast of Iwate, Miyagi & Fukushima prefectures, there were 300km of coastal levees.
- 190km of the levees were fully or half destroyed.

Before

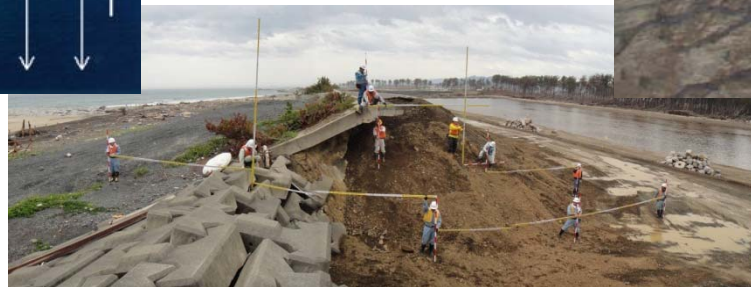
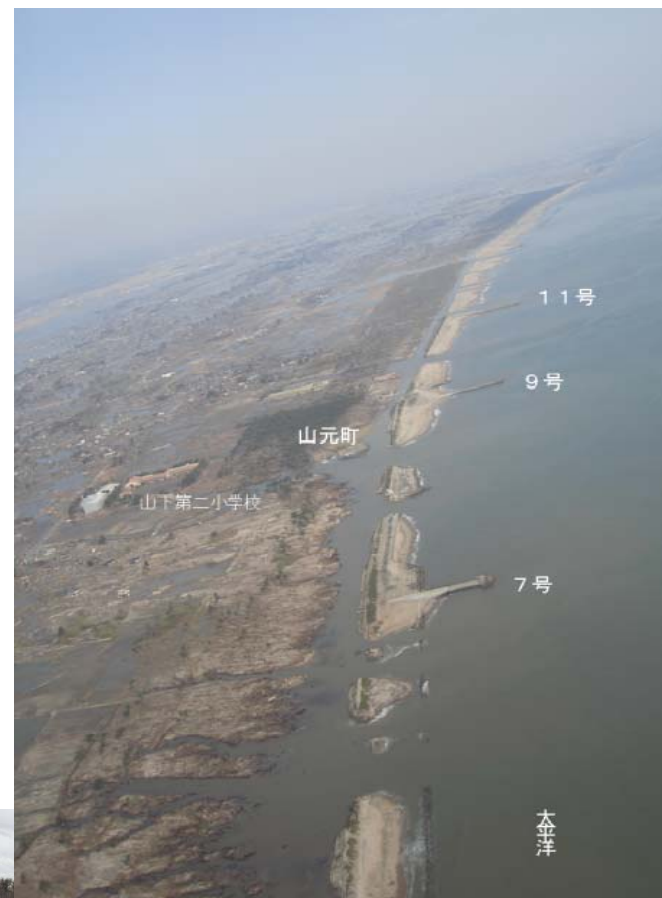
【Kasano District】

After

Photo on March 12, 2011

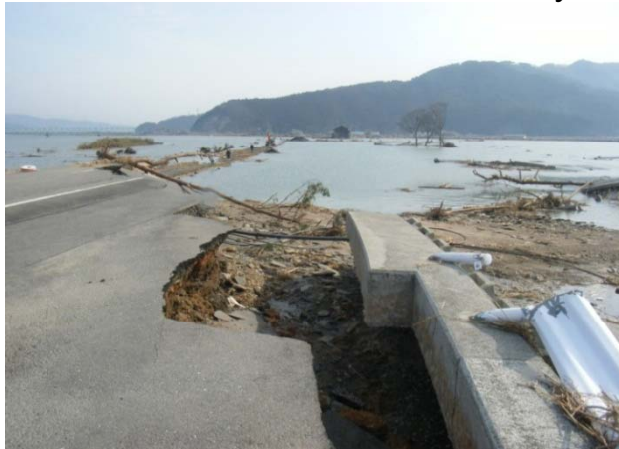
Kitakami River 【Ishinomaki City】

Levee washout/failure

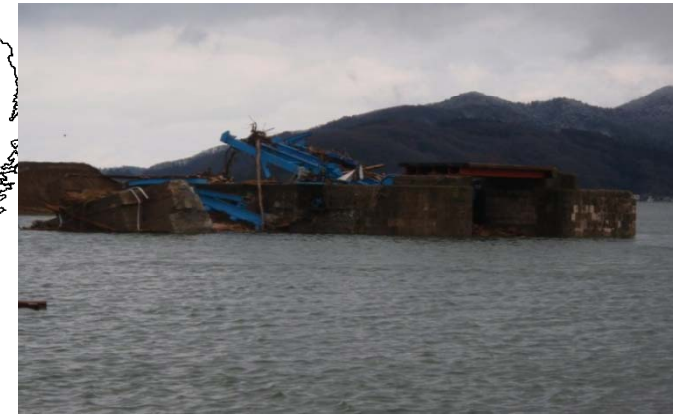
Kitakami River (Kamaishi Gate)
【Ishinomaki City】

Damaged Gates

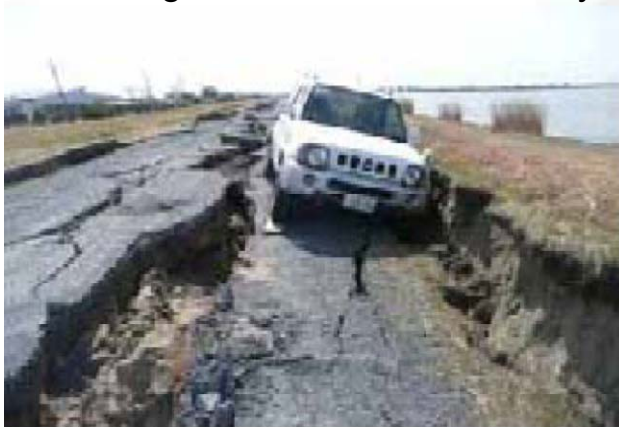
Kasumigaura Lake 【Inashiki City】

Levee Sinkage

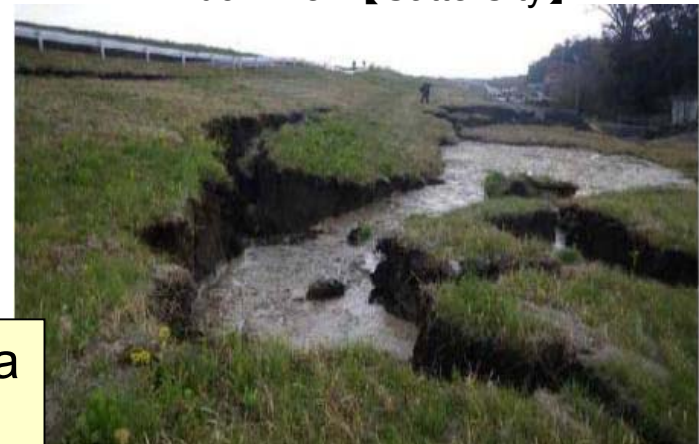
Edo River 【Satte City】

Levee slope failure
