**XXIV<sup>th</sup> World  
Road Congress  
Mexico 2011**

# Issues and Lessons Learned from the Great East Japan Earthquake

1. Overview of the Earthquake and Tsunami
2. Damages on Roads:  
Lessons Learned from the Past
3. Recovery of Roads:  
Emergency Recovery for Affected Area
4. Issues in Road Infrastructure:  
For the "Next" Great Earthquake

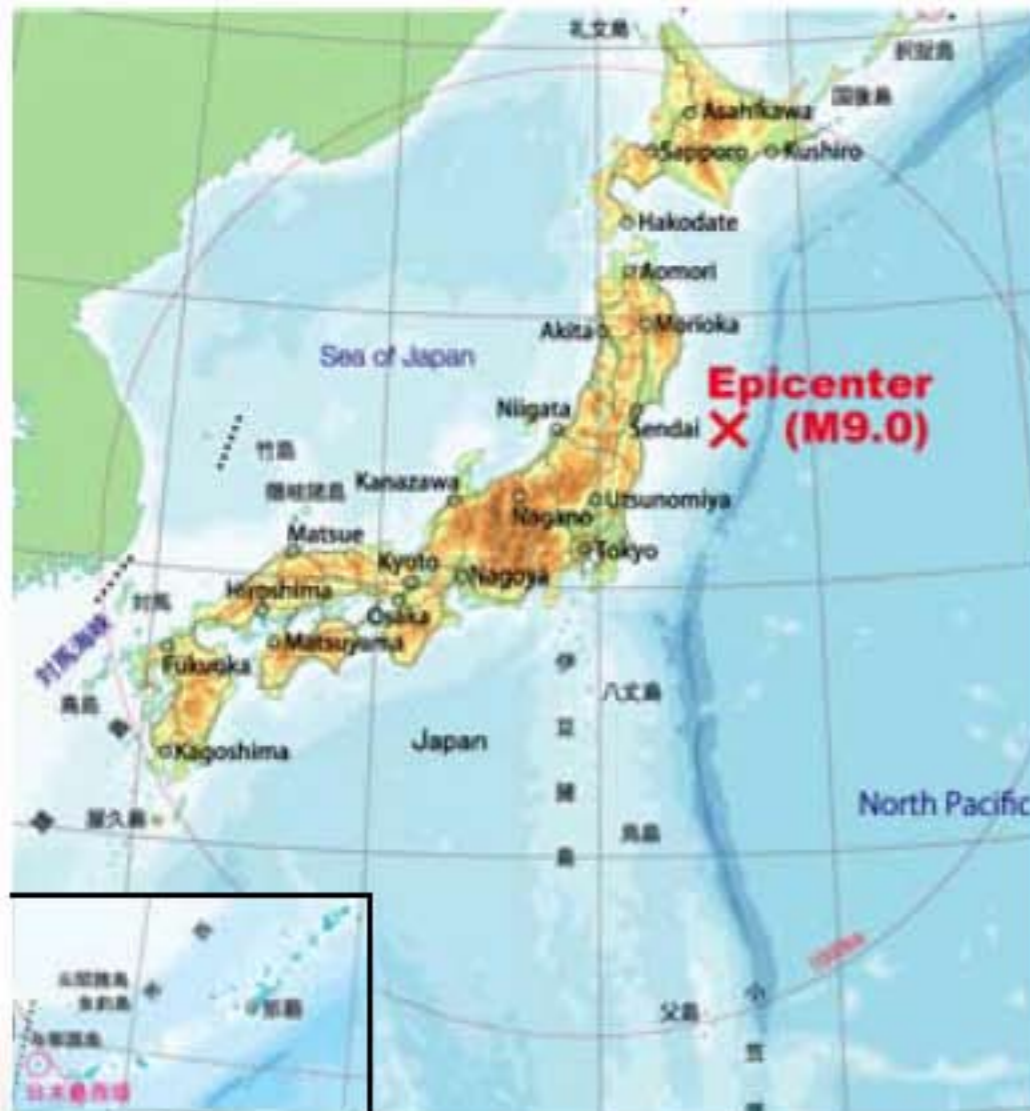
- “The Great East Japan Earthquake” occurred at 14:46 on March 11, 2011.
- This was the 4th largest earthquake in the world since 1900.

Rank	Date (Japan Time)	Location	Magnitude (Mw)
1	May 23, 1960	Chile	9.5
2	Mar 28, 1964	The Gulf of Alaska	9.2
3	Dec 26, 2004	Western coast of Sumatra, Indonesia	9.1
4	Nov 5, 1952	The Kamchatka	9.0
	Mar 11, 2011	Tohoku area off the Pacific Coast	9.0

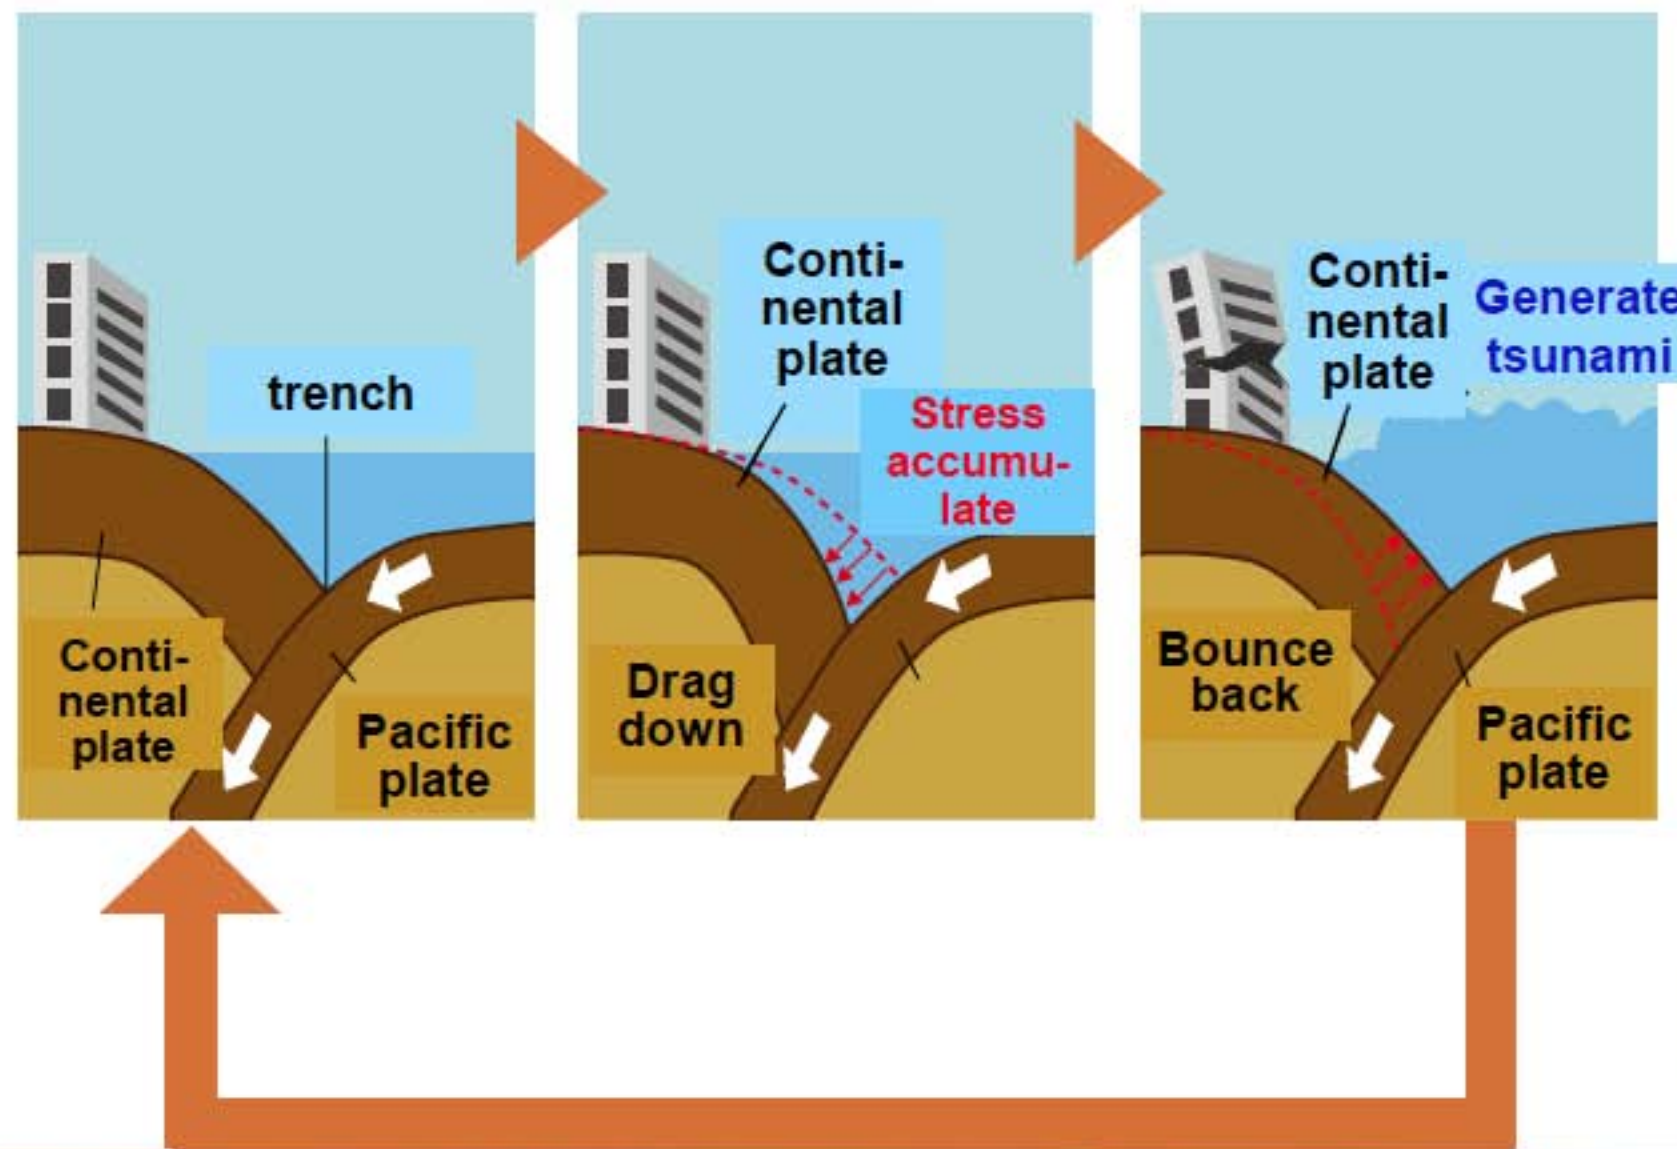
- Earthquakes and tsunamis occur when accumulated stress of a plate bounces back.
- Probability of this earthquake in 30 years was 99%.

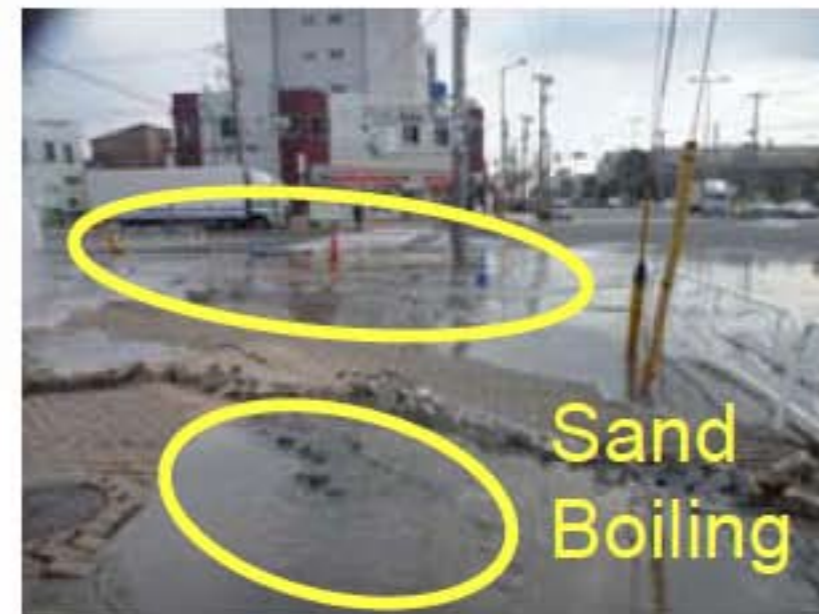
Sand boiling  
in reclaimed  
land

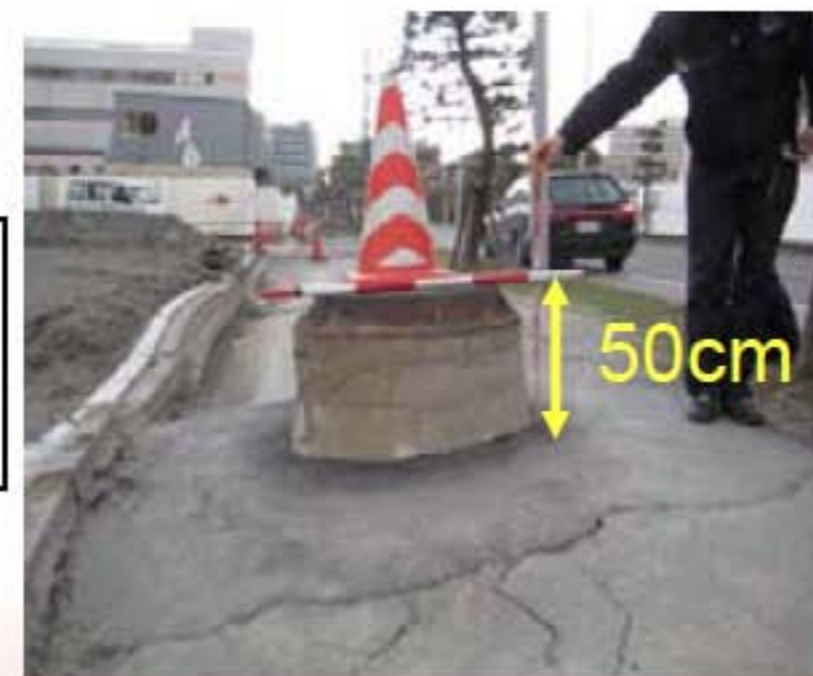
Lifted  
Manhole

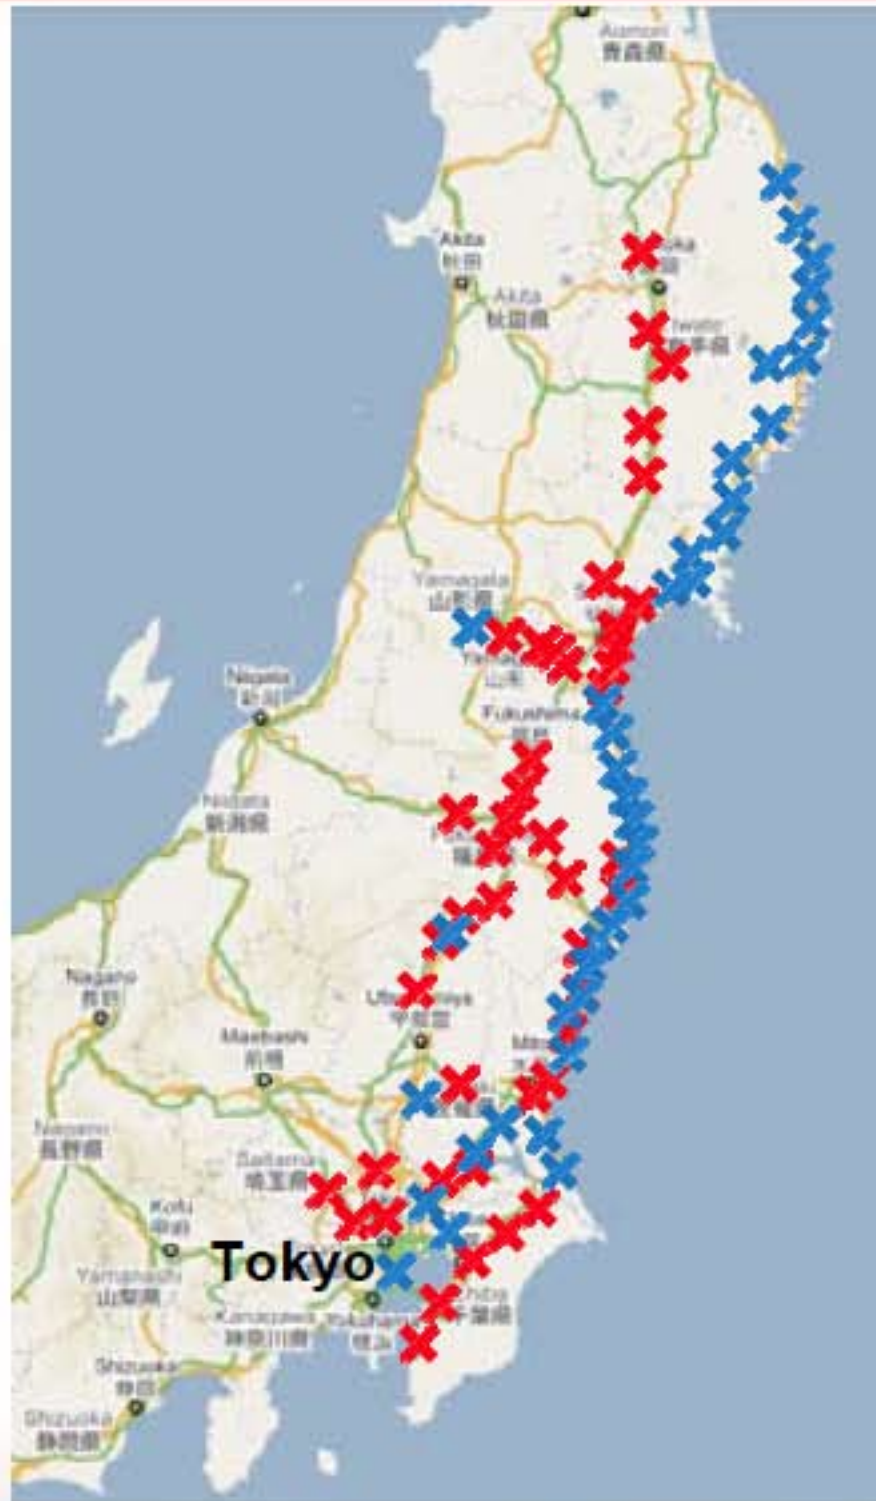
- Damages were caused on roads in wide areas.
- 15 expressway routes and 69 sections on the national highways were closed, mainly in Tohoku Region.

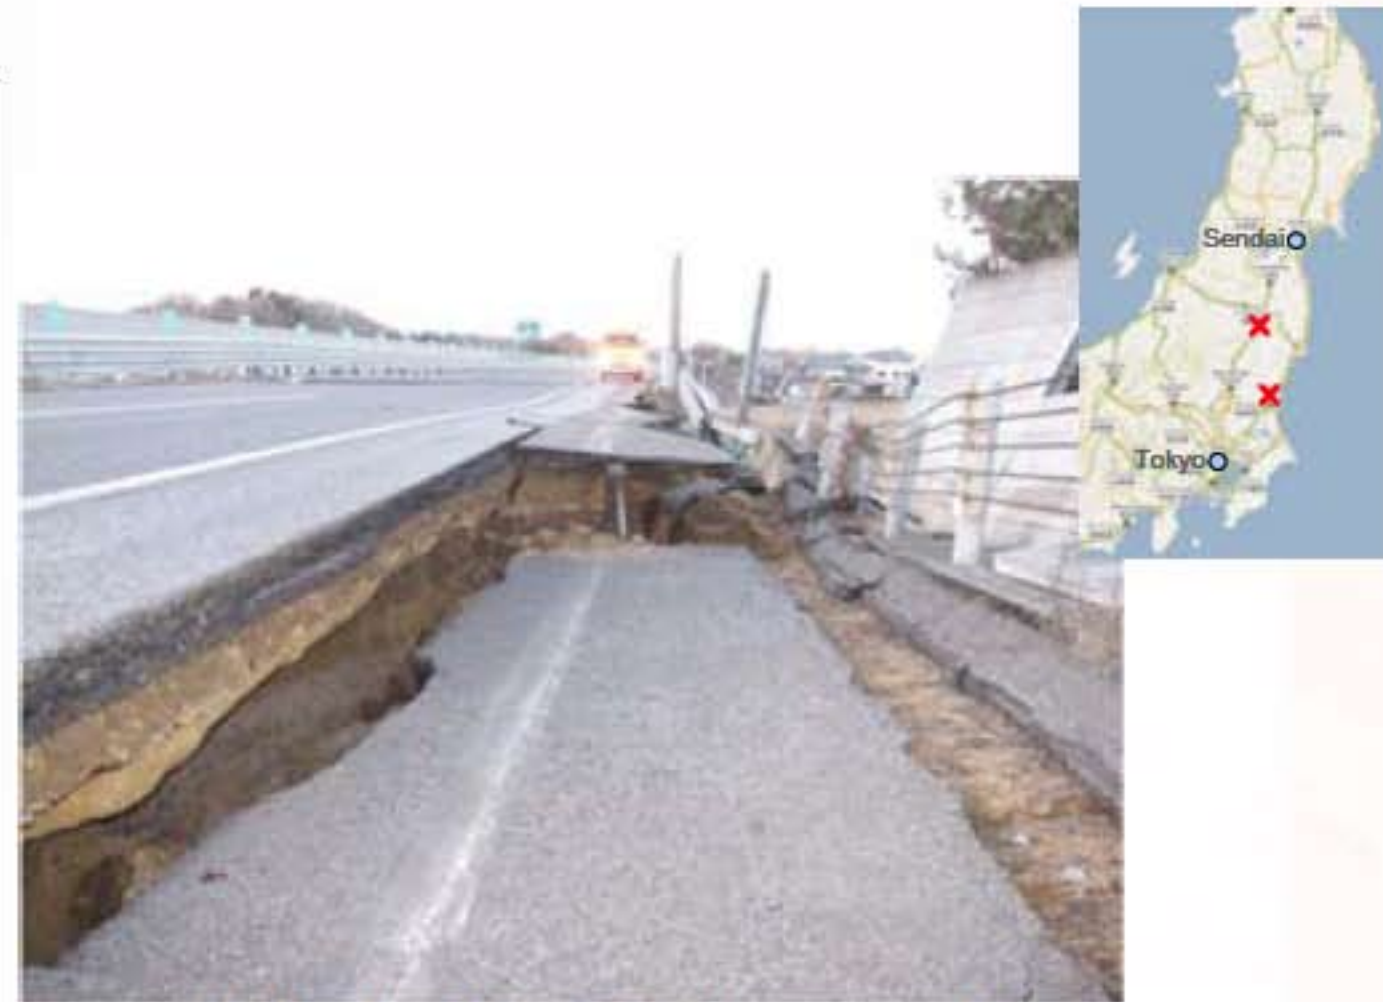
**Yabuki IC – Sukagawa IC  
(Tohoku expressway)**

- Embankments fell on the traffic lanes at 21 locations.
- None of 1,079 expressway bridges in the stricken areas was collapsed.

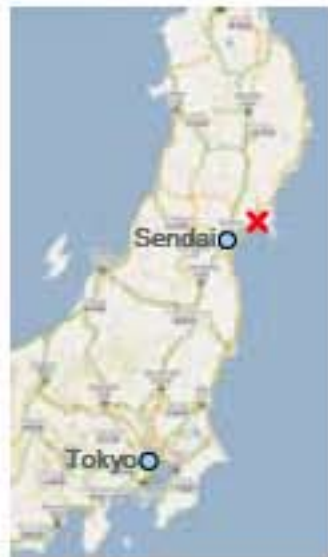
Near Ishinomaki city  
(Ntn'l Hwy 45)

- On national highways, a lot of damages were observed (e.g. small cracks on the road surface).
- None of 1,528 bridges had significant damages by earthquake (e.g. collapse).

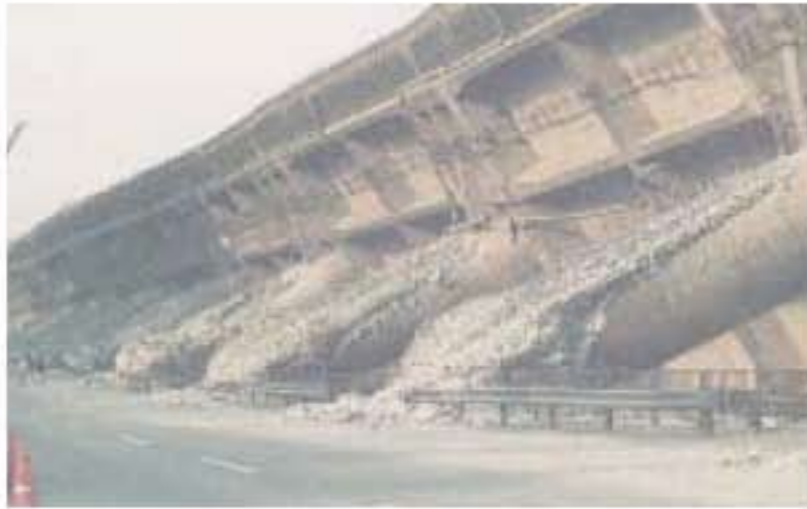
- Hanshin-Awaji Earthquake (1995) caused significant damages (e.g. structure collapse of Hanshin Expressway).

- Revising Standards
- Seismic Reinforcement

Jacketed columns and  
connecting  
superstructures

1. By having applied the lessons of the past earthquakes, such as the revised standards and associated seismic reinforcements, damages on bridges were significantly reduced.
2. Right after an earthquake, the top priority is to secure emergency traffic networks promptly.
3. We recognized the importance of multilayered expressway networks.
4. Right after disasters, necessary information should not be provided by multiple road administrators separately to avoid confusion. Moreover, road users need information such as available road networks.

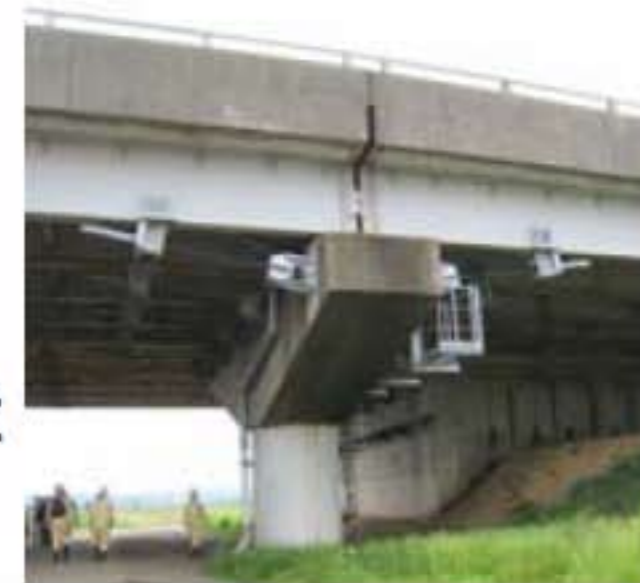
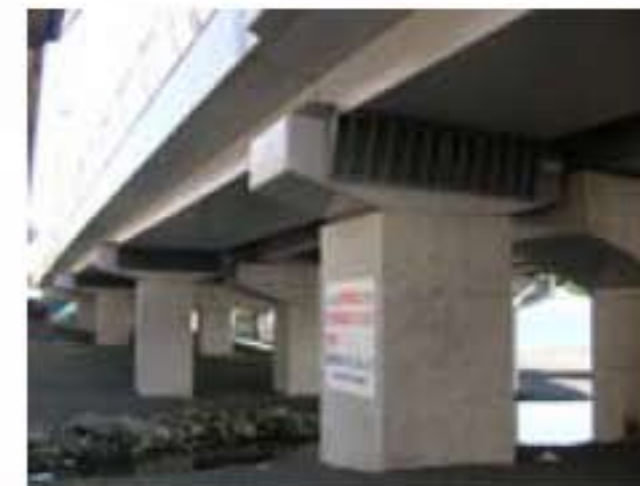
Damages by  
Hanshin-Awaji  
Earthquake (1995)

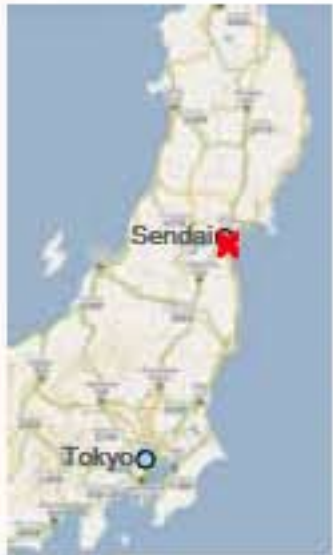
Wakabayashi JCT  
(Sendai Tobu expressway)

- Tsunami flooded roughly 100 km across the national highways.
- Tsunami brought massive debris (e.g. boat, building), which covered roads, towns, and agricultural fields.

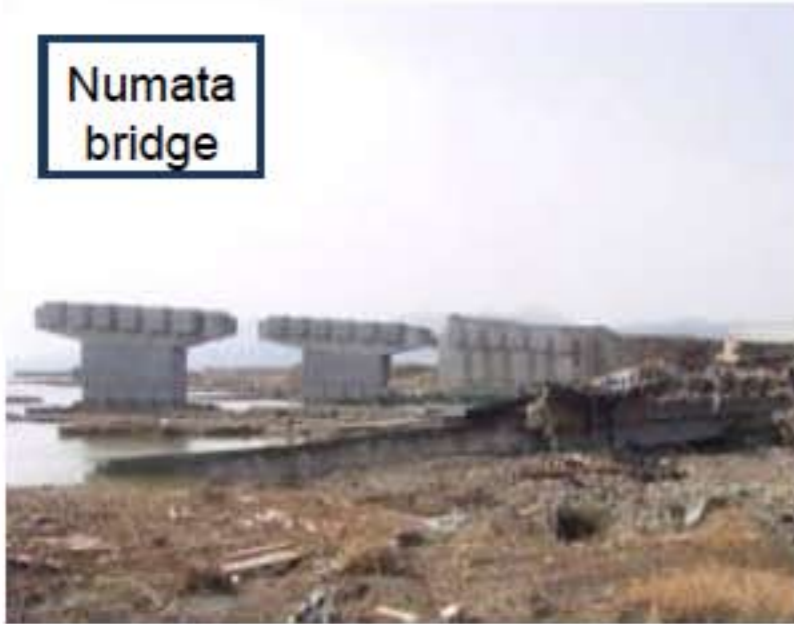
Numata  
bridge

- Five nationally-administrated road bridges were washed away.

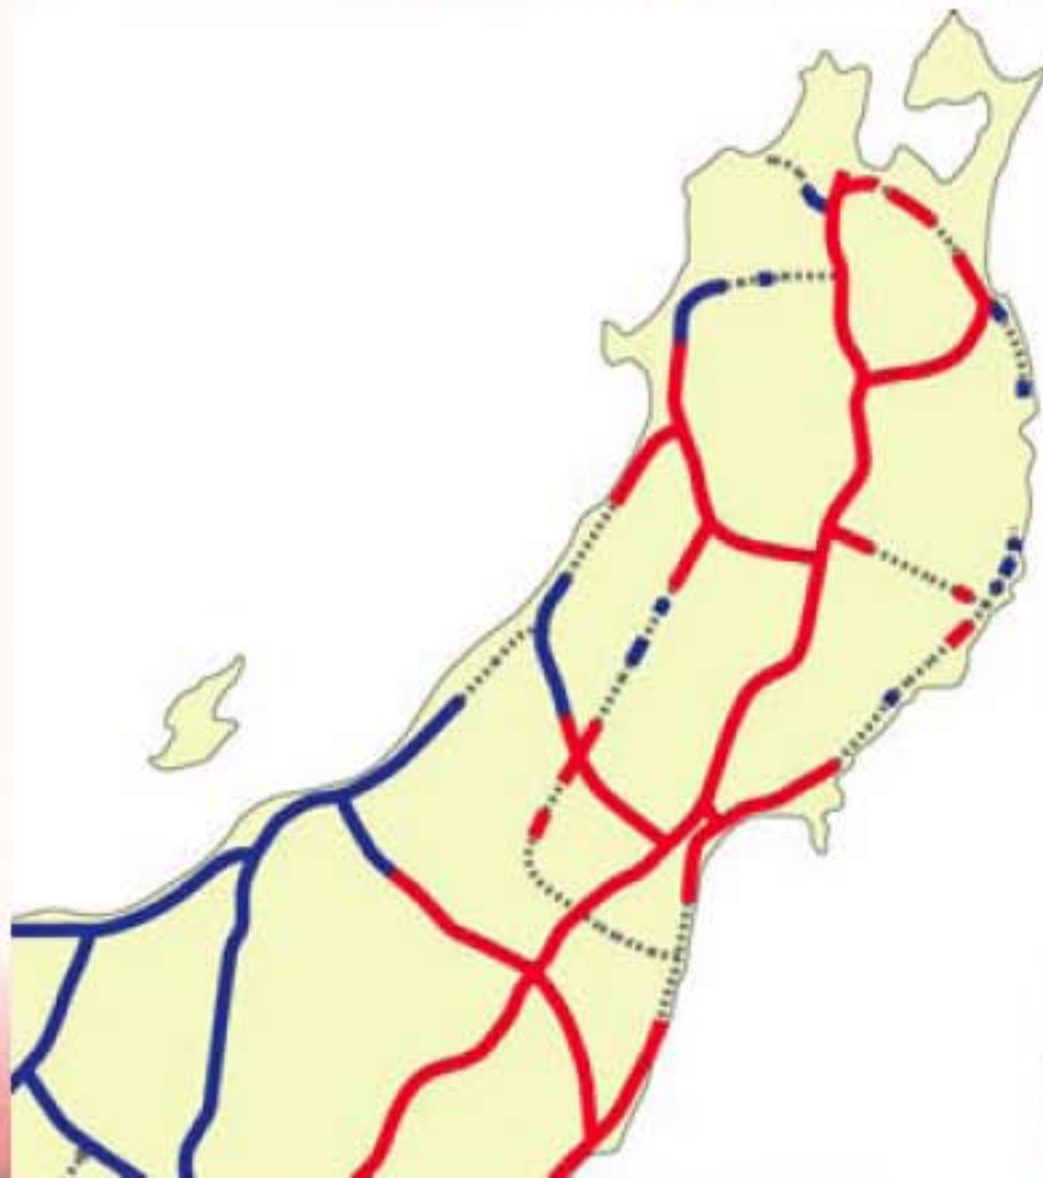
**Immediately after  
Earthquake (March 11)**

- Almost all expressways in Eastern Japan were temporarily recovered in one day and allowed emergency traffic.

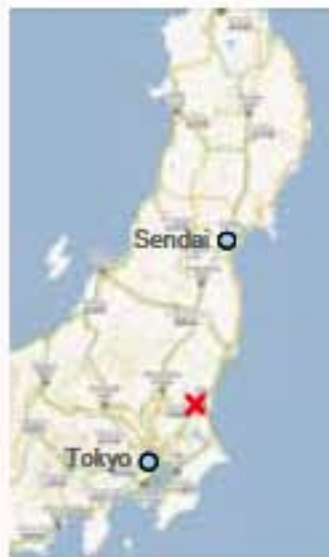
- Emergency recovery was completed at the damaged embankment areas on the Joban Expressway six days after the earthquake, and it was opened to general traffic.

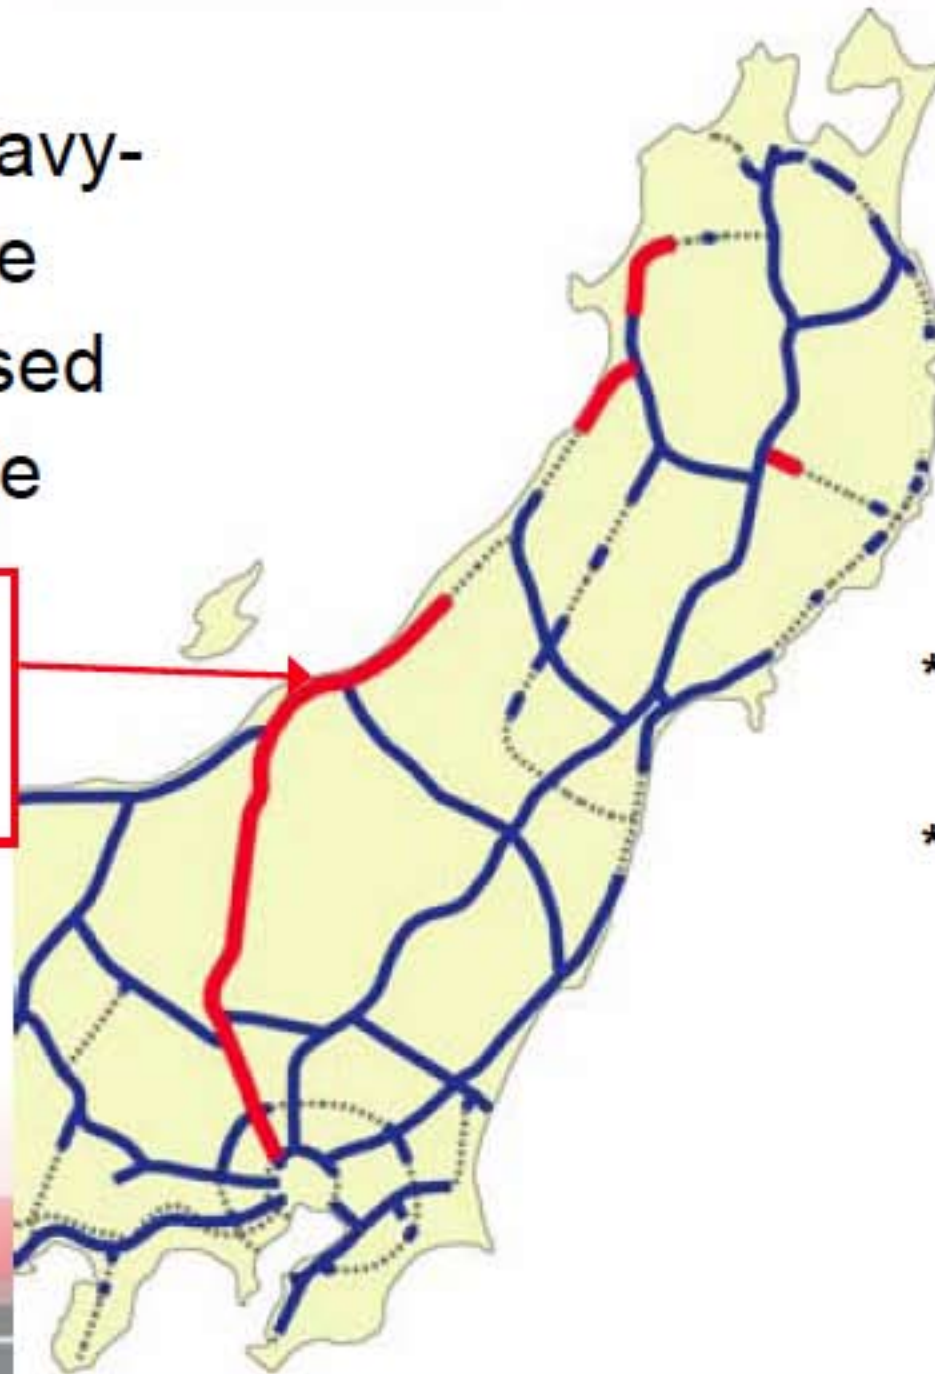
- The freight transport routes along the Sea of Japan functioned as an alternative to the damaged coastal routes along the Pacific.

- Traffic volume of Heavy-duty vehicles on the Expressways increased after the earthquake

**Traffic Increased  
by 30 to 50%**

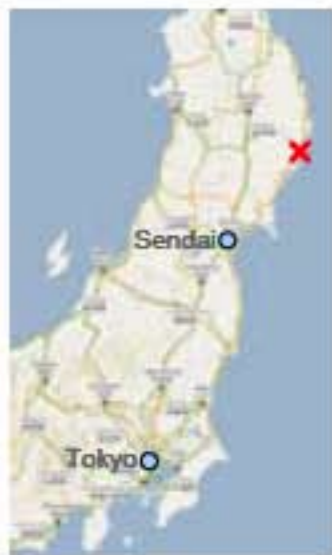
Ntn'l Hwy 45

- Since the Sanriku Expressway along the Pacific had been designed to avoid tsunamis based on the past tsunamis, it was free of damages.
- Reassured the importance of planning road infrastructure taking into account of tsunami risks.

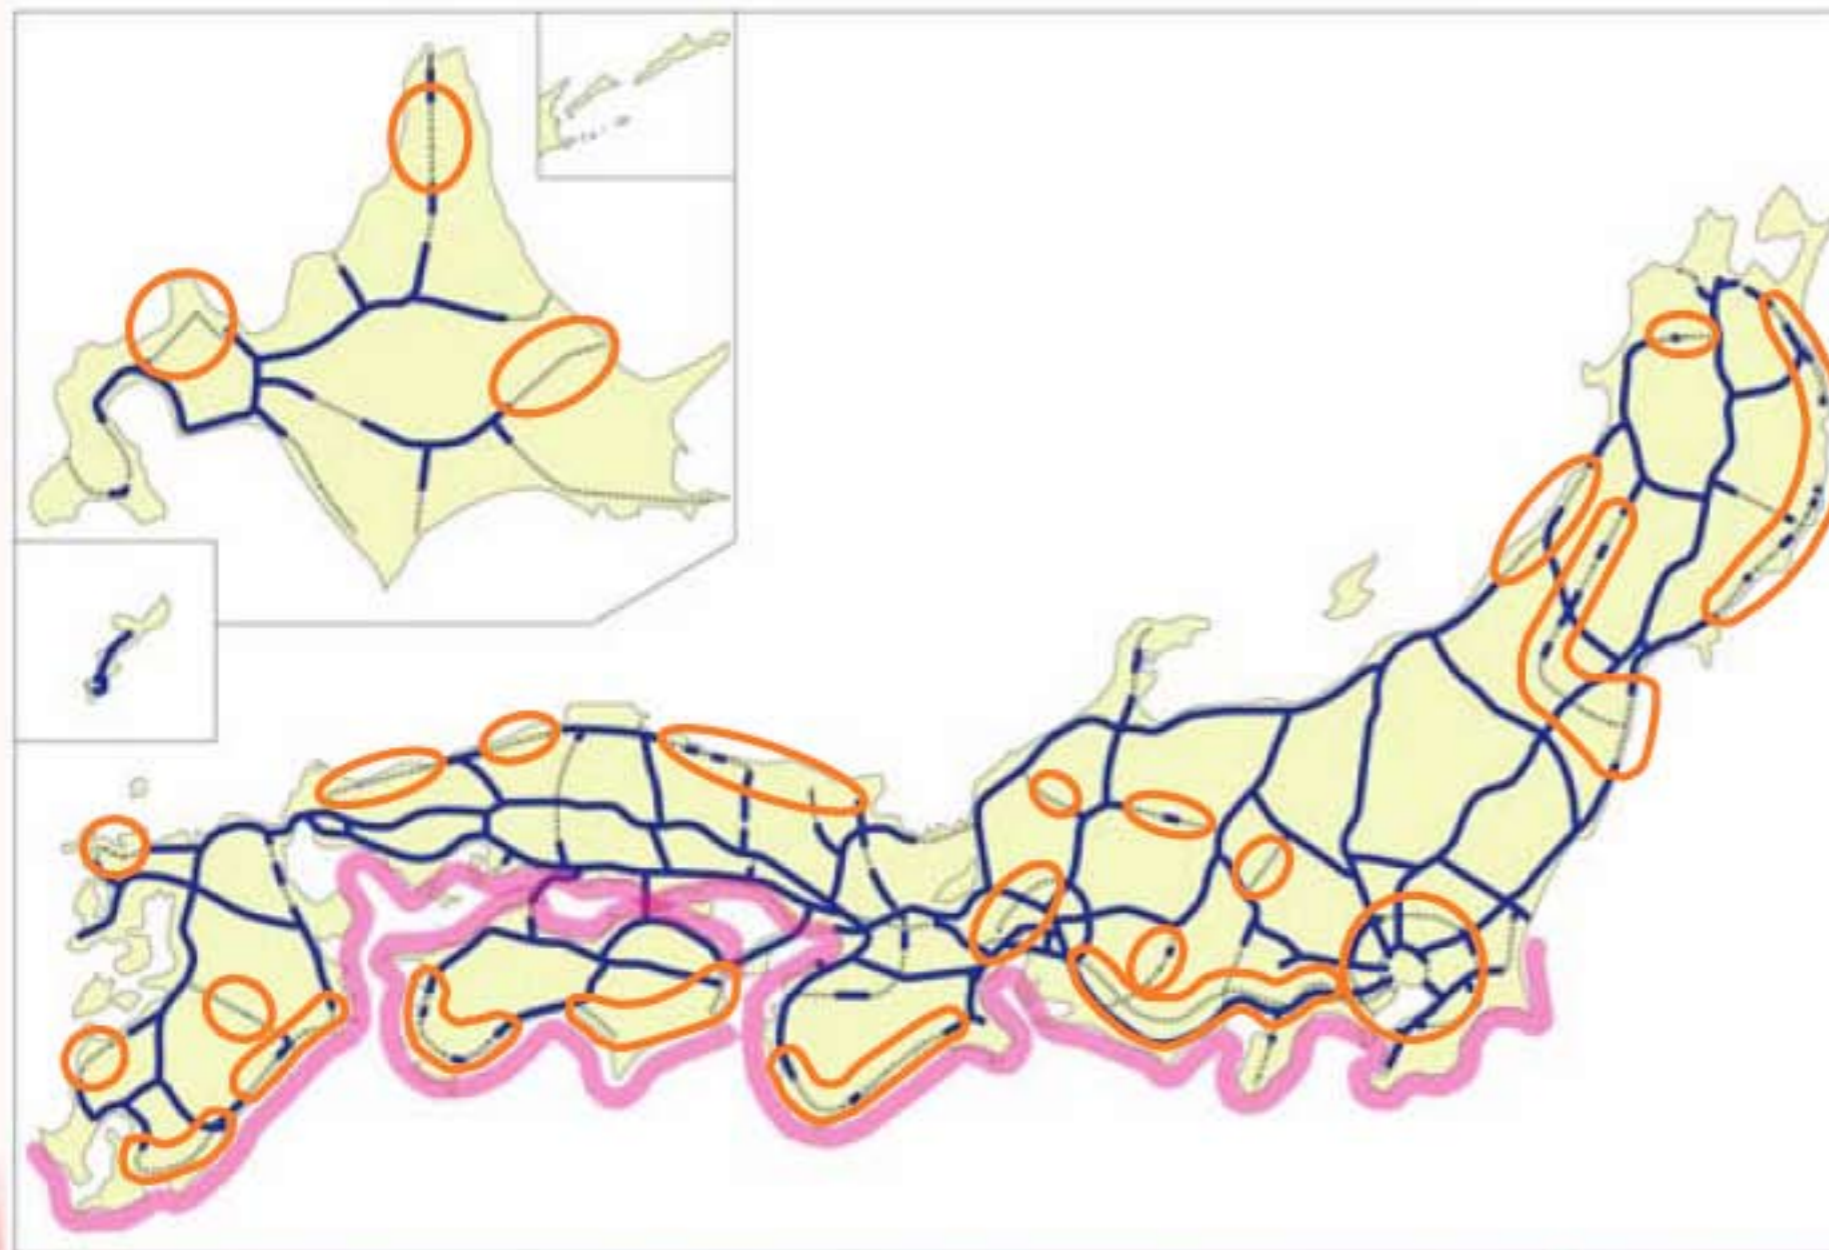
- Missing links of the expressways in these high-risk flood areas by tsunamis by possible large-scale earthquakes.

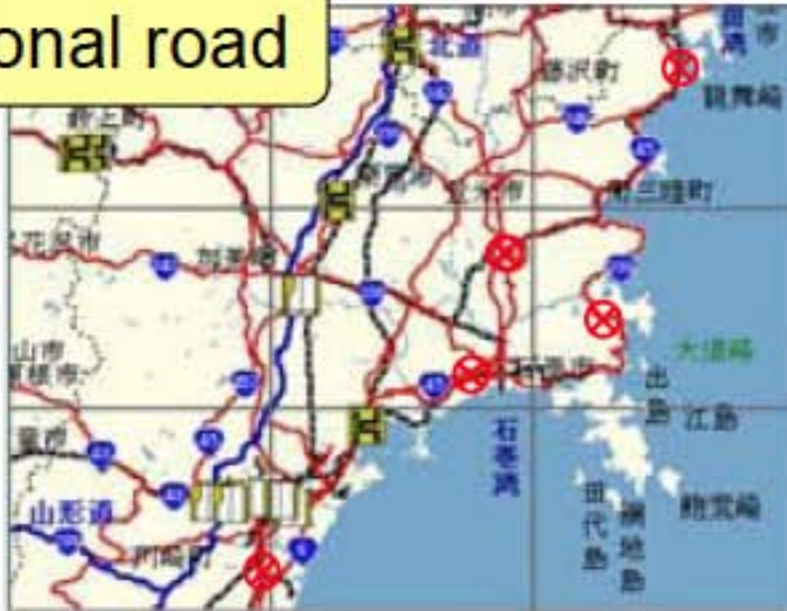
National road

- After the earthquake, each government provided information separately.

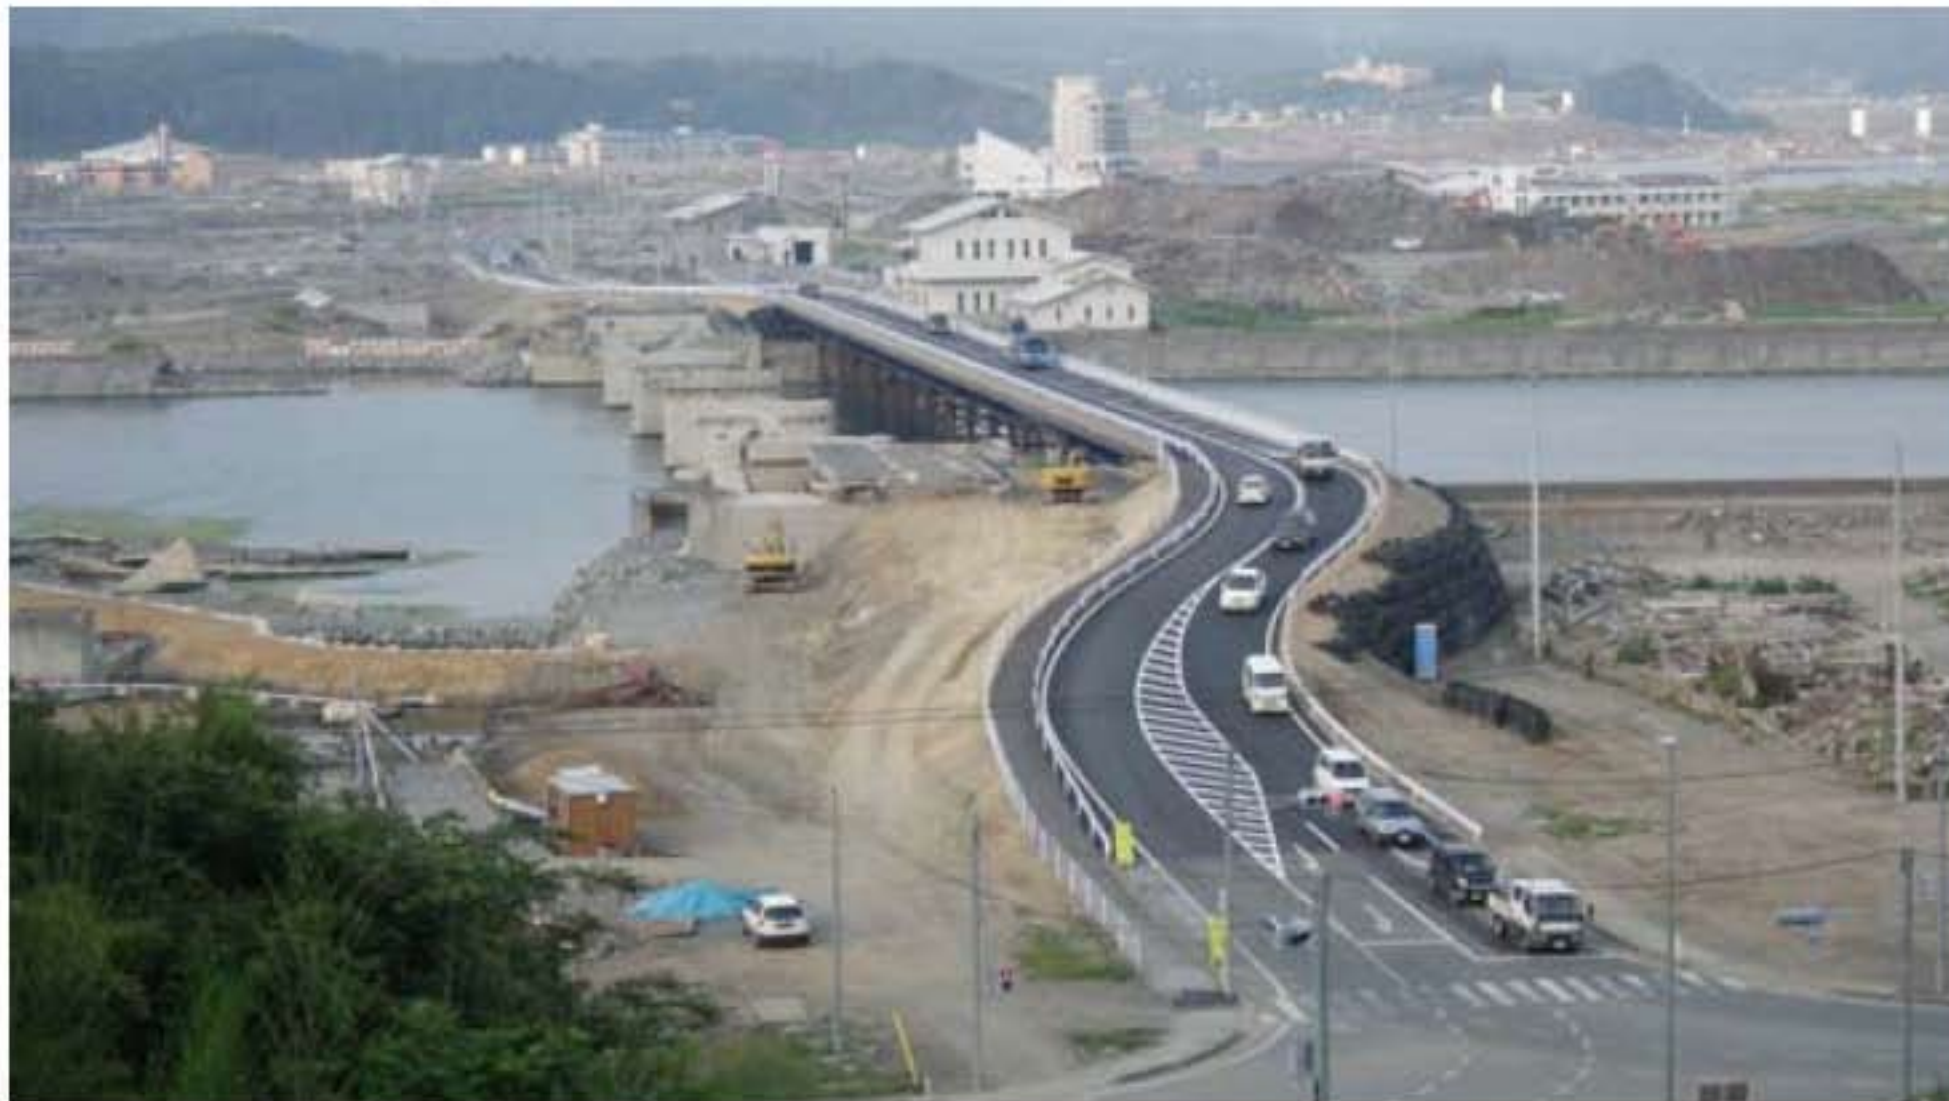
Temporary bridge was built in place of previous bridge washed away by tsunami; A step toward recovery.
