Study for Establishment of National Basic Geographic Data in The Republic of El Salvador

Establishment of Base Map and Hazard Maps for GIS in the Republic of Guatemala

Disaster Information Management Activities using GIS in the Hanshin – Awaji disaster area

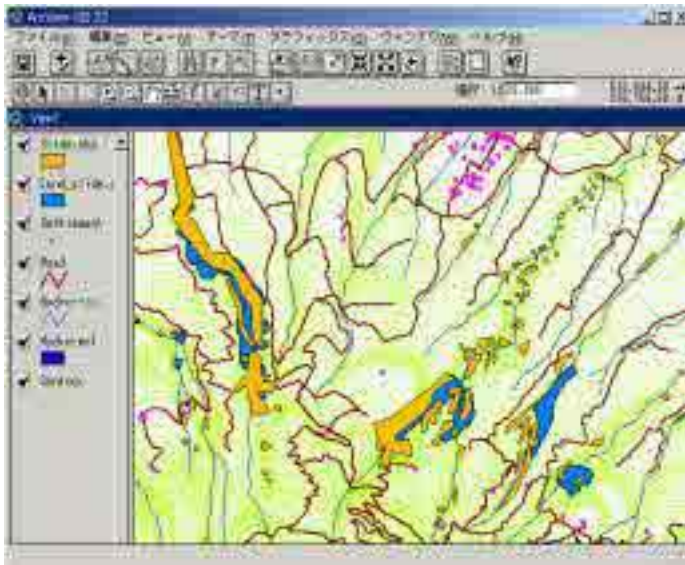
Figure 3. Example of the Disaster Map

An example of the disaster maps is shown on Figure 3, and an example of the hazard maps is shown on Figure 4.

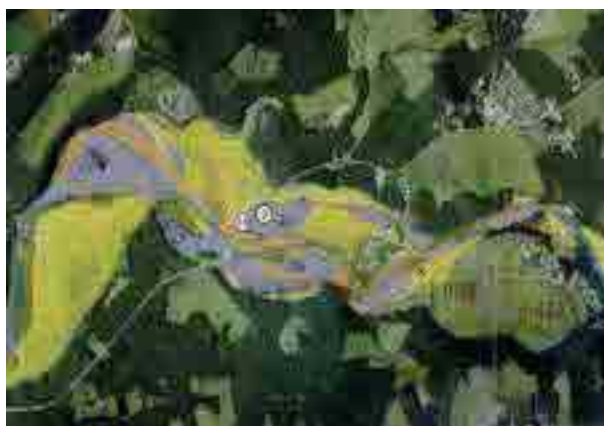
Fig. 2 Image of Hazard Map (Assessment of risk of flooding)

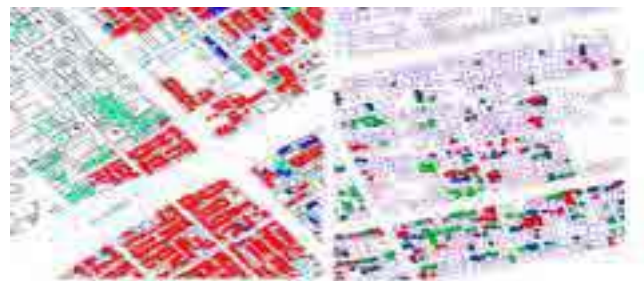
Nagata ward using GIS

Higashinada ward not using GIS

The effects on use of GIS was appeared at the rapid increase in the total of debris removals in April. The two kinds of different spatial pattern on Figure 2 shows the different situation of the debris removals in Nagata and Higashinada ward respectively, which suffered the heavy strike with the almost same damage ratio of collapsed houses. It follows from this that the aggregated spatial pattern indicates the effectiveness of the debris removal processing, because local public service workers of Nagata ward could easily realize where the collapsed houses were aggregated by the map visualization of GIS. In other words, Figure 2 shows why it could be removed efficiently by the use of GIS.

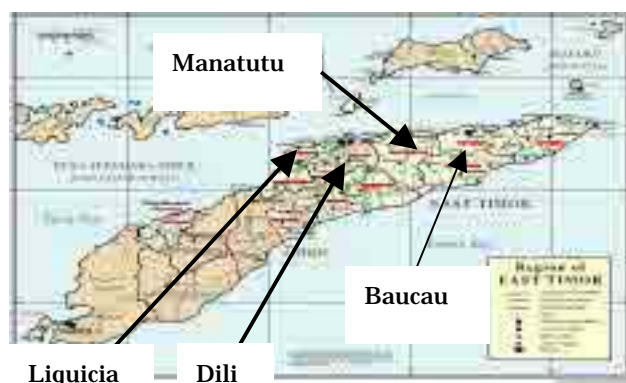
Fig.1 The Study Area

The Study area covers Dili City and its surrounding area in East Timor and the total study area is 107 square km for 1:2,000 scale digital topographic mapping and digital GIS data preparation (Fig.1) . The Study was started in February 2000 and ended in September 2000. It was the first digital topographic mapping in East Timor after the violence following the independence vote in September 1999.

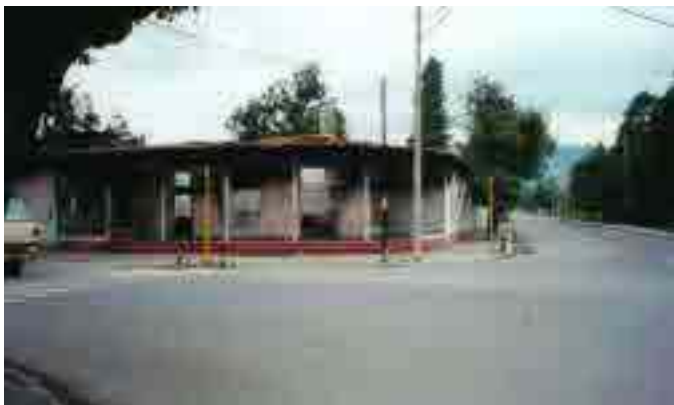
Fig.4 House destroyed and burnt in September 1999 in Dili
