Major Damage & Recovery in MLIT Tohoku Regional Bureau (as of 10:00 26 March 2011)

Major Damage & Recovery in MLIT Kanto Regional Bureau (as of 10:00 26 March 2011)

Major Damage & Recovery in MLIT Hokuriku Regional Bureau (as of 10:00 26 March 2011)

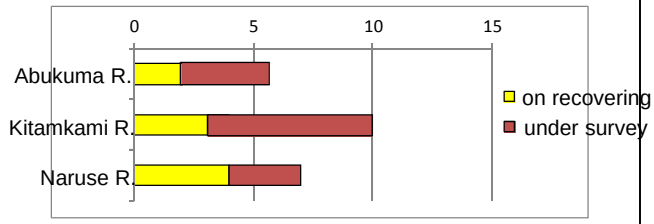
- Severe damages requiring emergent recovery before next flood
- 23 points, including 9 under survey and 14 under recovering works

- Totally 735 damages in Tohoku region

River System	Damage points	
		River Facility
Mabechi R.	12	1
Abukuma R.	122	8
Natori R.	27	0
Kitakami R.	429	55
Naruse R.	145	16
total	735	80

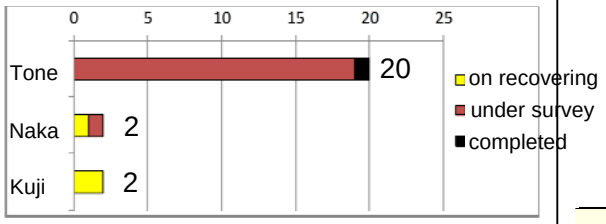
- Severe damages requiring emergent recovery before next flood
- 3 under survey, 20 recovering and 1 completed

- Totally 718 points in Kanto region

River System	Damage Point	
		River Facility
Tone R.	543	20
Ara R.	22	3
Naka R.	74	4
Kuji R.	79	5
Total	718	32

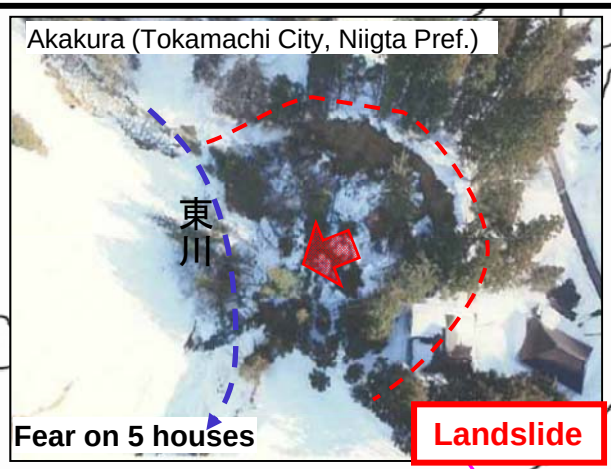
Akakura (Tokamachi City, Niigta Pref.)

Fear on 5 houses

Landslide

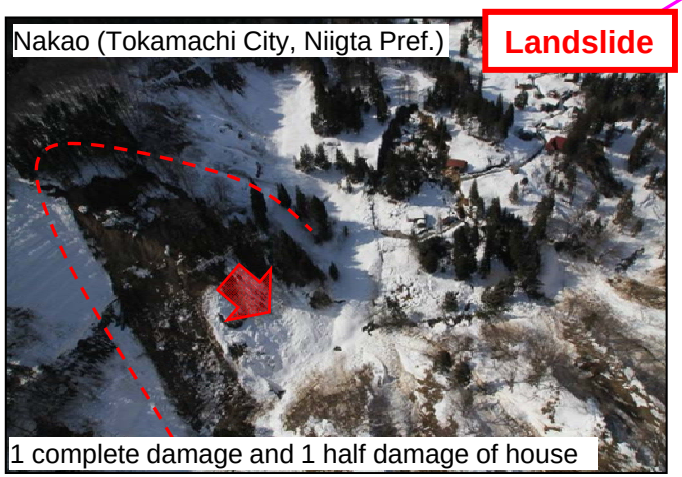
Nakao (Tokamachi City, Niigta Pref.)

1 complete damage and 1 half damage of house

Debris flow

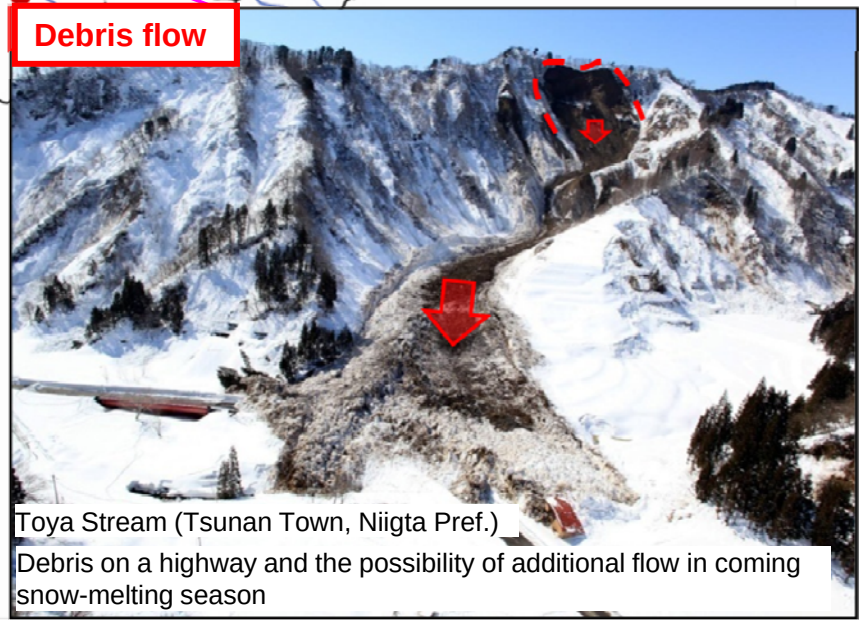
Toya Stream (Tsunan Town, Niigta Pref.)

Debris on a highway and the possibility of additional flow in coming snow-melting season
