Assessment Report – Battery Event at Narita on
a Boeing 787 aircraft operated by Japan Airlines

December 19, 2014
Japan Civil Aviation Bureau

- Operator : Japan Airlines Co., Ltd. (JAL)
- Type : Boeing 787-8
- Registration Number : JA834J
- Time of event : Approximately 16:15 (time is Japan Standard Time, the same shall apply hereinafter)
January 14, 2014
- Assessment : Battery event at Narita International Airport

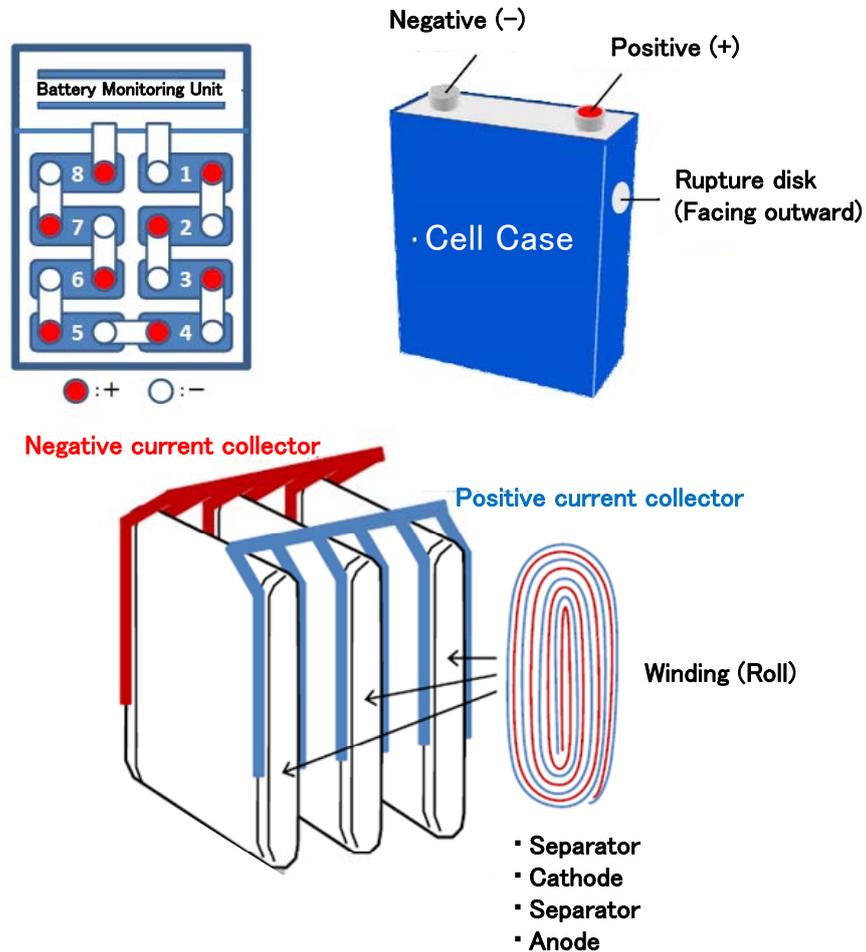
1) Components surrounding the battery

- a) The area adjacent to the main battery enclosure was clean and no damage was confirmed in the surrounding components.
- b) For the battery charging unit (BCU), no anomaly was confirmed by the successful completion of the usual acceptance test procedure (ATP) tests and checks at the manufacturer of BCU (Arizona, USA).
