**Final Report  
of Committee on Large Container Ship Safety**

Committee on Large Container Ship Safety

The Bahamian flagged large container ship (8,000 TEU class) “MOL COMFORT” (herein referred to as “The Ship”) experienced a fracture of midship part while transiting the Indian Ocean from Singapore to Jeddah (Saudi Arabia) on 17 June 2013. Following this, The Ship split into two halves, which were adrift before sinking. Thanks to the swift rescue efforts of ships navigating the area and Indian disaster relief authorities, no loss of life occurred in this accident. We express our gratitude to those involved in this rescue.

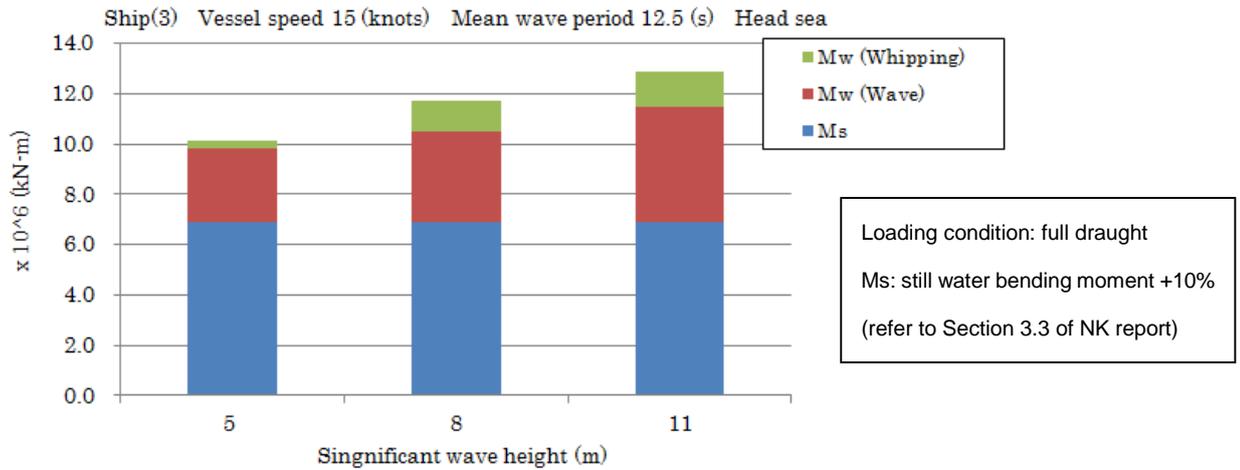
Figure 4.3.1 Example of the effect of acting loads (ship speed is constant)

An example of the effect of wave height on acting loads in simulation is shown in Figure 4.3.1 (ship speed is constant). An example of the effect of ship speed on acting loads is shown in Figure 4.3.2 (wave height is constant).

The acting loads may increase or decrease by sea condition and ship speed. On the other hand, wave-induced vertical bending moment in Longitudinal Strength Standard (S11) of IACS Unified Requirements is based on past operational results such as damage experiences, considering the effects operation such as rough sea avoidance,

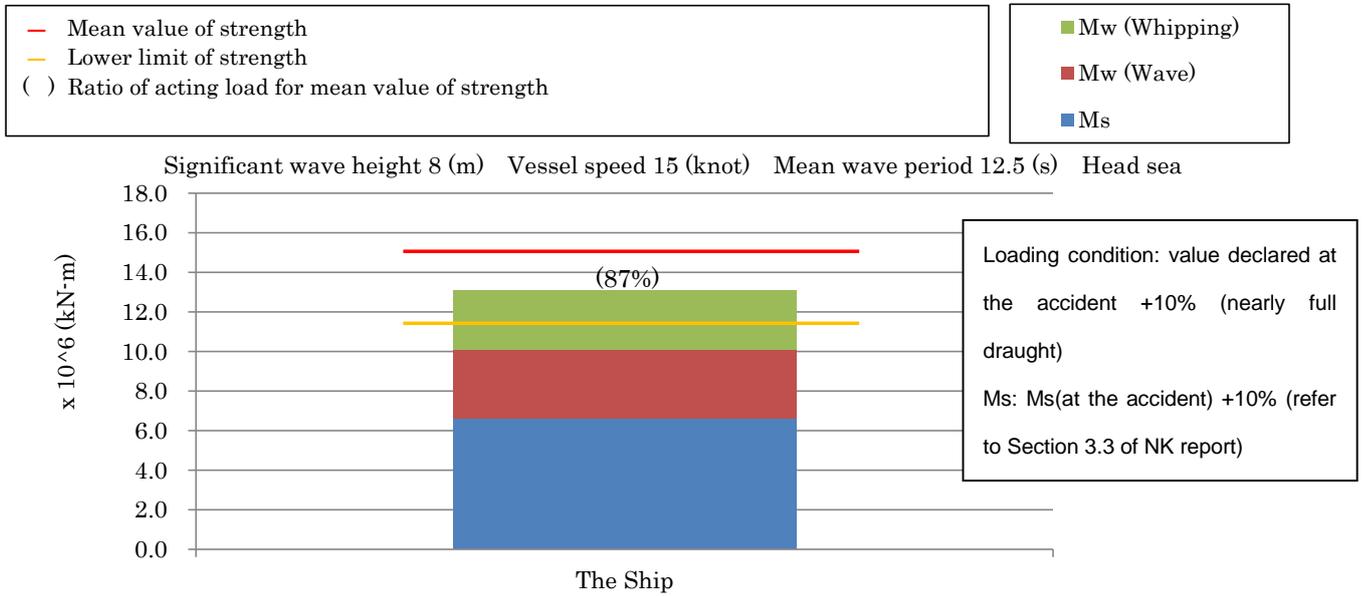
Figure A4-1 Same as Figure 2.2.1

- .1 With regard to the possibility of the fracture accident, it considered comparison between acting loads and ship structural strength, taking into account the deviation of uncertainty factors such as yield stress of steel data, sea condition at the accident and the gap of declared container weight and actual weight.
- .2 The result indicated that there was actually possibility, although quite low, that ship

fracture occurred where the load of the vertical bending moment exceeded the hull girder ultimate strength at the time of the accident.

An example of the effect of whipping response in simulation of acting loads is shown in Figures A4-1 and A4-2. Large acting loads by the effect of whipping response could occur.

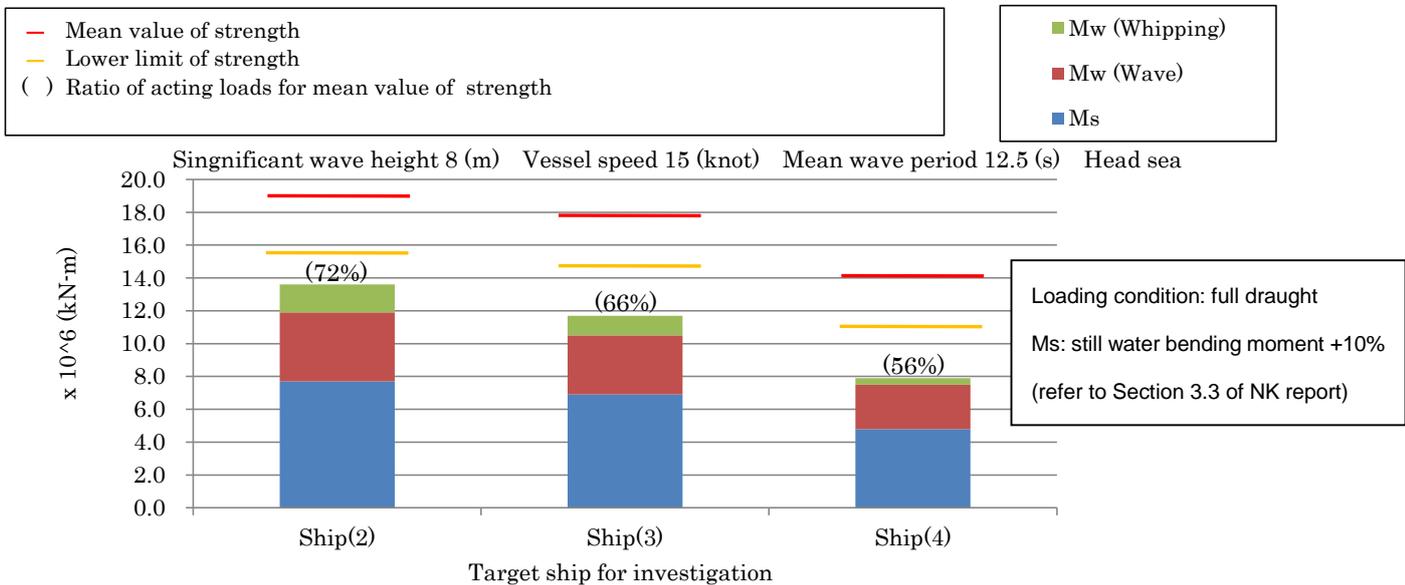
Figure A4-2 Same as Figure 3.3.1

The results of the comparison between ship structural strength and acting loads are shown in Figure 3.3.1, which should be contrasted to Figure 2.2.1. It can be found that the large container ships except for The Ship (accident ship) had enough margins for ship structural strength compared to The Ship (refer to Figure 2.2.1).

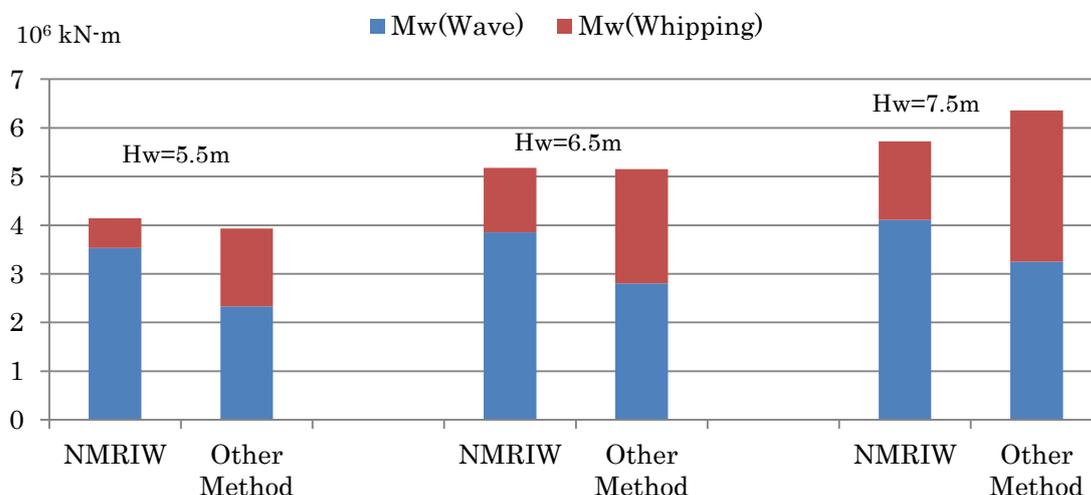
Figure A4-3 Comparison with the methods of analysis for consideration of whipping loads (Ship speed of 17 knot, head sea, a mean wave period of 12.5 second and loading condition as value declared at the accident of ship (The Ship))

With regard to whipping loads, which have not been explicitly considered in current structural requirements, examples for comparison between the method used in this simulation (NMRIW) and the other method are shown in Figure A4-3. This example was under the condition of ship speed of 17 knot,

head sea, a mean wave period of 12.5 second and loading condition as value declared at the accident of Ship (1) (The Ship). Even if ship speed was the same, the sum of wave-induced bending moment and whipping loads increased with growing significant wave height. By methods of analysis, composition ratio and value of whipping loads are different.

In comparison between acting loads and ship structural strength, the effect of whipping loads has not been explicitly considered in current structural requirements. Therefore, it is technically informative to collect the data by on-board full scale measurements.

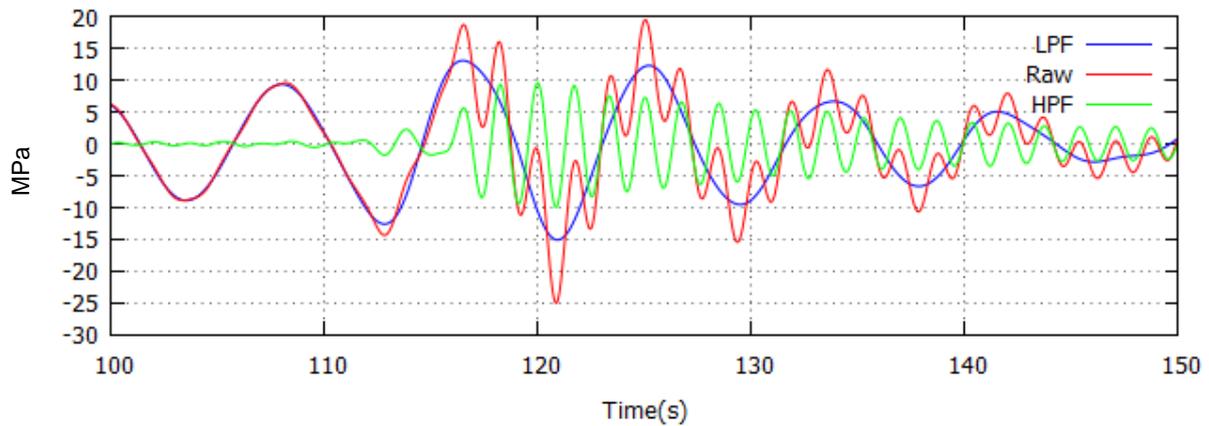
Figure A4-4 Longitudinal direction stress on the bottom shell plates

In this analysis of on-board full scale measurements, the data have been collected by setting some stress and acceleration measuring equipment in the bottom shell plates, etc. An example of measured data by stress measuring equipment (bi-axial stress) in May 2014 is shown in Figures A4-4 and A4-5. Blue line corresponds to Mw (Wave), while Green line corresponds to Mw (Whipping). Data of both lines are obtained by processing raw data through low and high pass filters, respectively.
