# 航空事故調査報告書

キャセイ・パシフィック航空会社所属  
ロッキード式L1011-385-1型VR-HOC  
新東京国際空港  
平成2年3月24日

平成4年2月12日

キャセイ・パシフィック航空会社所属ロッキード式L1011-385-1型VR-HOCは、平成2年(1990年)3月24日、同社定期便508便としてホンコン国際空港を出発し、協定世界時05時12分(日本標準時14時12分)ごろ、新東京国際空港の滑走路16へ着陸する際ハード・ランディングして、左主翼翼根部リヤ・スパー及びその周辺部が破損し、第1燃料タンクから燃料が流出した。火災は発生しなかった。

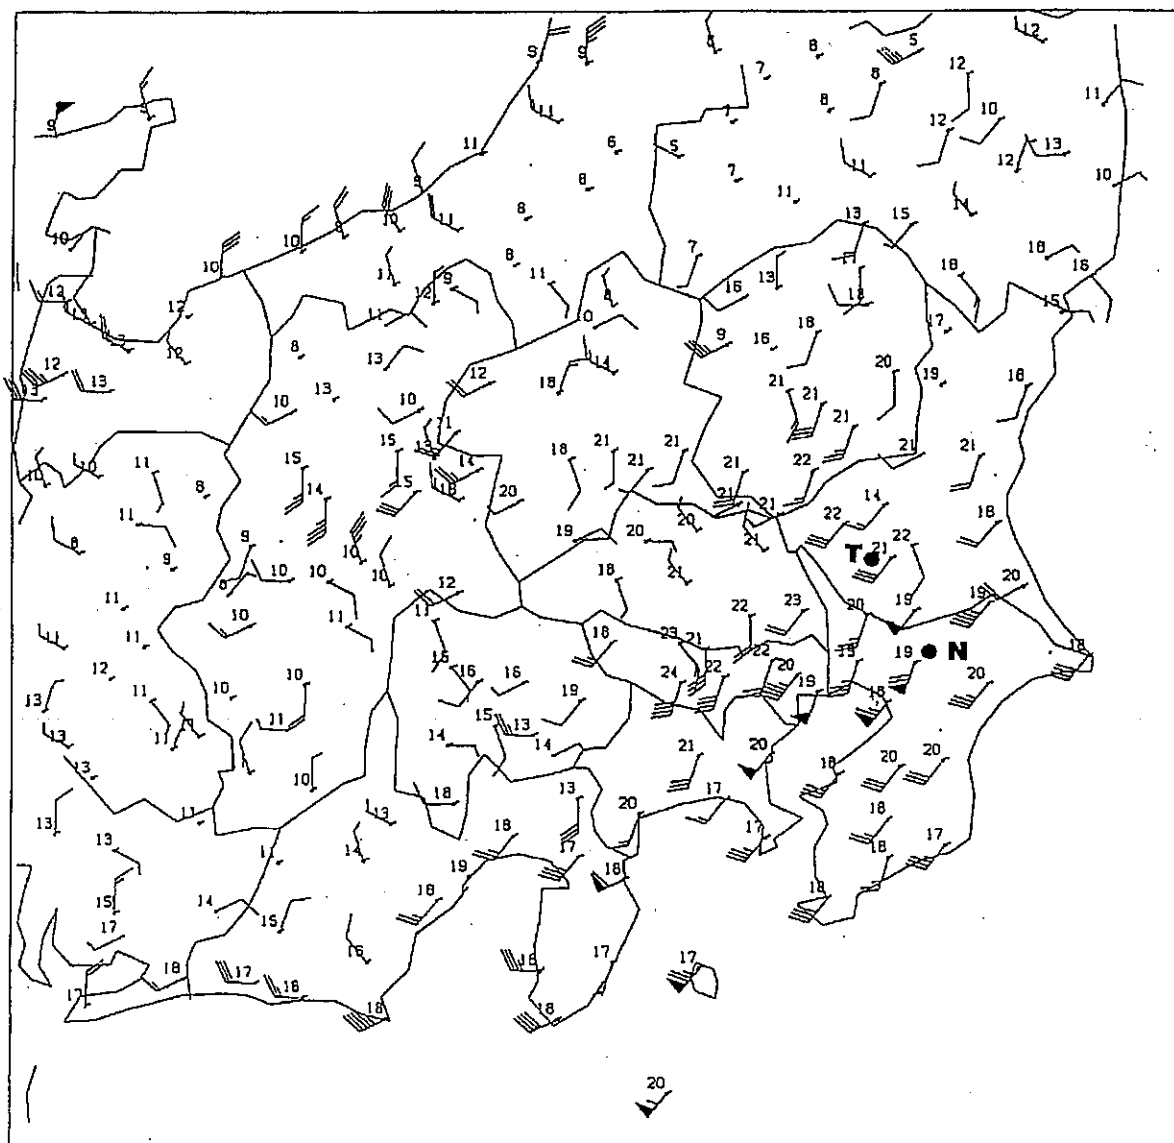
付図 9 地域気象観測網（アメダス）による風向風速及び気温

事故の発生した時刻(05時12分UTC:14時12分JST)に近い24日06時00分(UTC)には、1000hPaの低気圧は本州の東海上にあり、これからの寒冷前線は関東地方の北部を通り九州に達している(付図6参照)。この寒冷前線は成田空港を24日11時40分(UTC)頃に通過したが、それまでは南南西～南西の風で00時30分(UTC)から08時30分(UTC)頃までは特に強い(付図8参照)。事故に最も近い05時00分(UTC)の地域気象観測網データによると、寒冷前線の前面には、伊豆半島から東京湾を通り成田空港付近に達する地上の強風帯が認められる(付図9参照)。

付図9によると、成田空港は、つくば市館野の高層気象台(成田空港の北西約40キロメートル)と同じ強風域の中にあるので、鉛直方向の構造を知るために同気象台の高層観測値を用いた(付図10参照)。これによると00時(UTC)には高度960~900hPaに逆転層があり、風速は944hPa(高度580メートル)で極大を示し218度/15.9メートル/秒(31ノット)となっている。

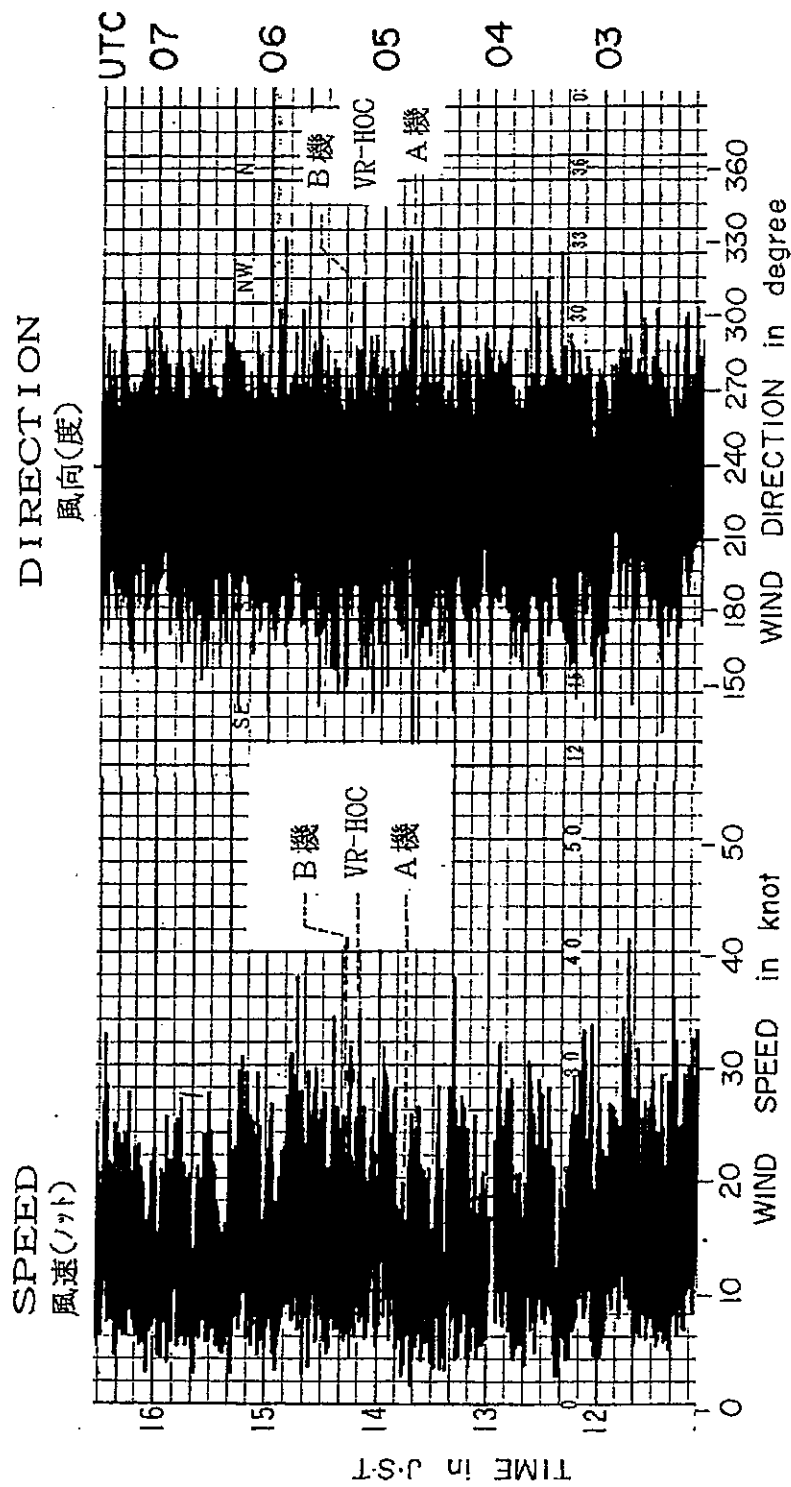
付図 1 1 滑走路 1 6 側の風向風速の記録  
 1990年(平成2年)3月24日 02時~07時UTC

- (4) 風向、風速の記録にはガストより周期の長い数分から10数分の風速と風向変動がある(付図11参照)。

3.2.4.2 2分間平均風向風速計の記録によると、滑走路16側の風向変動が大きいのは04時30分(UTC)から06時00分(UTC)頃、風速の極大値が大きいのは05時00分(UTC)から05時40分(UTC)頃で、事故はこの風の乱れの大きい時間帯に発生している(付図11参照)。

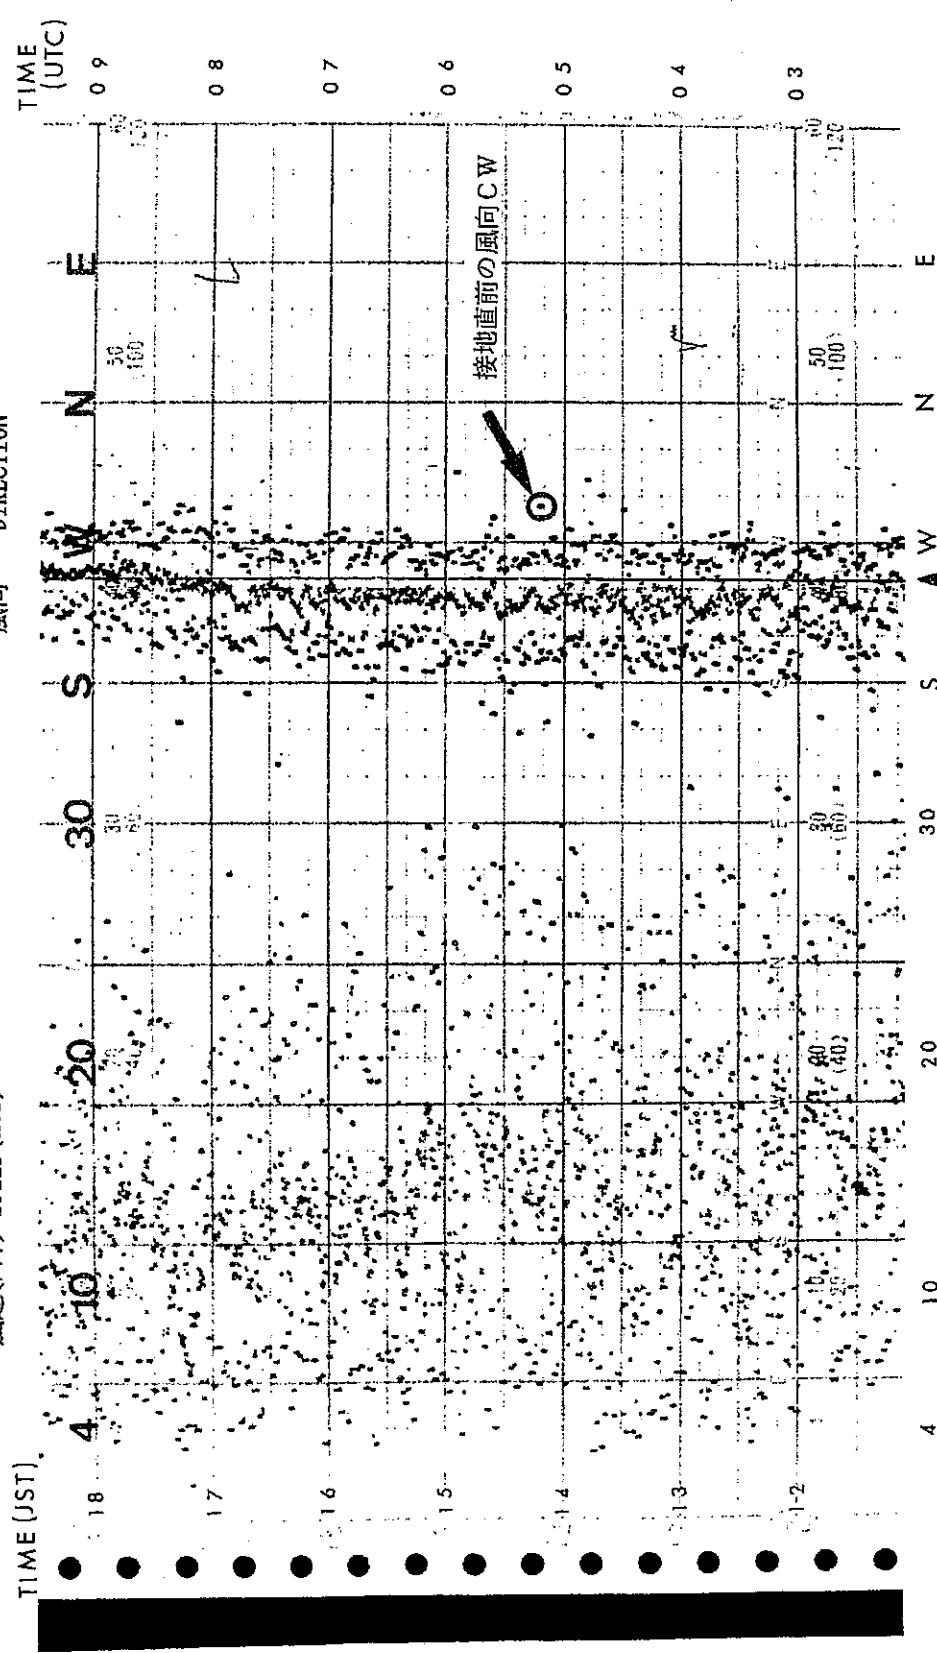
# 付図 1 2 滑走路 1 6 側の 2 分間平均風向風速計の記録

- (1) 成田空港は低層の強風域(下層ジェット)の中にあった。
- (2) 滑走路16の風は滑走路34の風より平均風は小さいがガストは大きい。  
20分毎の瞬間最大風速と10分間平均風速との比は滑走路16の方が滑走路34より大きい、平均風速は滑走路34の方が滑走路16より大きい。  
これは南西の強風時の成田空港の特徴である(付表1参照)。
- (3) 2分間平均風向風速計(付図12参照)によると、滑走路16での風向変動の大きいのは04時30分(UTC)から06時00分(UTC)、風速の極大が大きいのは05時00分(UTC)から05時40分(UTC)ごろなので、事故は風の乱れの大きい時間帯に発生している。付図12の赤線の右側は追い風の部分だが、瞬間値としては、この日にはしばしば追い風が現れている。

しかしこの部分は、2分間平均風向風速計に3秒間平均値として風向287度(付図12の赤矢印)、風速27ノットが記録されており、渦の移動を考えると時間の一致はあるので、絶対値は明らかでないが同機は一時的に追い風を受けたことが考えられる。

滑走路16風向風速計の記録(本文付図11)には、05時11分(UTC)頃に極値として $310^{\circ} / 35\text{kt}$ が記録されている。この記録ではピークの継続時間はわからないが2分間風向風速計の記録(注参照)には、ほぼ同じ時刻に3秒間のベクトル平均で $287^{\circ} / 27\text{kt}$ の極値(風速の読み取り値には誤差がある。)が記録されている。

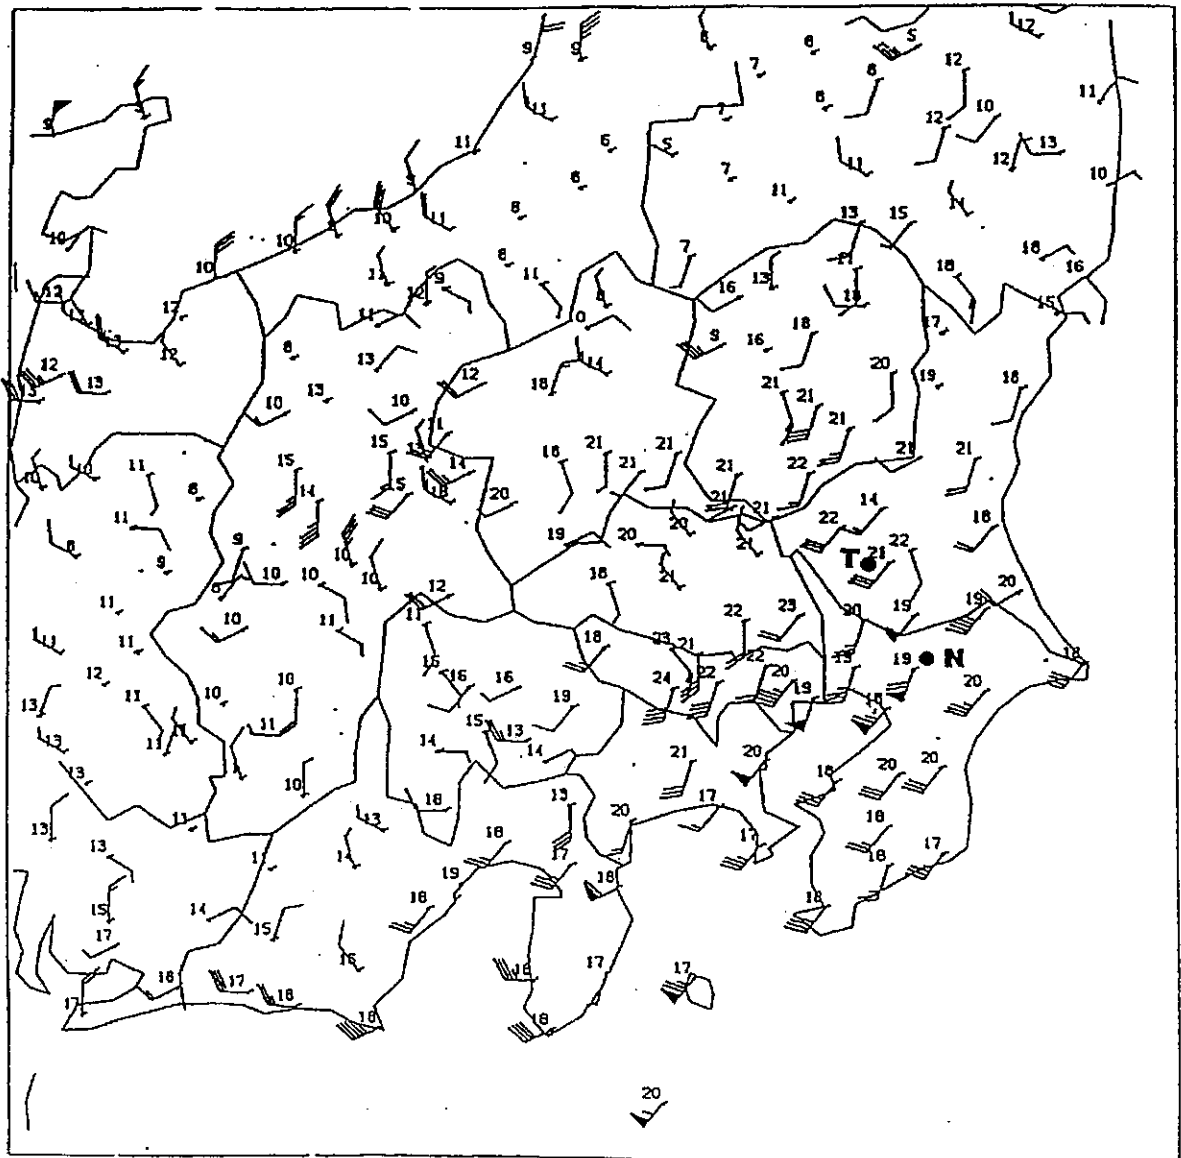
Attached Fig. 9

At 0600 UTC of the 24th day, near the time the accident occurred (0512 UTC:1412 JST), a Low of 1000 hPa was located on the ocean east of the Honshuu, from where a cold front was extending as far to the Kyuushuu Island passing through a northern part of the Kanto Area. (see Attached Fig. 6) The cold front passed Narita Airport about 1140 UTC of the 24th day, until which the wind had been from SSW~SW with a significant intensity for the period of 0030 UTC to about 0830 UTC. (see Attached Fig. 8) In front of the cold front is recognized a strong wind belt extending from the Izu Peninsula and reaching near Narita Airport through Tokyo Bay, in accordance with data of the Automated Meteorological Data Acquisition System at 0500 UTC, the nearest to the time of accident. (see Attached Fig. 9)

Since, as shown in Attached Fig. 9, Narita Airport was in the same area of strong wind as the Aerological Observatory at Tateno in Tukuba City (located approximately 40 km NW of Narita Airport), the data of upper air currents observed at the observatory were used to estimate its vertical structure at Narita Airport. (see Attached Fig. 10) According to this, there was an inversion layer at height of 960~900 hPa at 0000 UTC with the maximum wind speed of 15.9 m/s (31 kt) from 218° at 944 hPa (a height of 580 meters).

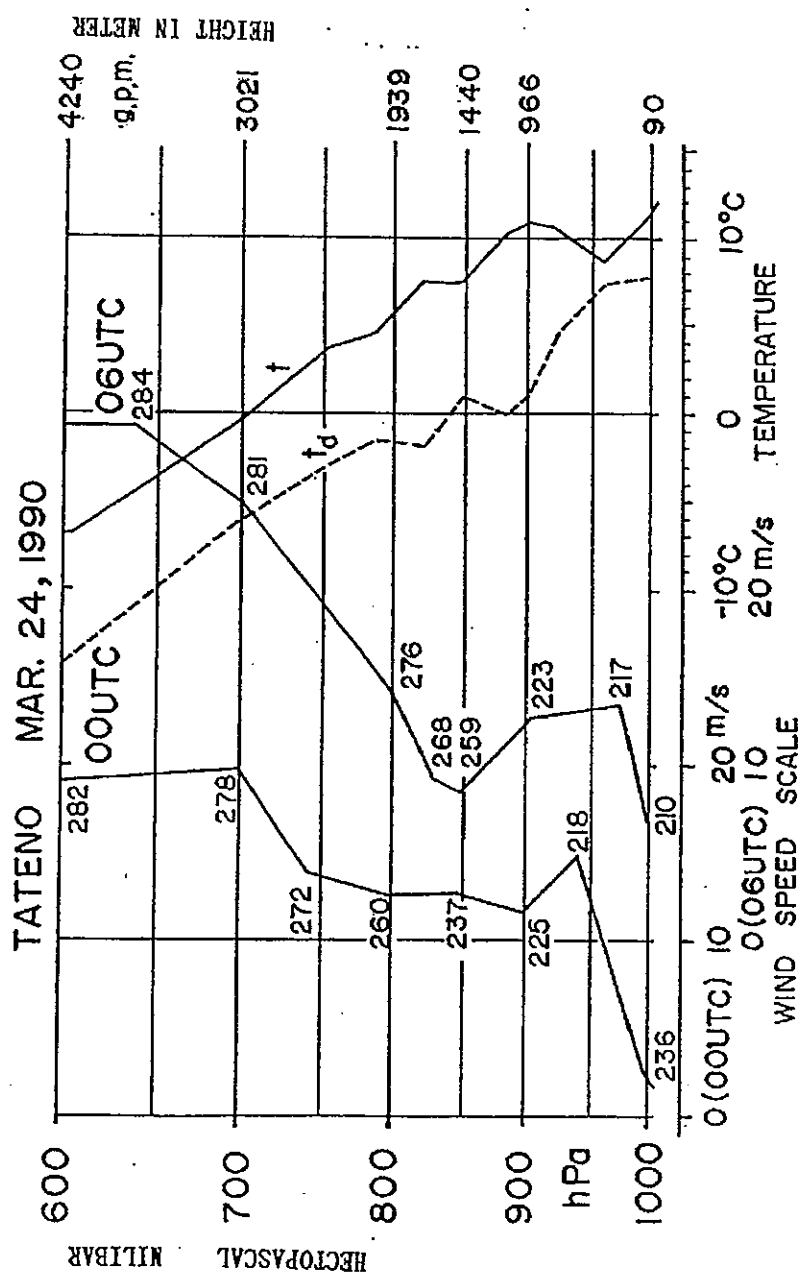
2.7.7 In Attached Fig. 10 is shown the "vertical profiles of temperature, dew point and wind at Tateno" for 0000 UTC and 0600 UTC of the day, made from observations at the Aerological Observatory (Tateno) of the Meteorological Agency .

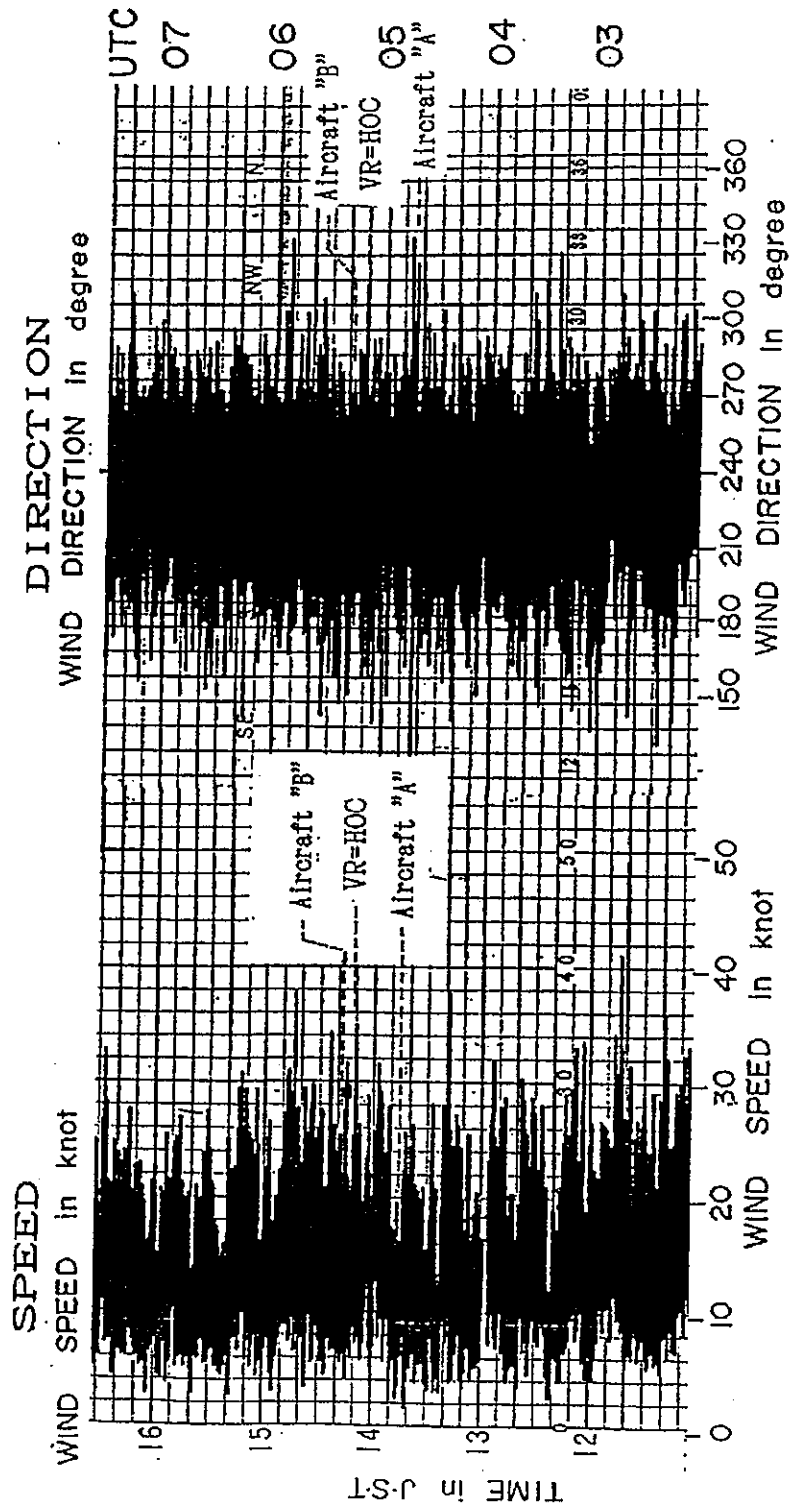
Attached Fig. 11  
 Records of Wind Direction/Speed at Runway 16  
 0200 - 0700 hours, March 24, 1990

2.7.8 In Attached Fig. 11 is shown a part of the record of wind direction and speed of the wind sensor on the Runway 16 side on the day in a time zone involving the time the accident occurred.

(4) In records of the wind direction and the wind speed, there are variations in the wind speed and direction having a period longer than the gust, ranging from several minutes to slightly more than 10 minutes. (see Attached Fig. 11)

3.2.4.2 According to records of the 2-minute wind sensor, it was about from 0430 to 0600 UTC that the variation in wind direction on the Runway 16 side was remarkable, and about from 0500 to 0540 UTC that the maximum in wind speed was large; and the accident occurred in this time zone in which the gustiness was significant. (see Attached Fig. 11)

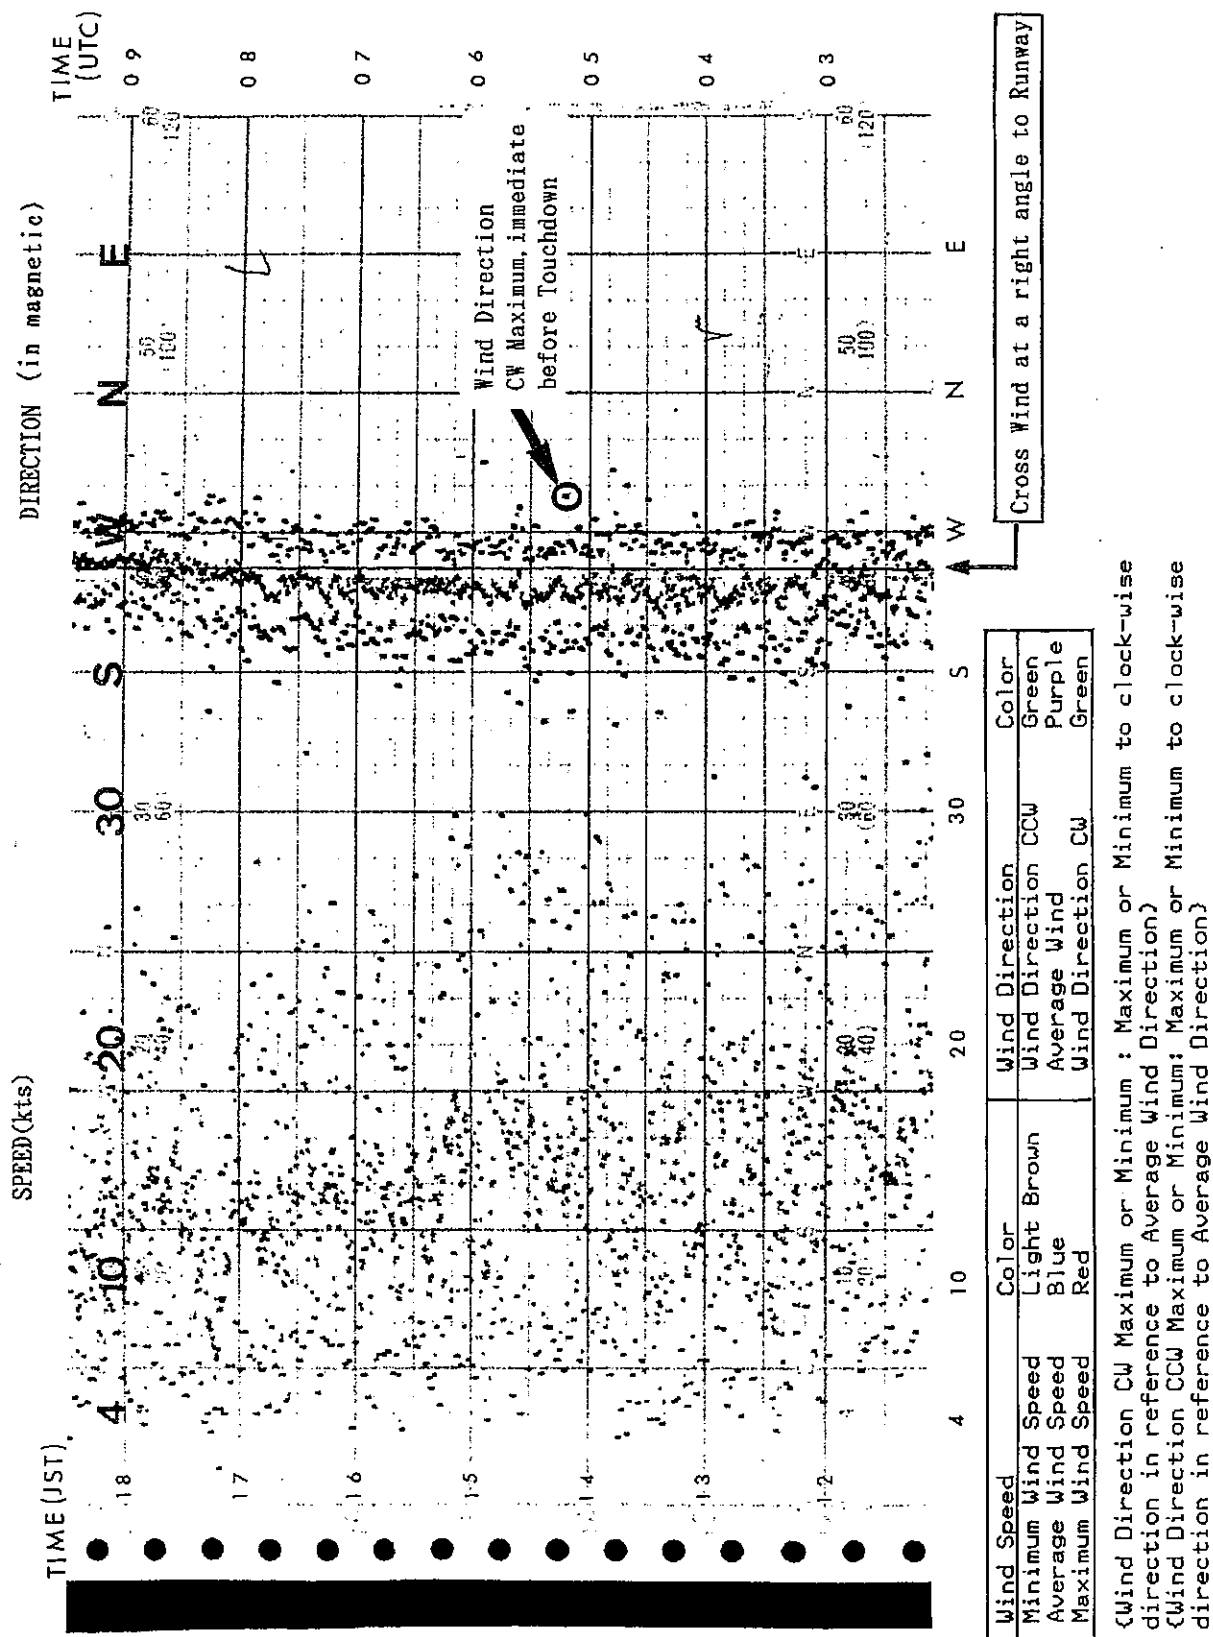
Attached Fig. 12  
Records of TWO(2) Minutes Average of Wind Direction/Speed at Runway 16  
March 24, 1990

In Attached Fig. 12 is shown a part of the record of the wind direction and wind speed of 2 minutes mean on the Runway 16 side on the day in a time zone involving the time the accident occurred.

For this portion, however, a wind direction of 287 deg (red arrow mark in Attached Fig. 12) and a wind speed of 27 kt are recorded in the 2-minute wind sensor as 3-second average values, and when movement of an eddy is taken into account, a chronological consistence could exist. From this, it is conjecturable that the aircraft would have temporarily been subjected to a tailwind although its absolute value is unknown.

(40) values for 2 minutes, the average and the maximum in the 2 minutes are dotted. However, the maximum must be within the 2 minutes, and the time it appears is not recorded. The wind is calculated as a vector. As to the wind speed on the left side of Attached Fig. 12, the light brown indicates a maximum, and the blue an average, while as to the wind direction the green indicates a maximum, and the purple an average.

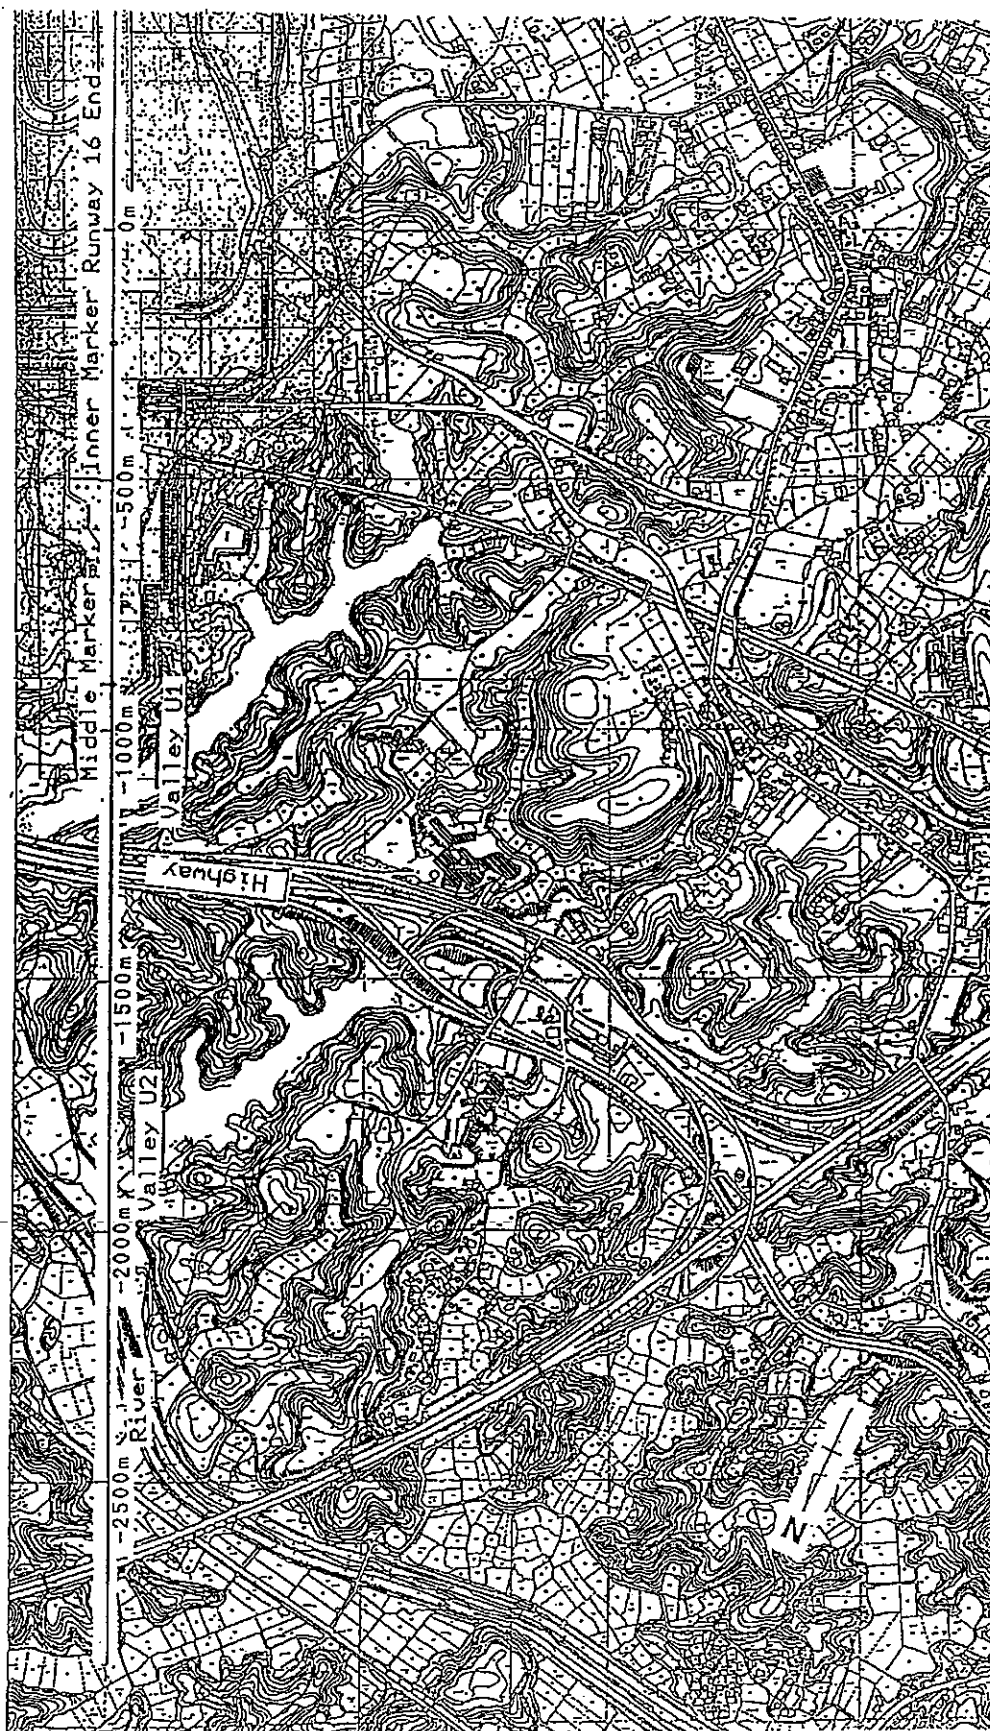
The area where variation in CAS was intense is of such complicated topography that from 200 meters ahead on the upstream side is lying the outside of the airport where sunken places and hills are abound and a valley (Valley U1 in Attached Fig. 13) running on a bearing of about 200 degrees is crossing. The plateau on which the middle marker is

This point is located on the edge of the airport near the middle marker, where the flight height is about 200 ft. The location (Point G or Point H), where change in CAS is significant, is having outsidess of the airport boundary lying beyond about 200 meters on the windward side (i.e., to the right facing the approaching direction) thereof, of such a complicated topography that there are sunken places and hills and, besides, a valley running at a heading of 200 degrees is crossing nearby. (see Attached Fig. 13 "Topographical Chart" of the Text)

In case of Aircraft 'A' and Aircraft 'B', the wind suddenly decreases from near the inner marker. Since such a decrease would be inconceivable as a vertical shear, the abrupt decrease in the wind would be related to the topography. According to Attached Fig. 13 (Topographical Chart) of the Text, the portion where the wind is strong corresponds to an area of such topography that there is a steep cliff on its windward side and the wind blows up, while the portion where the wind weakens corresponds to a

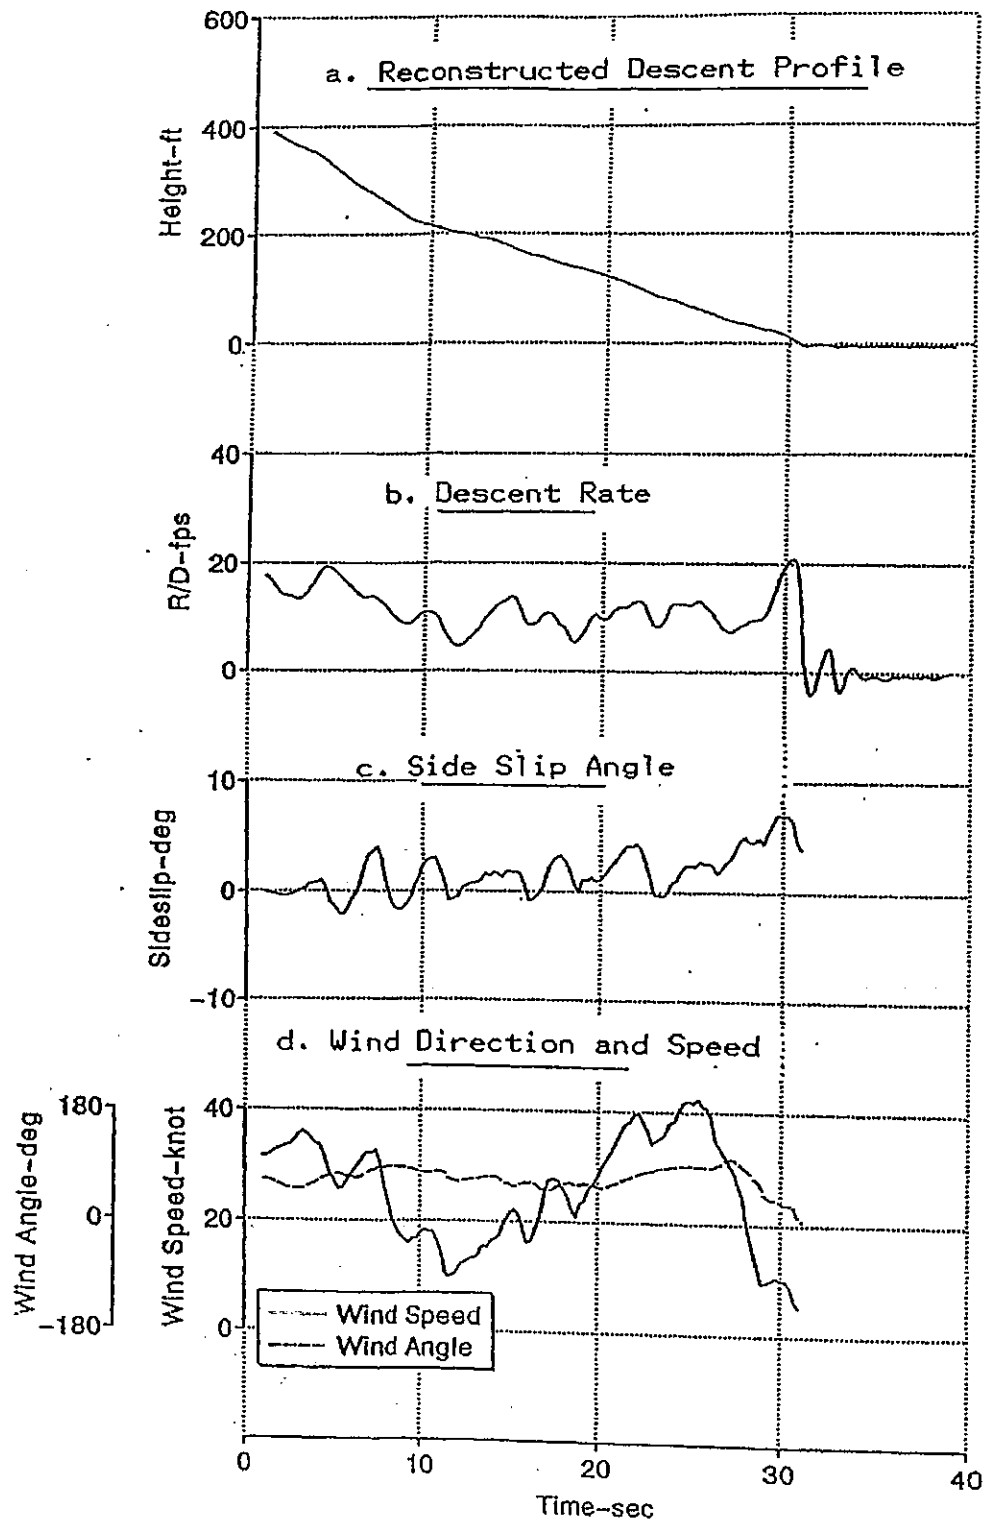
Attached Fig. 14:  
Estimation of Descent Rate and Side Slip Angle

Based on readouts of DFDR on the radio altimeter altitude and the vertical acceleration, and using the Karman Filter, the descent rate was estimated for a period from a height above the touch-down zone's elevation mark (hereinafter referred to as "height") of 400 meters down to the touch-down. The Karman Filter is a method to estimate a status amount at a certain time in a manner the most probably accurate, when the status equation (motion equation) representing the system's characteristics as well as the error distribution involved in each estimation are known. Results of the estimation on descent rates are shown in Attached Fig. 14b. It is estimated that the descent rate of the aircraft abruptly increased immediately before touch-down, reaching as much as 21 ft/second.

It is impossible to estimate the crosswise wind by the same method as used in the calculation of the longitudinal wind in (1) above, since no side-slip angle of the aircraft is recorded in DFDR and the recorded data on the lateral position is also less accurate. Therefore, using the Karman Filter in the same manner as in the estimation of the descent rate in para. 3.1.3.1, an estimation was made of the crosswind to the aircraft axis by reconstituting measurements concerning the motion of the aircraft to the lateral direction (each operated amount of aileron, spoiler and rudder, roll and yaw attitude angles, and lateral acceleration). The aircraft characteristics used in the calculation are based on data provided by the Lockheed Company. Results of the estimation are shown in Attached Fig. 14c.

From results in (1) and (2) above was obtained the wind direction and speed the aircraft encountered in the coordinate system fixed on the ground. Results of the estimation are shown in Attached Fig. 14d., in which the wind direction is measured clockwise from the runway direction. Furthermore, its comparisons with the winds which Aircraft 'A' and Aircraft 'B' encountered are shown in Attached Figs 15, 16 and 17. The estimation results above would approximate the results of analysis in para. 3.1.3.2 stating that "The wind the aircraft (VR-HOC) encountered is estimated to have been between Aircraft 'A' and Aircraft 'B' in wind direction, and at a similar level with Aircraft 'B' in wind speed", and would therefore be considered greatly reliable.

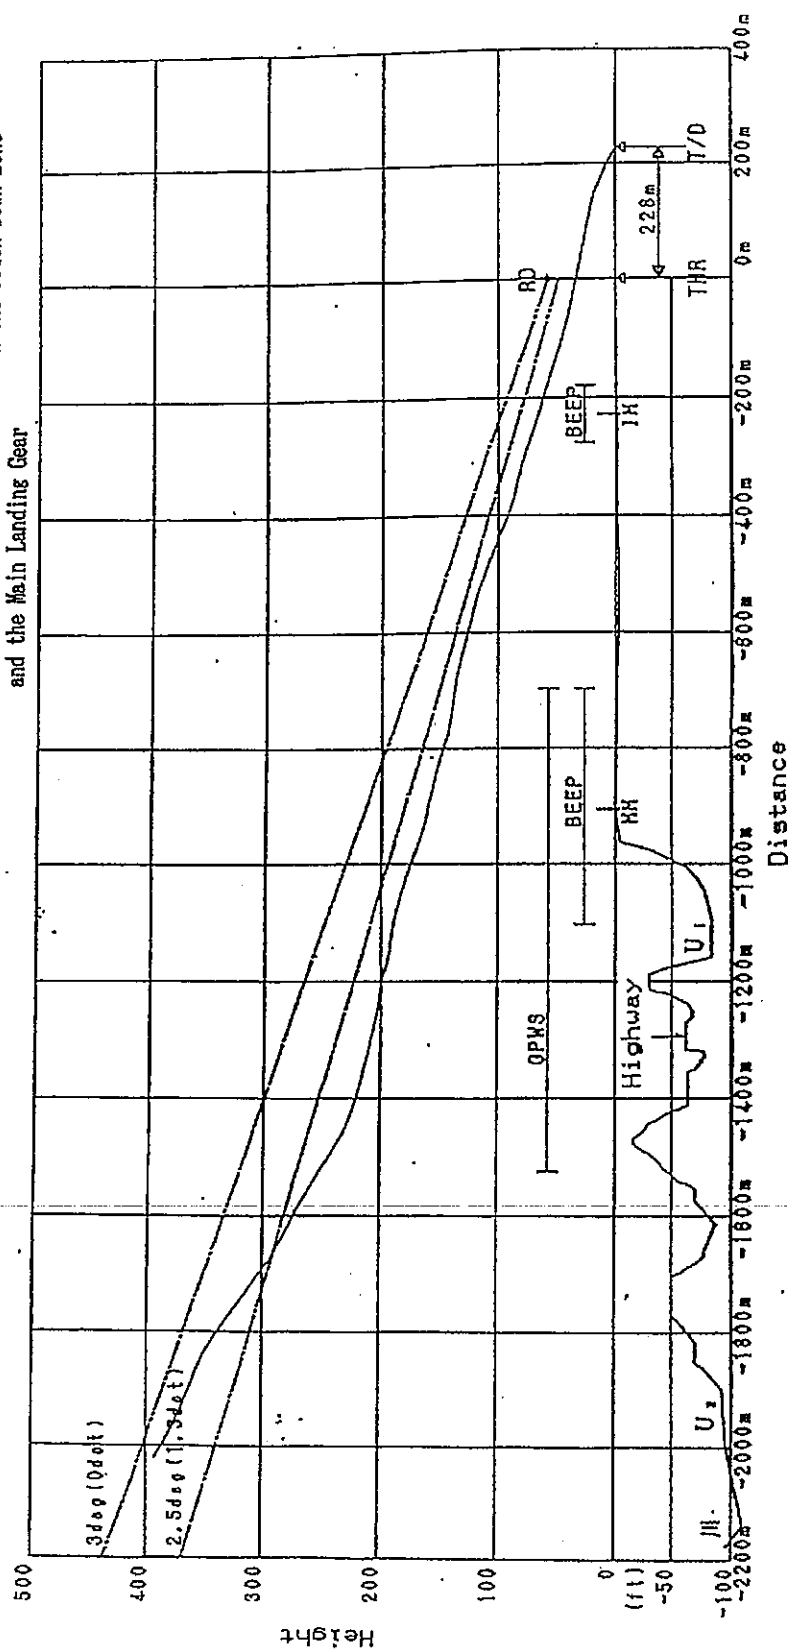
Attached Fig. 18 Estimated Descent Profile

Results of the estimation are shown in Attached Fig. 18. The initial touch-down point of the aircraft is also estimated to have been about 230 meters inside of the approach end of runway.

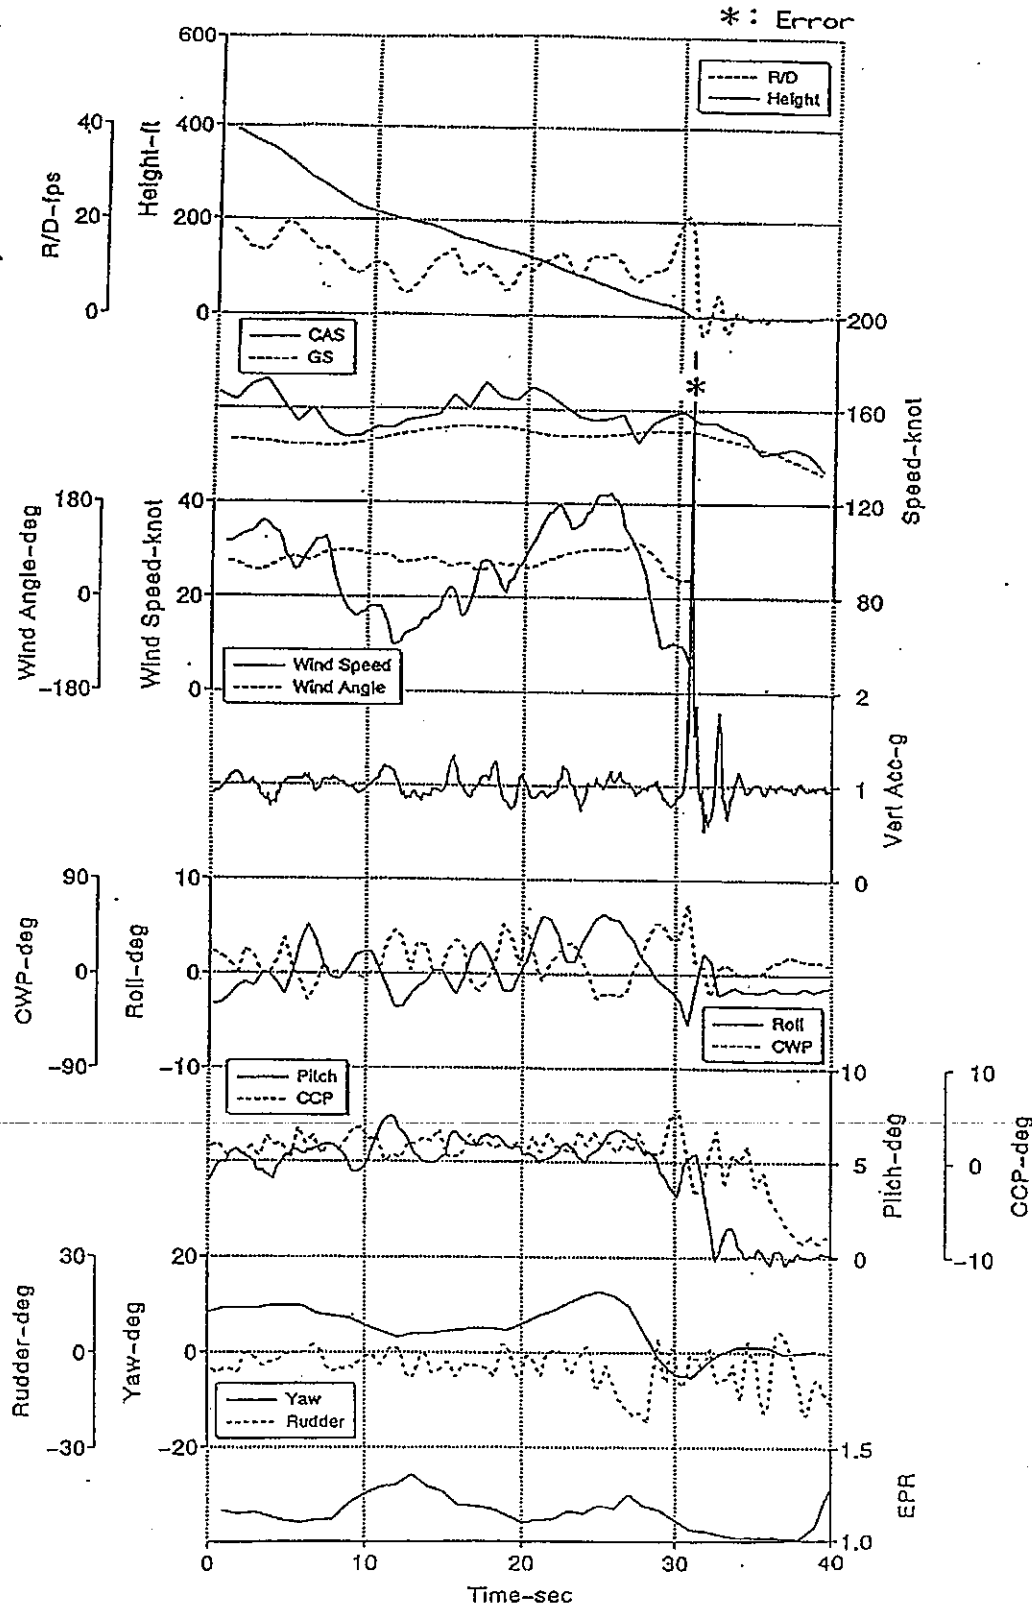
Attached Fig. 19 Chronological Records

In Attached Fig. 19 is shown the chronological sequence up to touch-down of the aircraft from the height of 400 ft, while in Attached Figs. 20 and 21 are shown details of the longitudinal and the lateral motion from 6 seconds prior to touch-down. In these figures, the height, rate of descent, ground speed, and wind direction and speed are values which were estimated in para. 3.1.4, and others are readouts of DSDR.
