航空事故調査報告書  
ノースウエスト航空会社所属  
ボーイング式747-400型  
N663US  
新東京国際空港  
平成3年(1991年)9月19日

平成5年8月26日

航空事故調査委員会議決

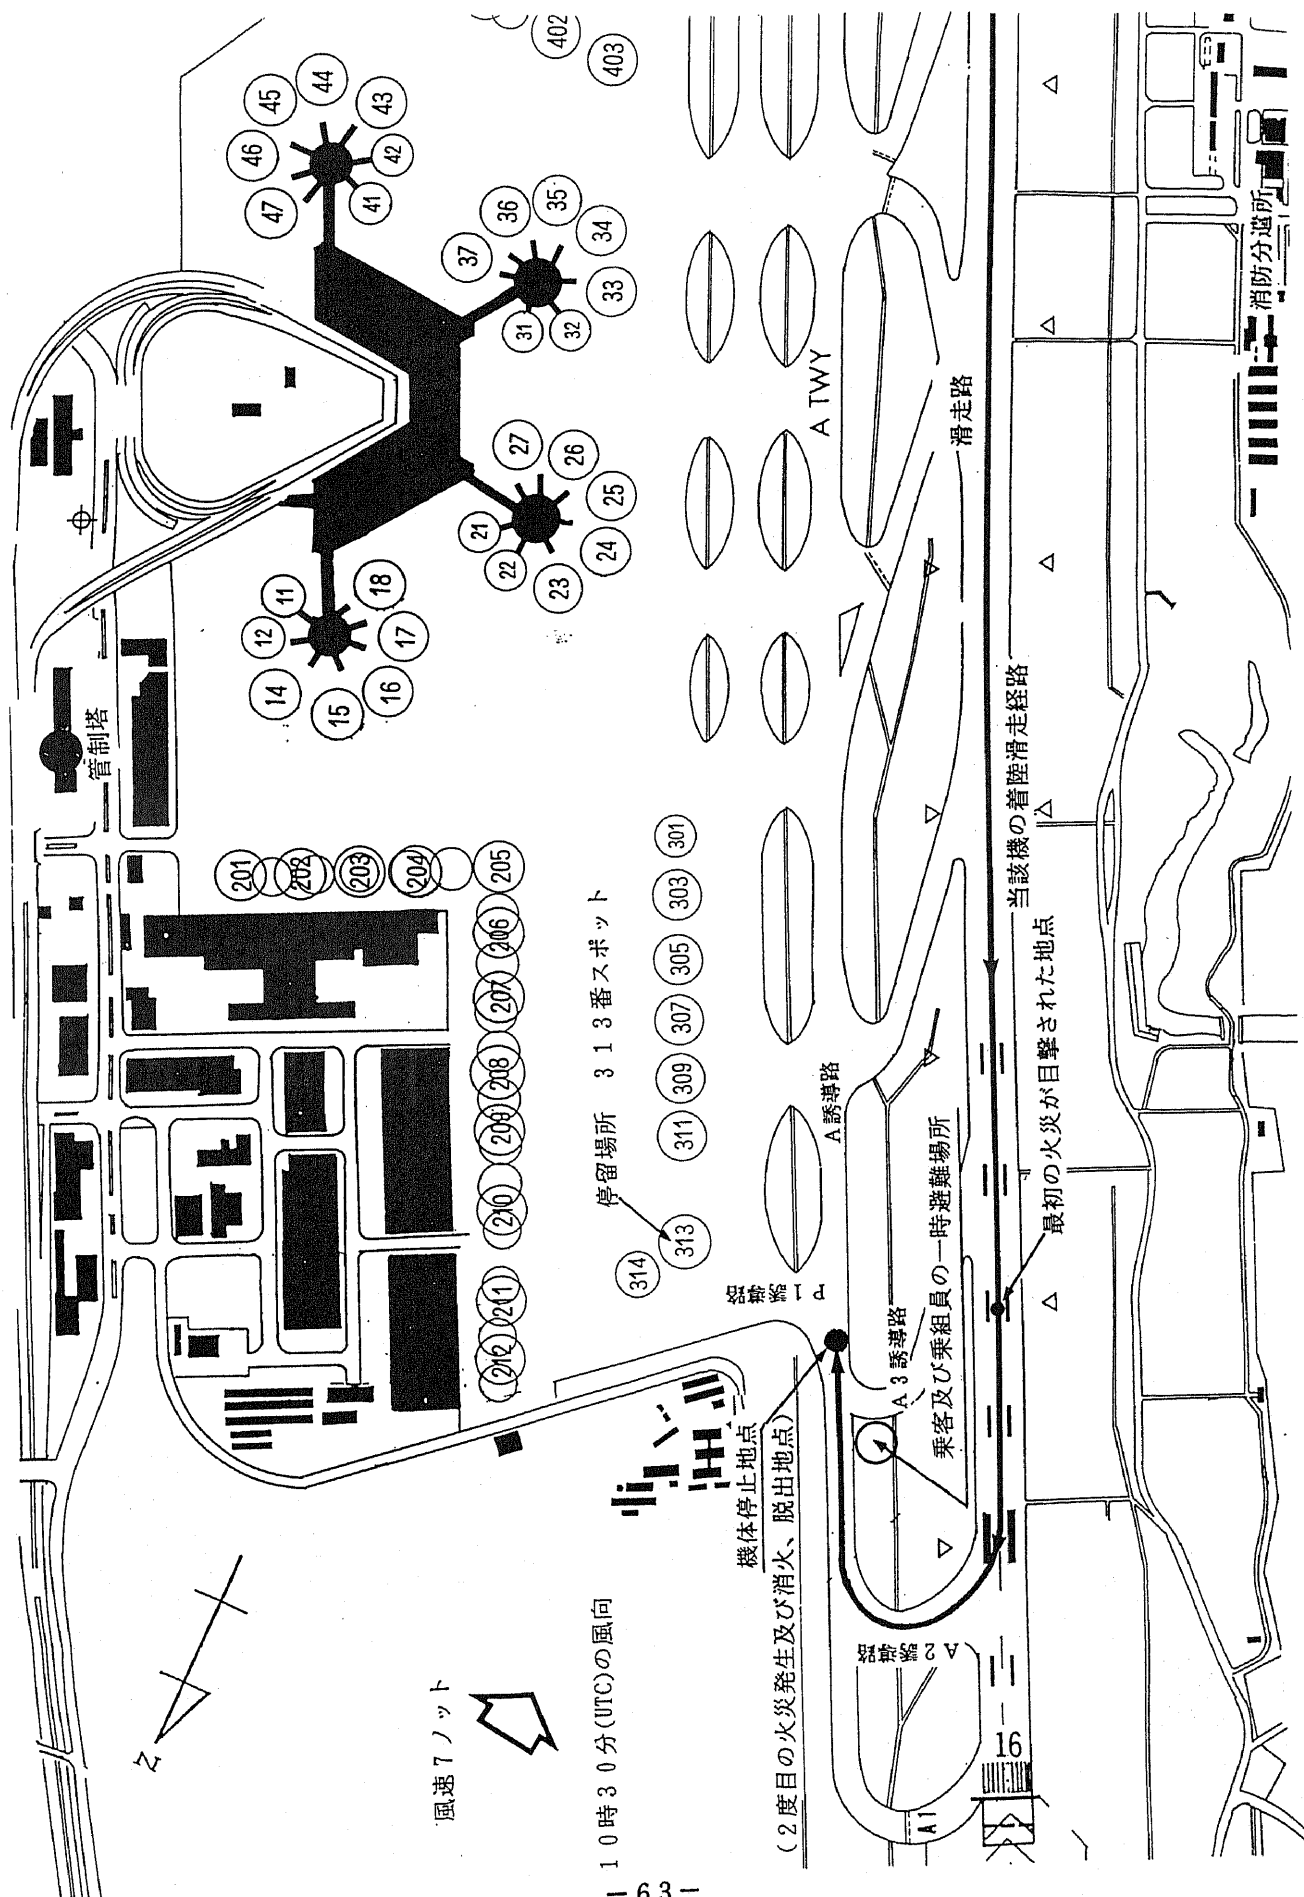
付図2 成田空港における事故機の経路

from the taxiway where the emergency evacuation was conducted. About 1301 UTC fire occurred near No.2 engine when a mechanic of the company connected external power in order to unload passenger baggage left in the cabin, but the fire was immediately put off. (see Attached Figs. 2, 8 and 9)

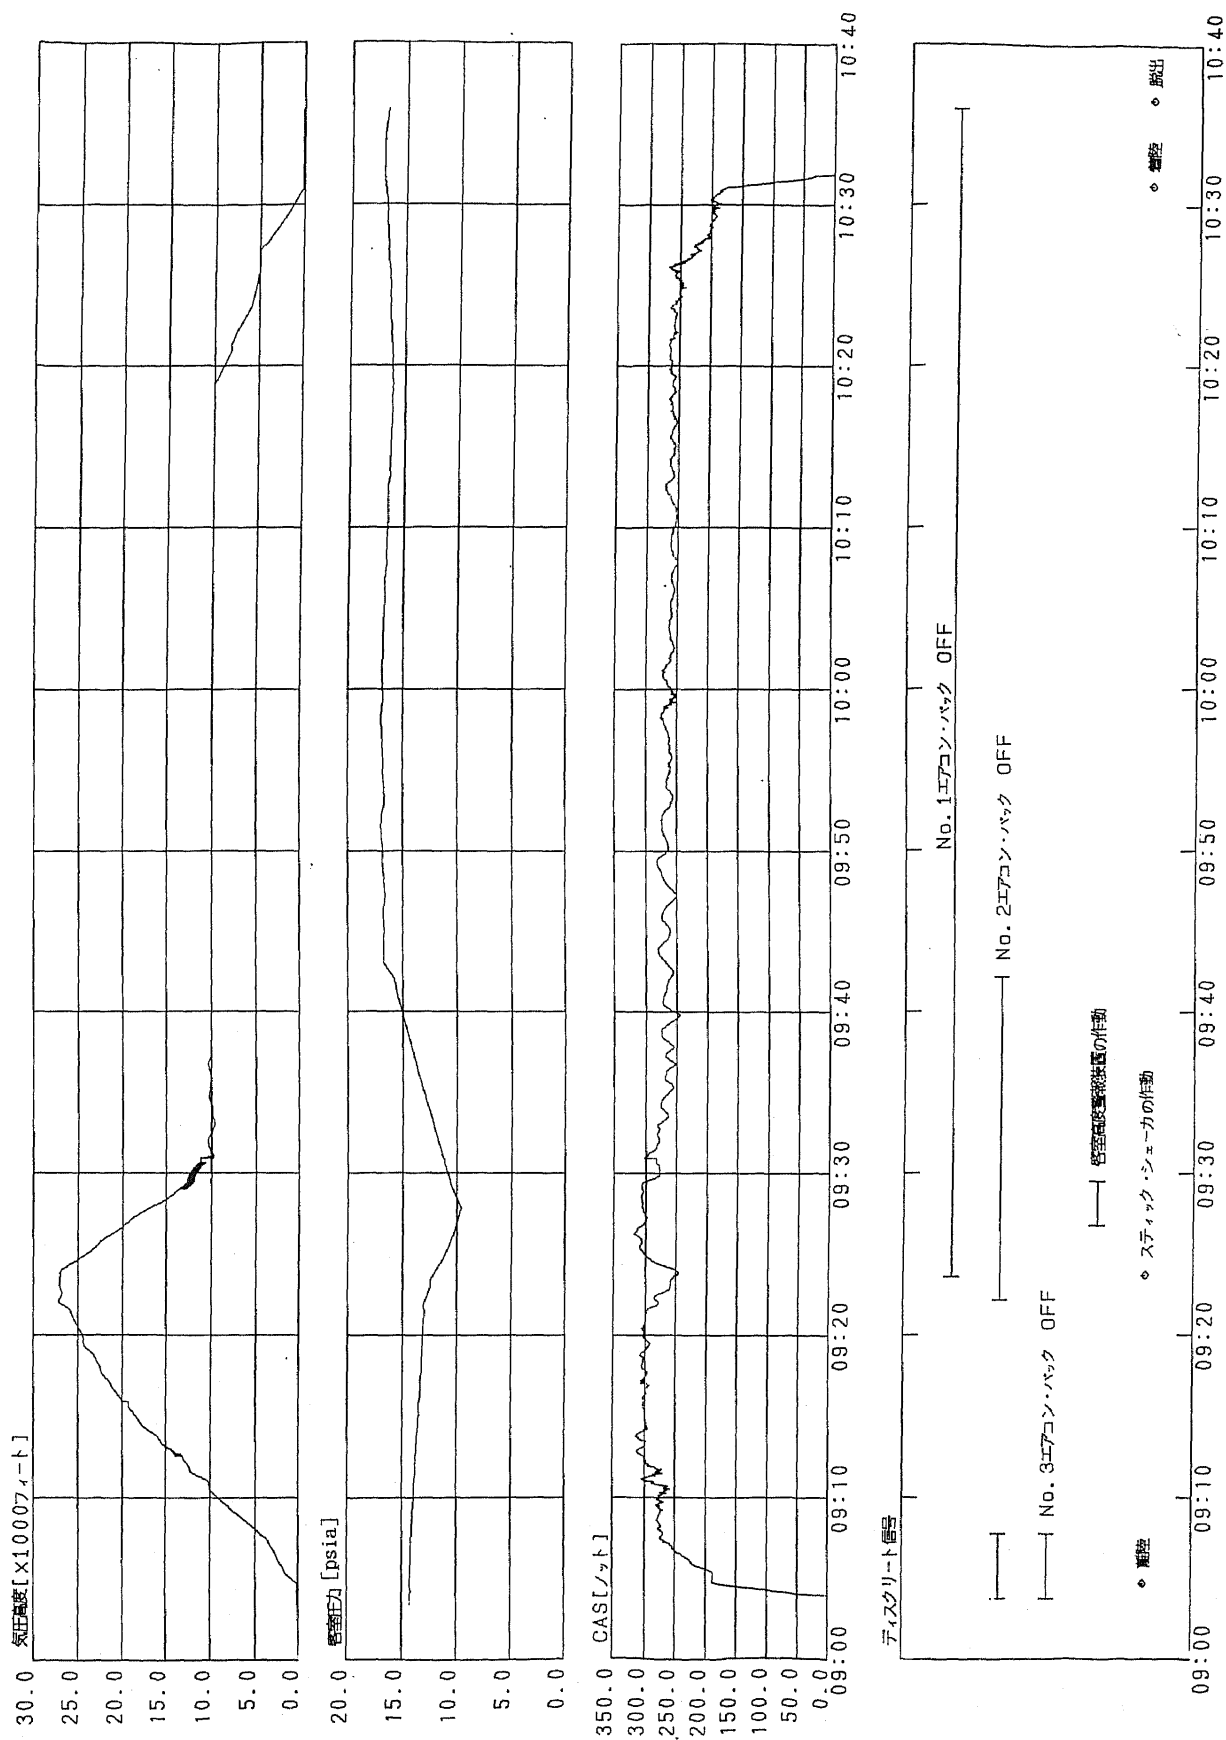
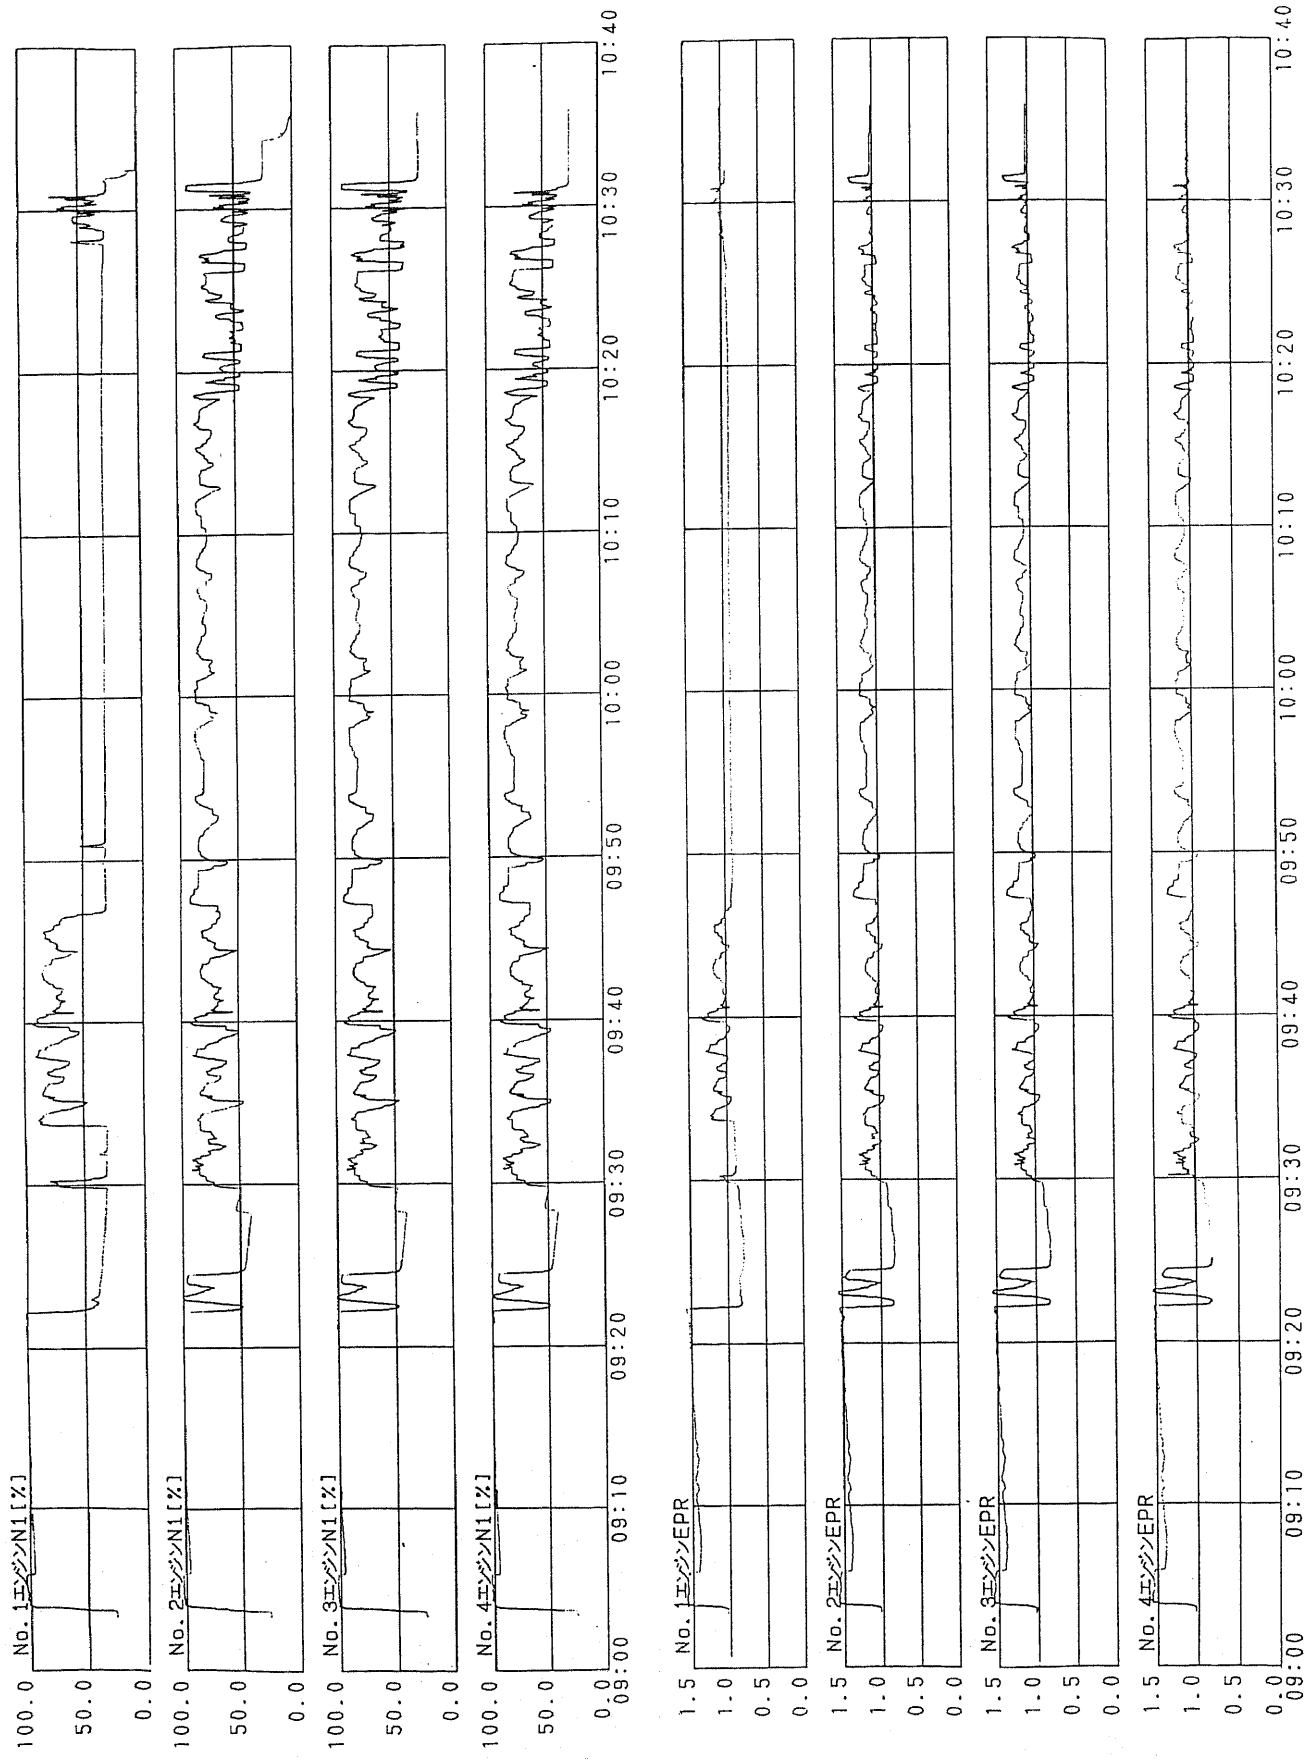
付図8 D F D R の記録

D F D Rの主な記録は次のとおりであった。（付図8及び9参照）

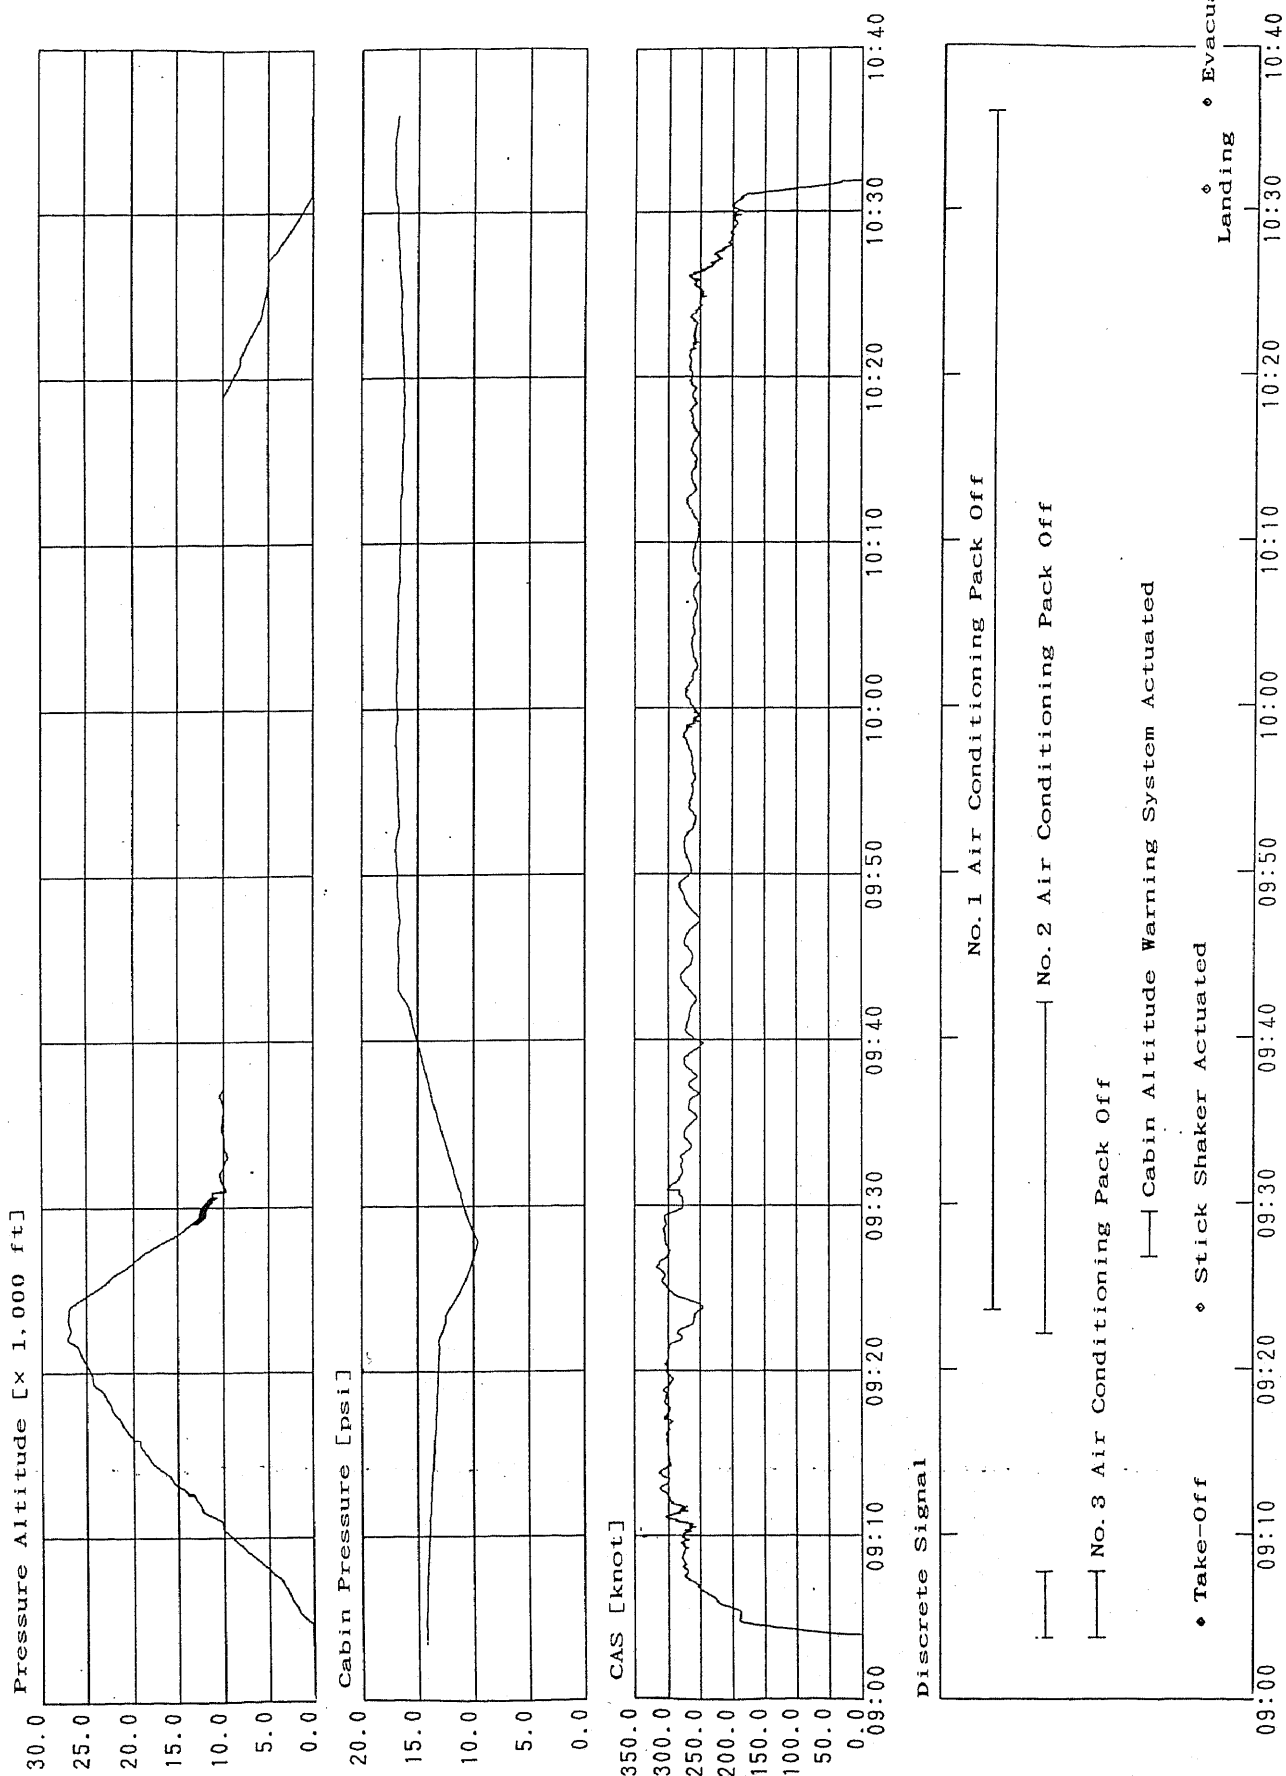
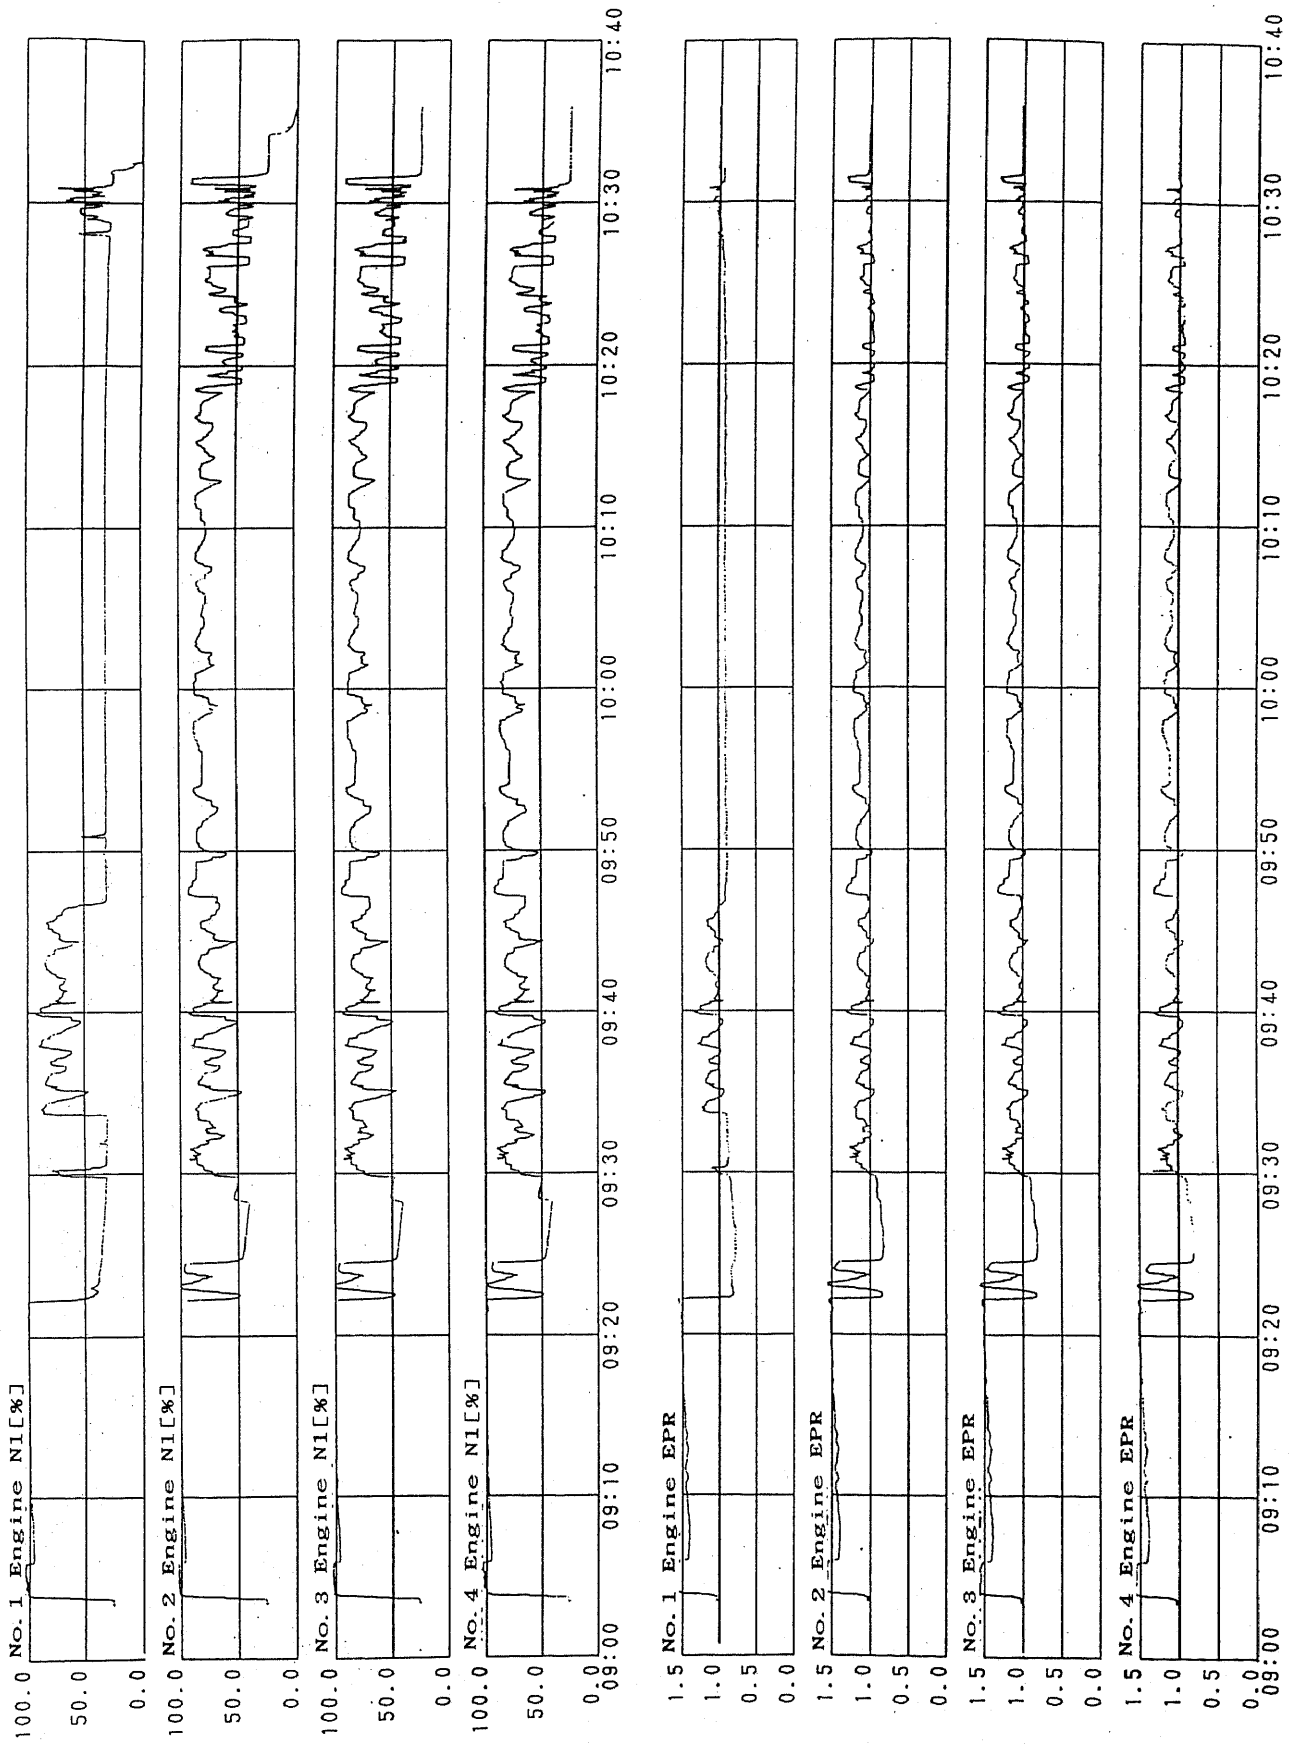
Attached Fig. 8 DFDR Records

Main records in DFDR were as follows: (see Attached Figs. 8 and 9)

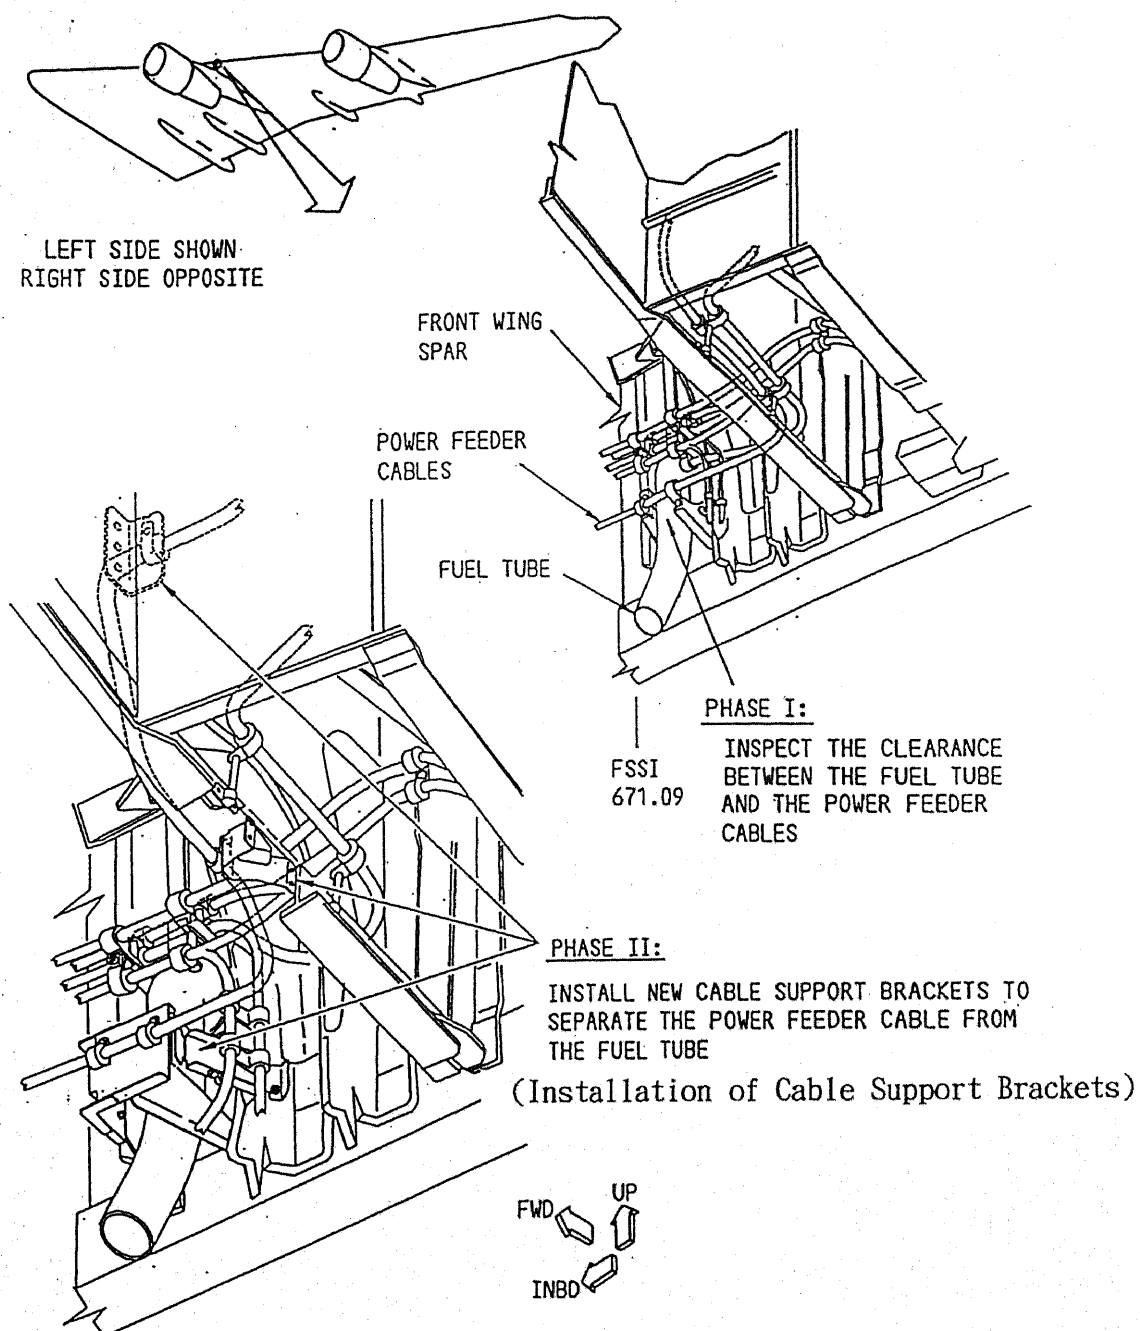
Attached Fig.10 Modification by Boeing SB of installation of  
No.1 Generator Feeder Cable Support Brackets

After this accident the Boeing Company issued a Service Bulletin (SB) No.747-24A2168 (as of September 24, 1991) and its revisions (as of Dec. 5, 1991 and as of Sept. 24, 1992), where a case in which fire occurred within No.2 engine strut due to a hole on the fuel feed pipe generated by chafing between the feed pipe and generator feeder cable was referred to as a reason for their issuance. (see Attached Fig. 10)

5.1.2 On April 9, 1992, the CAB revised the TCD above and issued it as TCD-3552A-92, by which the CAB for the purpose of preventing malfunctions which cause fire within the engine strut, directed users of Boeing 747-400 that inspection (including the repetitive inspection) and repair, as necessary, be made on the clearance between the fuel feed pipe and the generator feeder cable within the wing leading edge, and suggested modification to fit up support brackets on the feeder cable (see Attached Fig. 10) as an alternate measure of the repetitive inspection. The modification is intended to isolate the fuel feed pipe by installing support brackets to the feeder cable.
