AI2015-1

**AIRCRAFT SERIOUS INCIDENT  
INVESTIGATION REPORT**

**KOREAN AIR LINES CO., LTD.  
H L 7 5 9 9**

RUNWAY OVERRUNNING  
KOREAN AIR LINES CO., LTD.  
BOEING 737-900, HL7599  
ON RUNWAY 10 AT NIIGATA AIRPORT  
AT 19:42, AUGUST 5, 2013

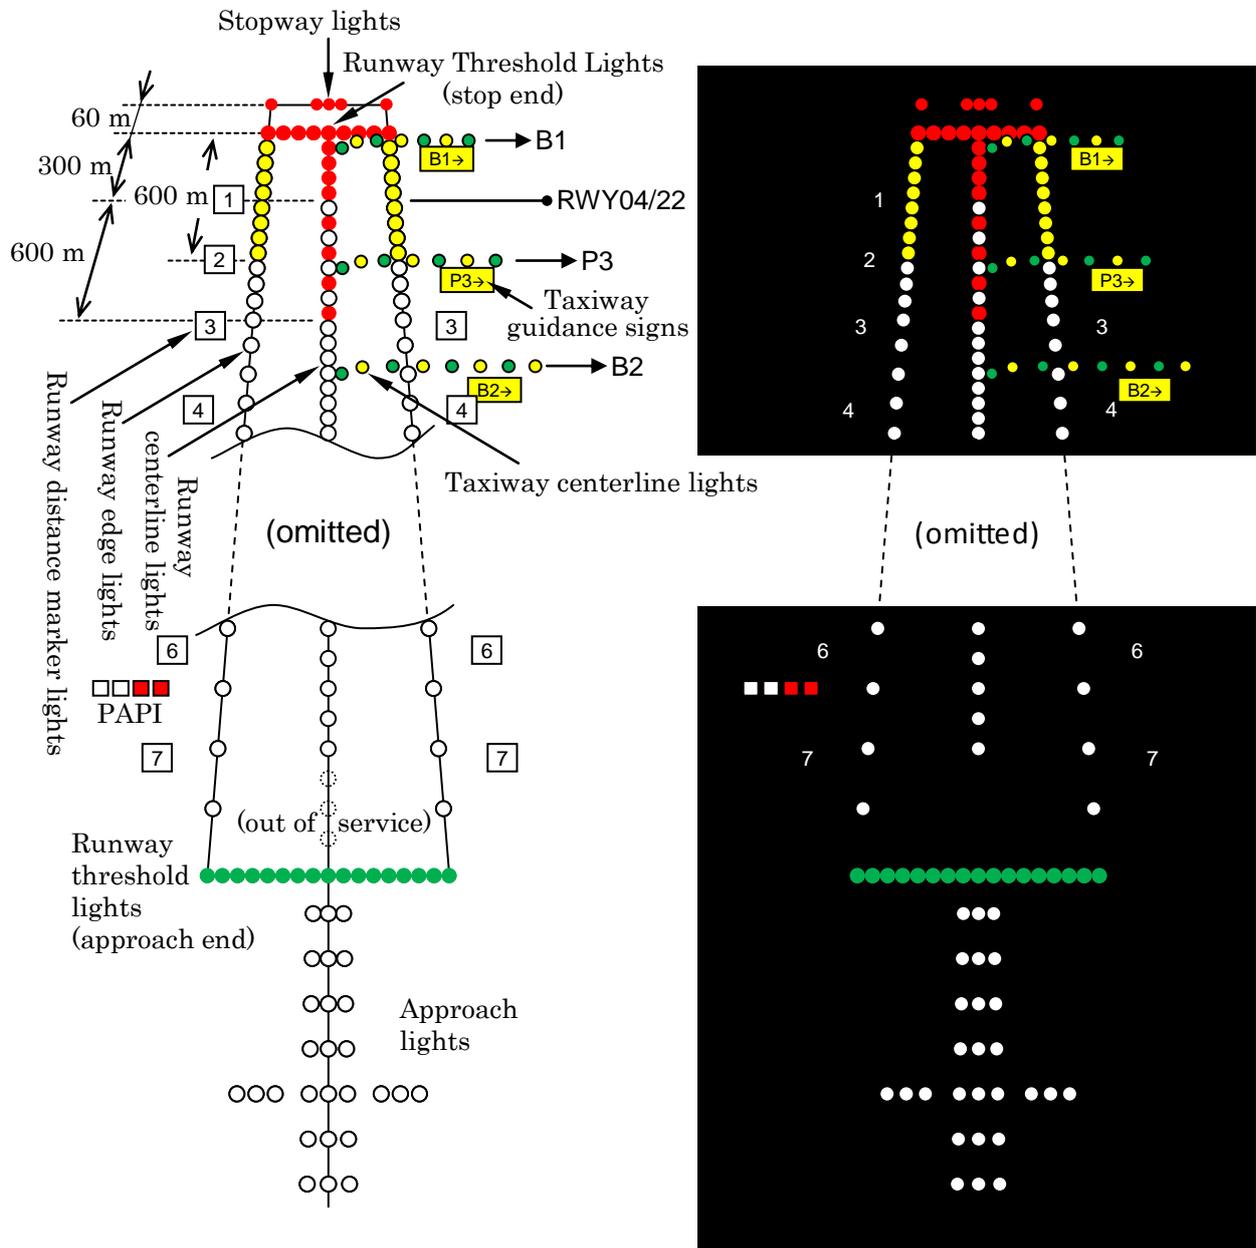
Figure 4 Actual Lighting Status on RWY 10 at the Occurrence of the Serious Incident

It is probable that the Captain and the F/O believed that they were short of the intersection of RWY 04/22 and understood the red lights (runway threshold lights ) that they observed ahead, as the stop bar lights in front of RWY 04/22, associated with the ATC instruction of “cross runway 04/22.”
