AA2018-4

**AIRCRAFT ACCIDENT
INVESTIGATION REPORT**

**KWANSEI GAKUIN UNIVERSITY
JA05KG**

DAMAGE OF GLIDER DURING LANDING
DUE TO ABORT OF WINCH LAUNCHING
AT ONO GLIDING FIELD, ONO-CHO, IBI-GUN, GIFU PREFECTURE
AT ABOUT 9:21 JST, NOVEMBER 10, 2017

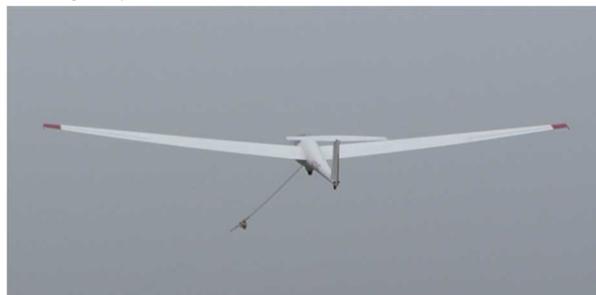
Photo 1: A glider immediately after a normal lift-off

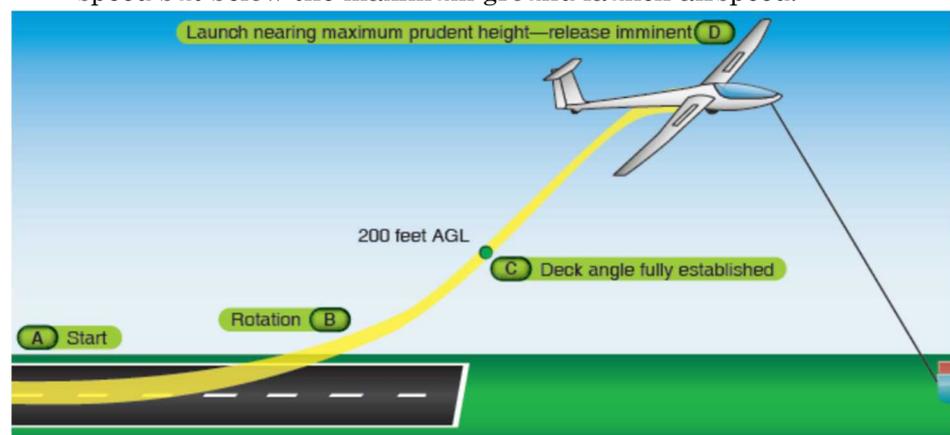
a. (Figure 2, position A) The glider pilot should track the runway centerline and monitor the airspeed. When the glider accelerates and attains lift-off speed, the glider pilot eases the glider off the ground. After the initial lift-off, the pilot should raise the nose to the proper pitch attitude, watching for an increase in airspeed. If the nose is raised too soon or too steeply, the pitch attitude is excessive while the glider is still at low altitude. If the launching mechanism loses power or other troubles happen, release and recovery will become difficult.

b. (Figure 2, position B) The pilot should ease the nose up gradually. While monitoring the airspeed to ensure that it is adequate for launch but does not exceed the maximum permitted ground launch tow airspeed.

c. (Figure 2, position C) When optimum pitch attitude for climb is attained, the glider should be approximately 200 feet AGL. The pilot must monitor the airspeed during this phase of the climb-out to ensure the airspeed is adequate to provide a safe margin above stall speed but below the maximum ground launch airspeed.

Figure 2: Ground launch takeoff profile
