**AIRCRAFT SERIOUS INCIDENT  
INVESTIGATION REPORT**

**FUJI GLIDER CLUB  
J A 1 0 9 B**

October 25, 2013

RUNNING OFF THE SIDE OF RUNWAY AFTER LANDING  
FUJI GLIDER CLUB  
GROB G109B (MOTOR GLIDER, 2 SIDE BY SIDE), JA109B  
FUJIKAWA GLIDER STRIP,  
SHIZUOKA CITY, SHIZUOKA PREFECTURE  
AT 11:19 JST, APRIL 7, 2012

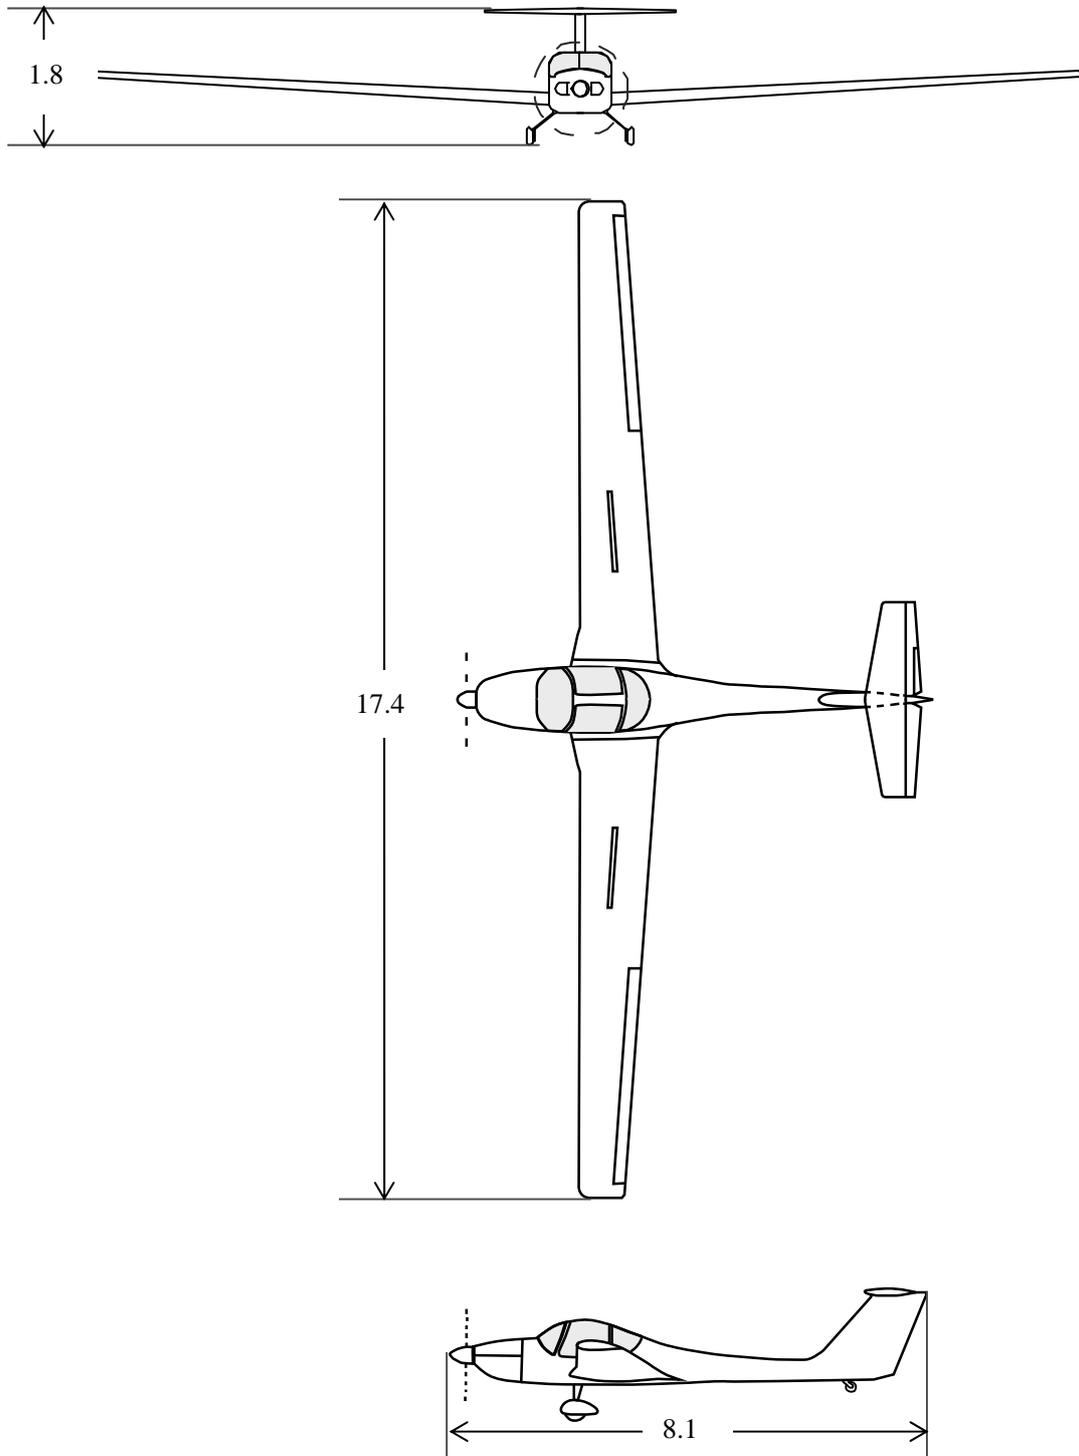
Photo 1 Serious Incident Glider

(See Photo 1 – Serious Incident Glider.)

It is highly probable that this serious incident occurred because the right main landing gear of the glider was damaged upon landing followed by right veering off the runway and the glider eventually collapsed.

It is highly probable that the damage to the right main landing gear occurred as the threads of the inboard gear mount nuts gave way and slipped out of the bolts, leaving the outboard mount to support the gear followed by the forward outboard nut failure due to the similar reason, causing the gear swivel aft on the aft mount bolt.
