**AIRCRAFT SERIOUS INCIDENT  
INVESTIGATION REPORT**

**AIR NIPPON CO., LTD.  
J A 1 6 A N**

**AIR NIPPON CO., LTD.  
BOEING 737-700, JA16AN  
NOSEDIVE FROM UPSET (LOC-I)  
AT AN ALTITUDE OF 41,000 FT, APPROX. 69NM EAST OF  
KUSHIMOTO, WAKAYAMA PREFECTURE, JAPAN  
AROUND 22:49 JST, SEPTEMBER 6, 2011**

September 19, 2014

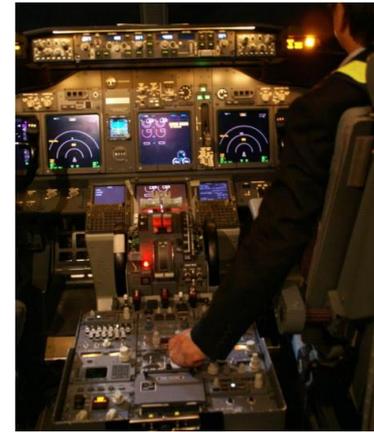
How rudder trim switch is operated

As described in 2.1.2 (2), the FO, with an intention of rotating the Door lock Selector, looked at the Rudder Trim SW, and then, depressing and rotated the switch, just like the Door Lock Selector, according to his statement. As described in 2.9.1, in a questionnaire survey conducted by the Company after this serious incident, the replies “The location of the Door Lock Selector for the 737-500 is very close to that of the Rudder Trim SW for the 737-700, which may cause possible misrecognition when transferring to 737-700” and “It may be hard to escape from the preconceived thought because these two switches are the same type in terms of a momentary rotary switch” were collected.

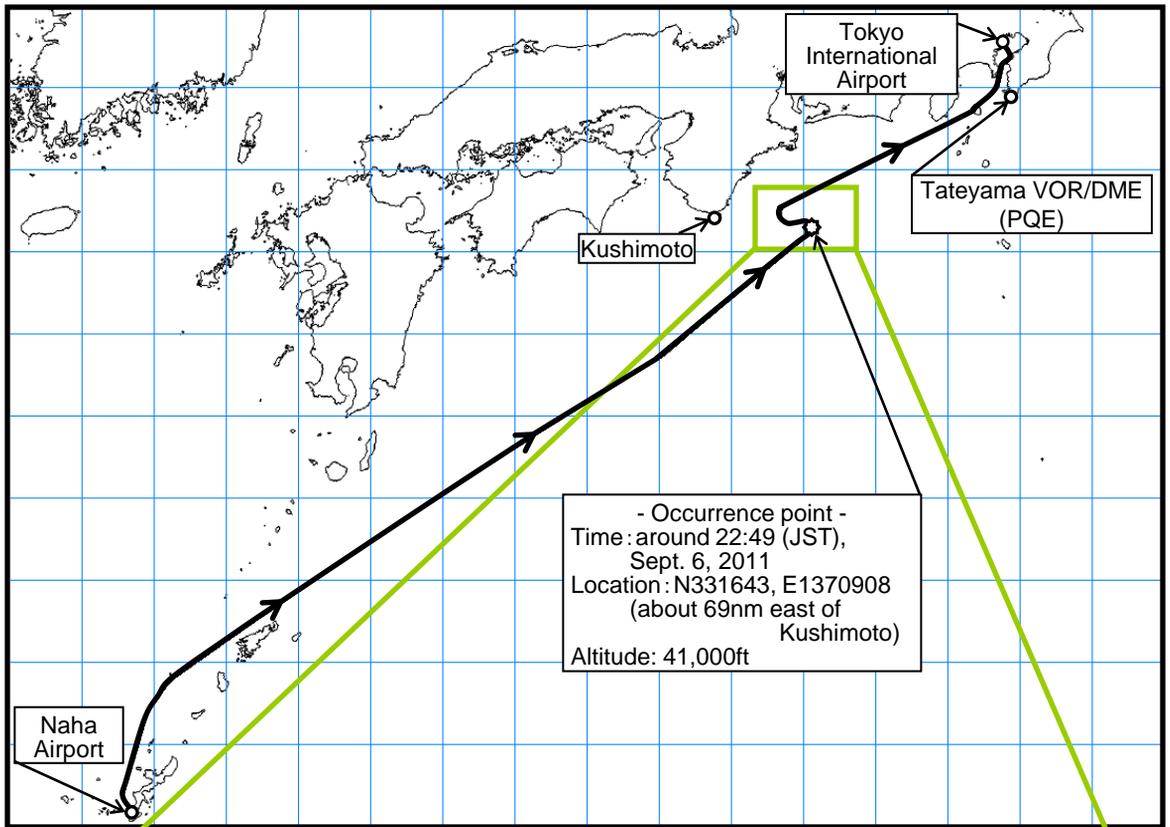
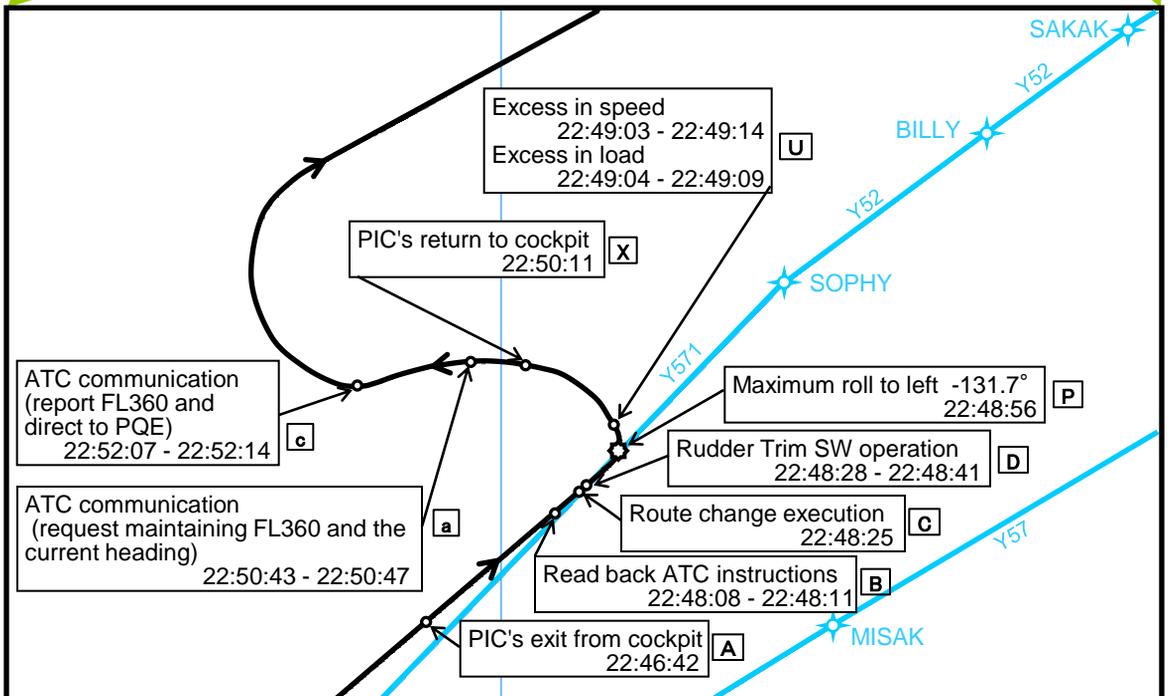
Figure 1 Estimated flight route

T	22:49:02	Recovery of roll angle
U	22:49:03	Excess in speed
	22:49:04	Excess in load
V	22:49:16	Nosedive seased
W	22:49:26	Recovery of pitch angle
X	22:50:11	PIC's return to cockpit
Y	22:50:38	Taking over flight duties
Z	22:50:39	Re-engaging Autopilot mode
a	22:50:43	Communication with Controller
b	22:51:49	LNAV mode set
c	22:52:07	Communication with Controller
d	22:52:13	Almost normal flight condition recovered

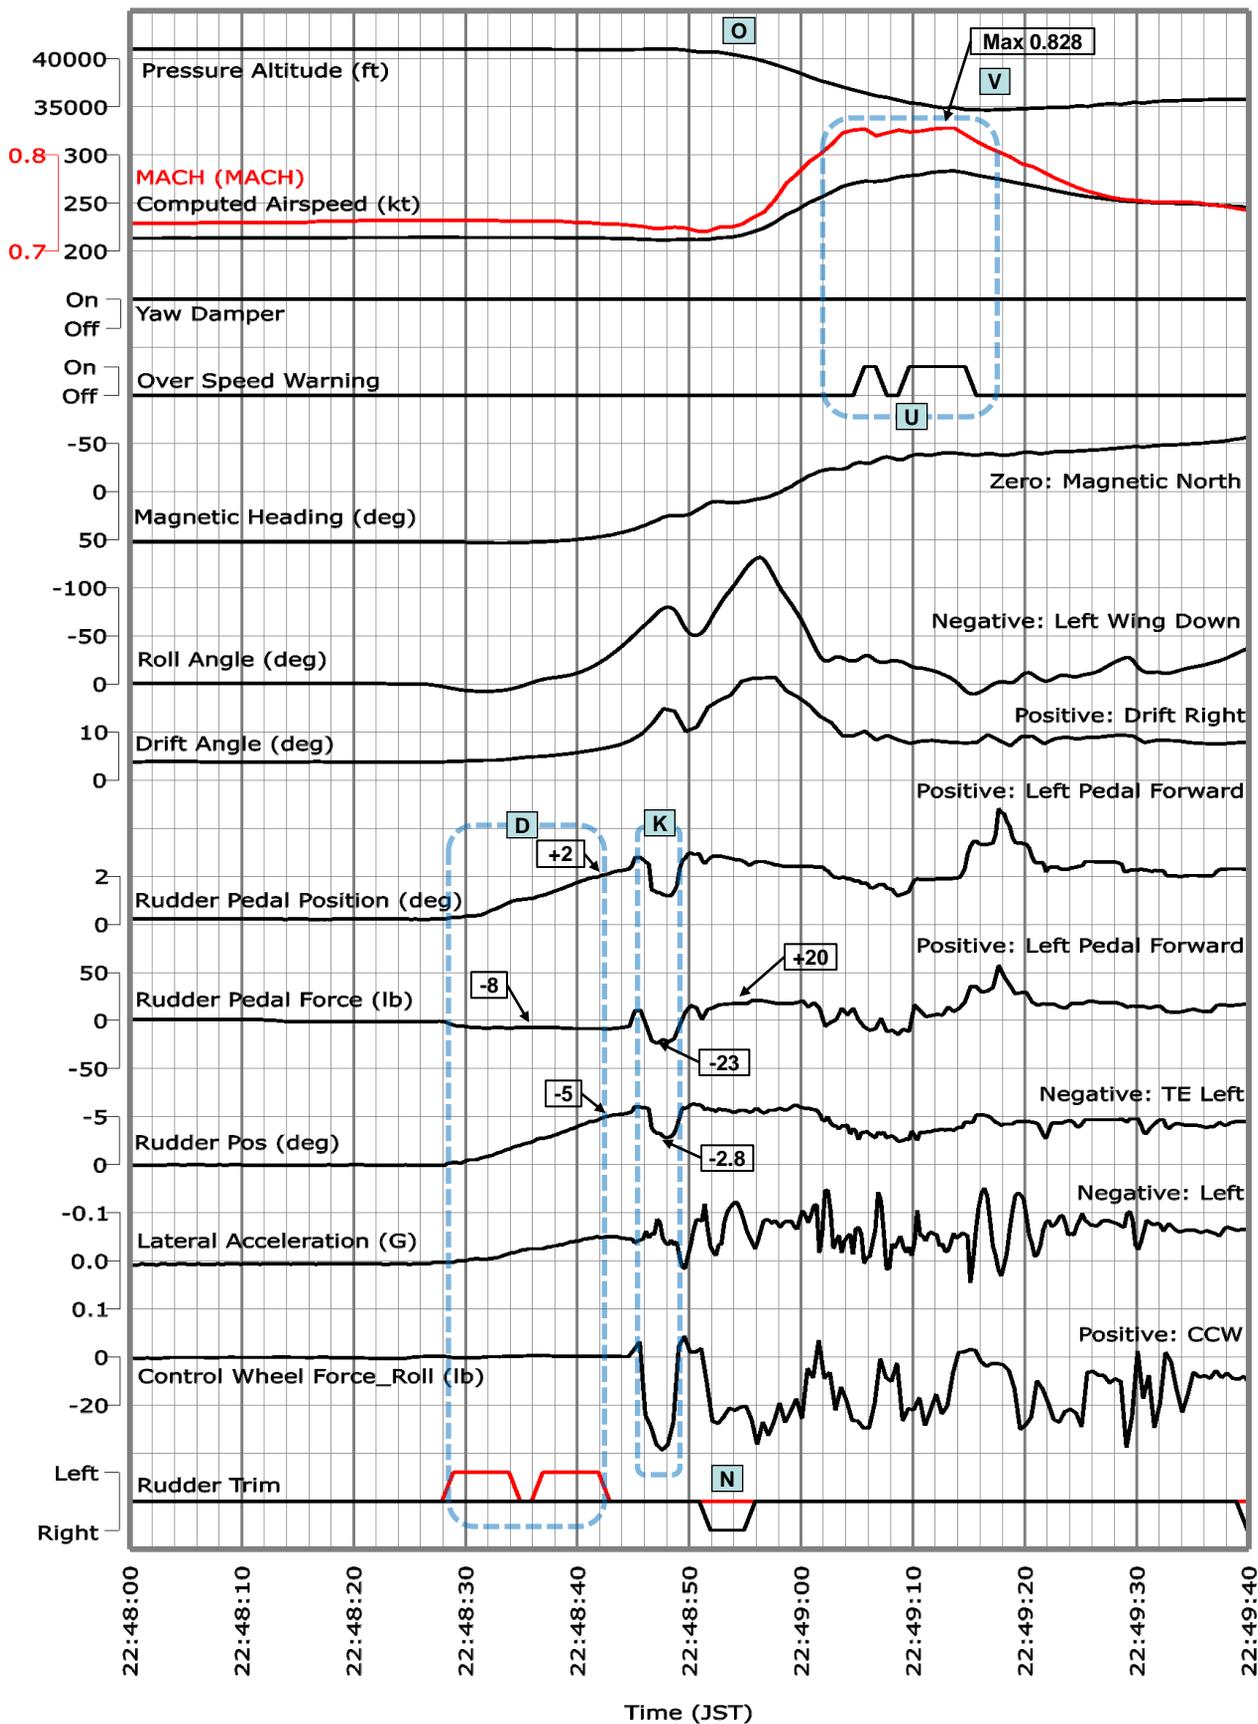
### Figure 5 DFDR Records (YAW)

While the rudder pedals were moving, rudder pedal force was applied by about 8 lb to the right side pedal. [D: Figure 5]

22:48:46 The right rudder pedal was pressed with a force of about 23 lbs and following this, the rudder moved about  $-2.8^\circ$ . (In this report, the rudder angle to the right is described in negative value.) (through 48:49) [K: Figure 5]

Other hand, as indicated in Figure 5, the Rudder Position data for Event N remained unchanged with the rudder displacement maintained at about  $-5^\circ$  despite the Rudder Trim SW on hold position. According to the data, the Rudder Pedal Force was +20 lb (the force applied on the left side rudder pedal).

As described in 2.1.2 (2), the FO did not use the rudder in the corrective operation, according to his statement. But, as described in Event K at 22:48:46 in 2.1.1, the right rudder pedal was pressed with a force of about 23 lb almost at the same time as the corrective operation on the Wheel. When the Wheel was significantly operated CW in this case, it is a natural and common action to press on the right rudder pedal as part of serial operations.

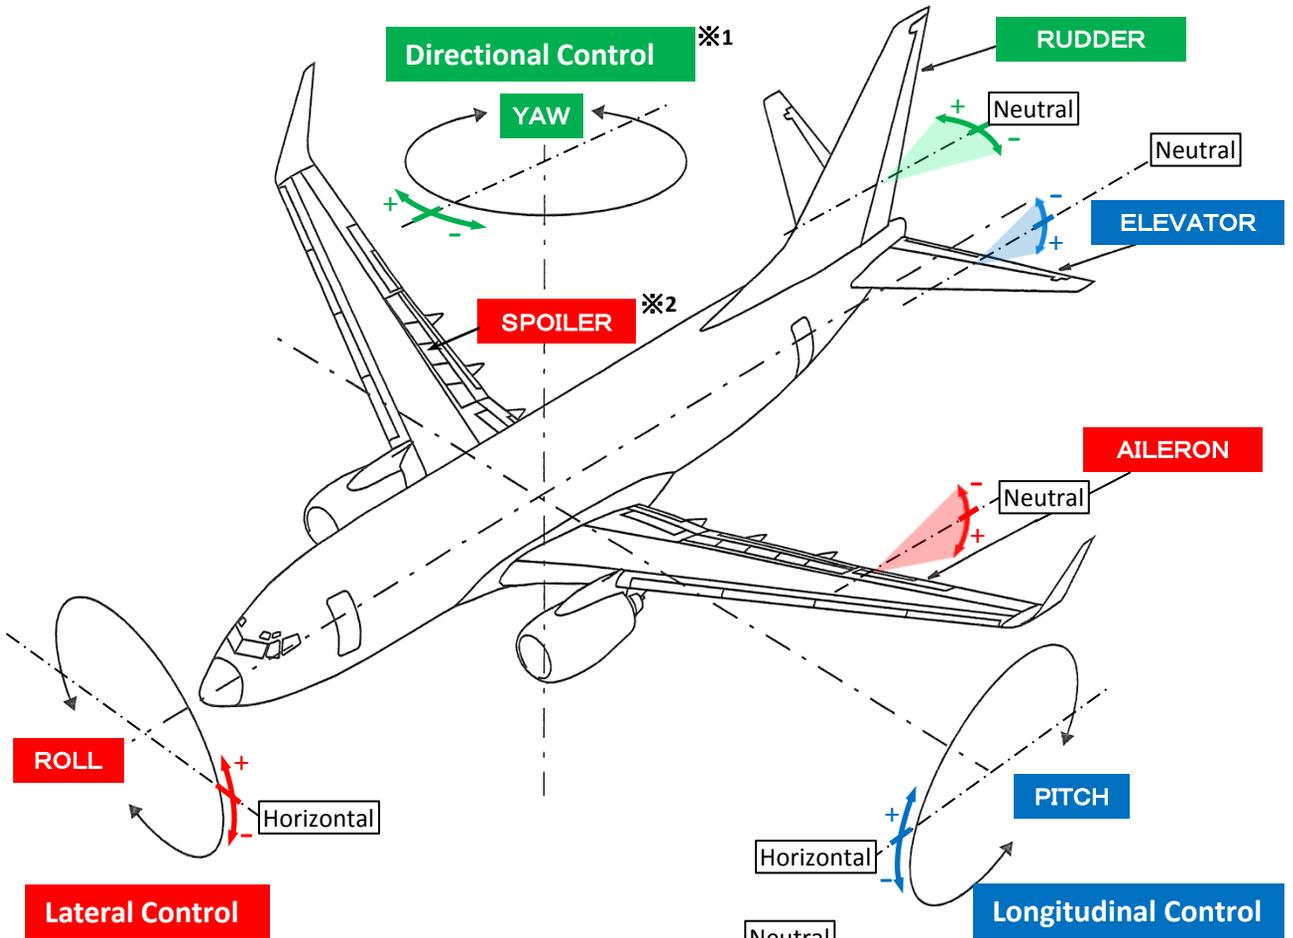
# Attachment 2 Basic flight control systems

※2 In this incident, only the left wing spoiler was moved in recovery operations. The DFDR had retained the data for No. 9 and No. 10.
