AA2016-8

**AIRCRAFT ACCIDENT  
INVESTIGATION REPORT**

PRIVATELY OWNED DIAMOND AIRCRAFT  
HK36TTC (MOTOR GLIDER, TWO-SEATER), JA21DA  
DAMAGE TO THE AIRFRAME IN LANDING  
BIEI GLIDING FIELD IN BIEI-CHO, KAMIKAWA GUN,  
HOKKAIDO, JAPAN  
AT ABOUT 11:40 JST, AUGUST 25, 2015

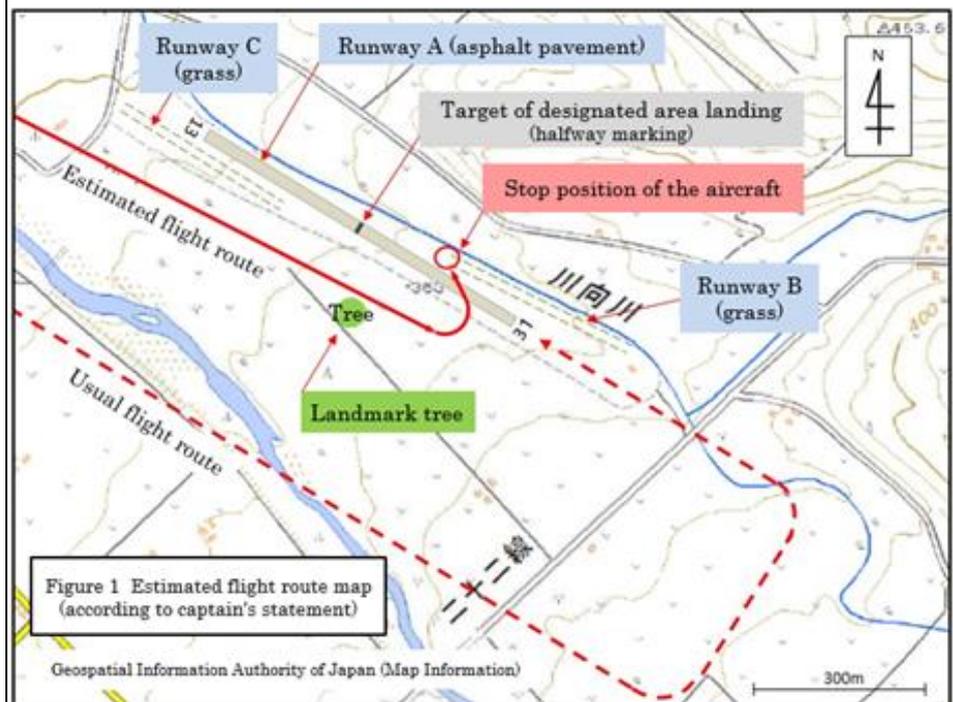
2.2 Injuries to Persons	None																		
2.3 Damage to the Aircraft	<p>Extent of damage: Substantially damaged</p> <ul style="list-style-type: none"> <li>• The rear of the fuselage was ruptured (It was not separated due to the control cable, etc.)</li> <li>• Nose landing gear and horizontal stabilizer fell off.</li> <li>• Propeller blades were broken.</li> <li>• The lower part of the nose was broken.</li> </ul>

There was an impact mark of the left wing tip at a point about eight meter away from the runway and many impact marks along the extension from the point. In one of the impact marks, one of the broken wooden propeller blade stuck to the ground and, beyond that point, there was the nose landing gear which fell off from the installation part.
