AA2013-1

AIRCRAFT ACCIDENT INVESTIGATION REPORT

J A 2 1 K A

J A 2 3 7 6

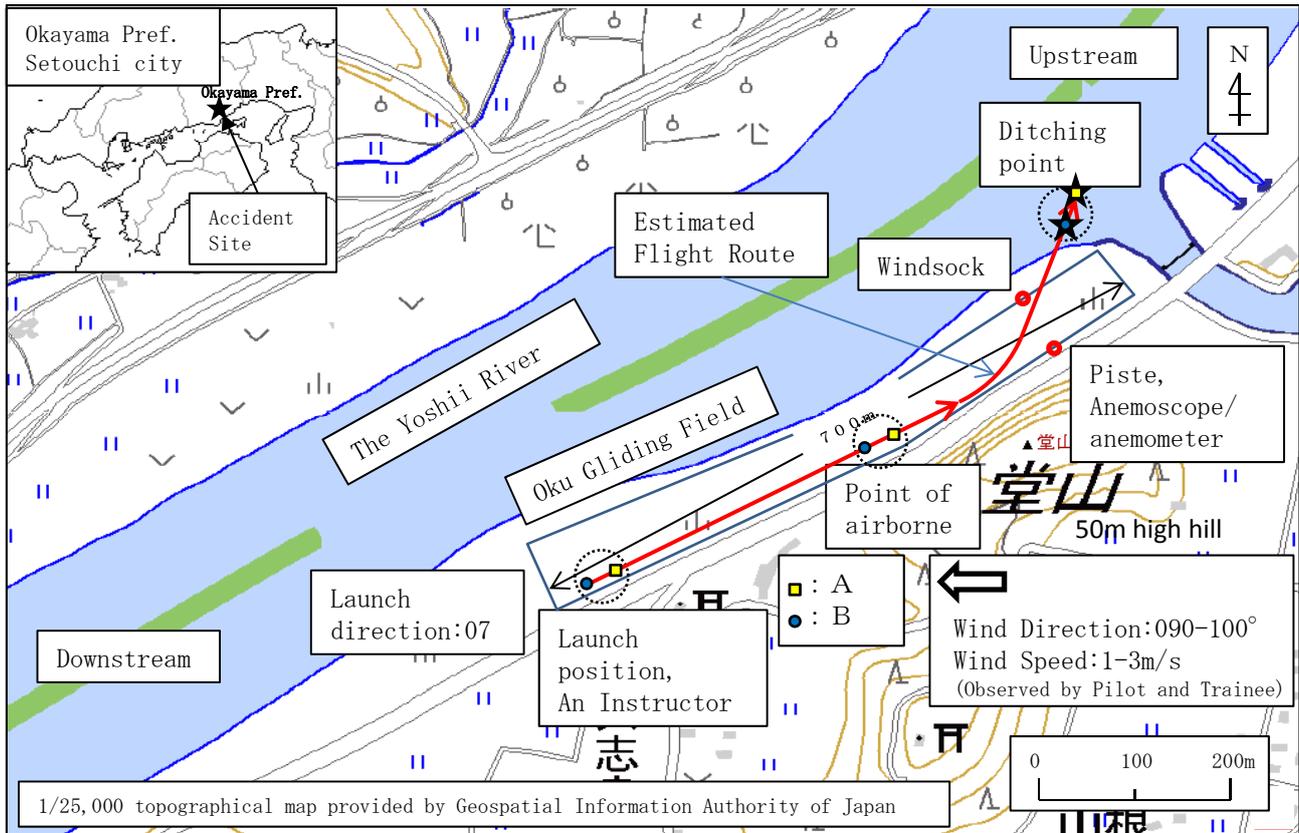
Figure 1 Estimated Flight Route and Accident Site Layout

<p>2.1 History of the Flight</p>	<p>On Saturday, April 28, 2012, a privately owned Scheibe SF25C, (registered JA21KA, a motor glider) started aircraft towing Schempp-Hirth Discus b (registered JA2376) at 13:45 at Oku Gliding Field in Setouchi City, Okayama Prefecture. A pilot was in the left seat of the towing glider. A trainee pilot was in the towed glider. At 13:55, both gliders ditched in the Yoshii River adjacent to the Gliding Field and sustained damage.</p> <p>The history of the flight up to the accident was summarized as below, according to the statements of the members of the glider flying club: the pilot, the trainee pilot, a piste member and an instructor.</p> <p>When the aircraft towing started, winds were blowing 1-3 m/s from 90-100°, slightly to the right of the launching direction of 07. There is about 50 m high hill located to the east of the Gliding Field and winds were blowing from that direction. After the takeoff roll of the towing glider, the towed glider became airborne, and the towing glider took off—normal operation. The towing glider normally accelerates to a speed exceeding 93 km/h while maintaining low altitude close to the ground after takeoff; however, it climbed by about 5 meters due to air disturbance just after takeoff when its airspeed slightly surpassed 80 km/h, bottom airspeed for the normal operation. Since its flight was stable after that, the pilot continued the towing; however, the towing glider encountered another air disturbance with sudden climb of 5 m. Its altitude above the ground level then was about 20 m.</p> <p>From the time when the towing glider made the first sudden climb, the towed glider was being towed in a nose-up attitude at low tow position. After the towing glider made the second sudden climb, its speed remained slightly above 80 km/h lower than the normal operation speed. Because the towing glider could not gain intended speed, the pilot felt that it is difficult to continue towing.</p> <p>The pilot concluded that it would be safer to tow to the river than releasing the towing line at a place where there was insufficient distance left on the Gliding Field for the towed glider to land. Keeping in mind the possibility of releasing the towing line above the river and ditching the towed glider into the river, the towed glider slowly turned to the left and tried to continue flying to the river along the normal climbing route. However the towed glider descended sliding to the left and ditched into the river from the left wing, then pulled the towing glider into the river with the towing line.</p>

The towing glider ditched into the river from its left wing.
2.2 Injuries to Persons	None
2.3 Damage	<p>Glider Damage</p> <p>Towing glider Destroyed (Left wing and propeller damaged)</p> <p>Towed glider Destroyed (Fuselage damaged)</p> <p>No fire broke out.</p>
