**AIRCRAFT ACCIDENT
INVESTIGATION REPORT**

**EXCEL AIR SERVICE INC.
J A 3 5 0 D**

DAMAGE TO AIRFRAME IN DITCHING EXCEL AIR SERVICE INC. EUROCOPTER AS350B3 (ROTORCRAFT), JA350D ON THE SEA NEAR 41 KM NORTHWEST OF NAHA AIRPORT, JAPAN AROUND 15:26 JST, JUNE 7, 2018

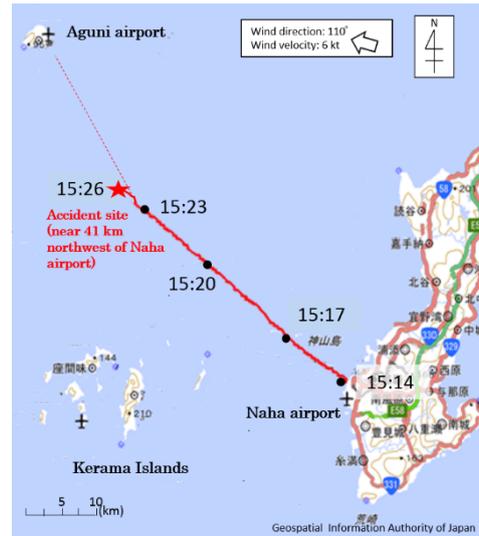
Figure 1: Estimated flight route

The pilot turned the twist grip only to the left paying attention to avoid an excessive NR, but was unable to increase NR.

Because the helicopter did not stop descending and came as close as about 300 ft to the sea surface, the pilot made a decision to ditch at this time. At

<p>15:25:30, the pilot sent distress message and manually activated emergency locator transmitter (ELT). The pilot thereafter strongly pulled the cyclic stick to decelerate for ditching and extended an emergency float (a float that extends by nitrogen gas in case of emergency ditching and is hereinafter referred to as “the Emergency Float”) at about 50 kt.</p> <p>The helicopter came near to the sea surface in 10 to 20 seconds after sending the distress message, and ditched at the speed of 20 to 30 kt without performing a sufficient deceleration. The helicopter immediately sank to the level of the pilot’s seat.</p> <p>The pilot unfastened shoulder harness and seat belt while dipped in the sea, escaped from the helicopter without putting on a life jacket equipped in the lower part of the right pilot’s seat. And he was grabbing the Emergency Float disconnected from the landing devices of the helicopter, and was waiting to come for rescue.</p> <p>A rescue helicopter of Air Self-Defense Force, which was drilling nearby and received the distress message, arrived near the accident site around 15:39 and found the pilot on the sea. The helicopter had already sank in the sea at this time. The pilot was rescued by the rescue helicopter and was taken to the hospital in the city of Naha via Naha airport around 16:20.</p> <p>When the rescue helicopter arrived at the accident site, it received a weak ELT signal near the site where the helicopter had sank, which became not receivable during the rescue activities.</p> <p>Around 16:22, an aircraft of Japan Coast Guard arrived near the accident site for searching floating wreckage and found no oil floating. From around 17:22 till around 19:00, a patrol ship of Japan Coast Guard gathered floating wreckage. Japan Coast Guard did not receive ELT signal from the helicopter.</p> <p>The place of the occurrence of the accident was on the sea near 313 ° and 41 km away from Naha airport (26 °27’ N, 127 °27’ E) and the time of the occurrence was June 7, 2018 around 15:26.</p>
