**AIRCRAFT ACCIDENT
INVESTIGATION REPORT**

TOHO AIR SERVICE CO., LTD.

UNCONTROLLED CRASH INTO THE GROUND

EUROCOPTER AS350 B3, JA508A

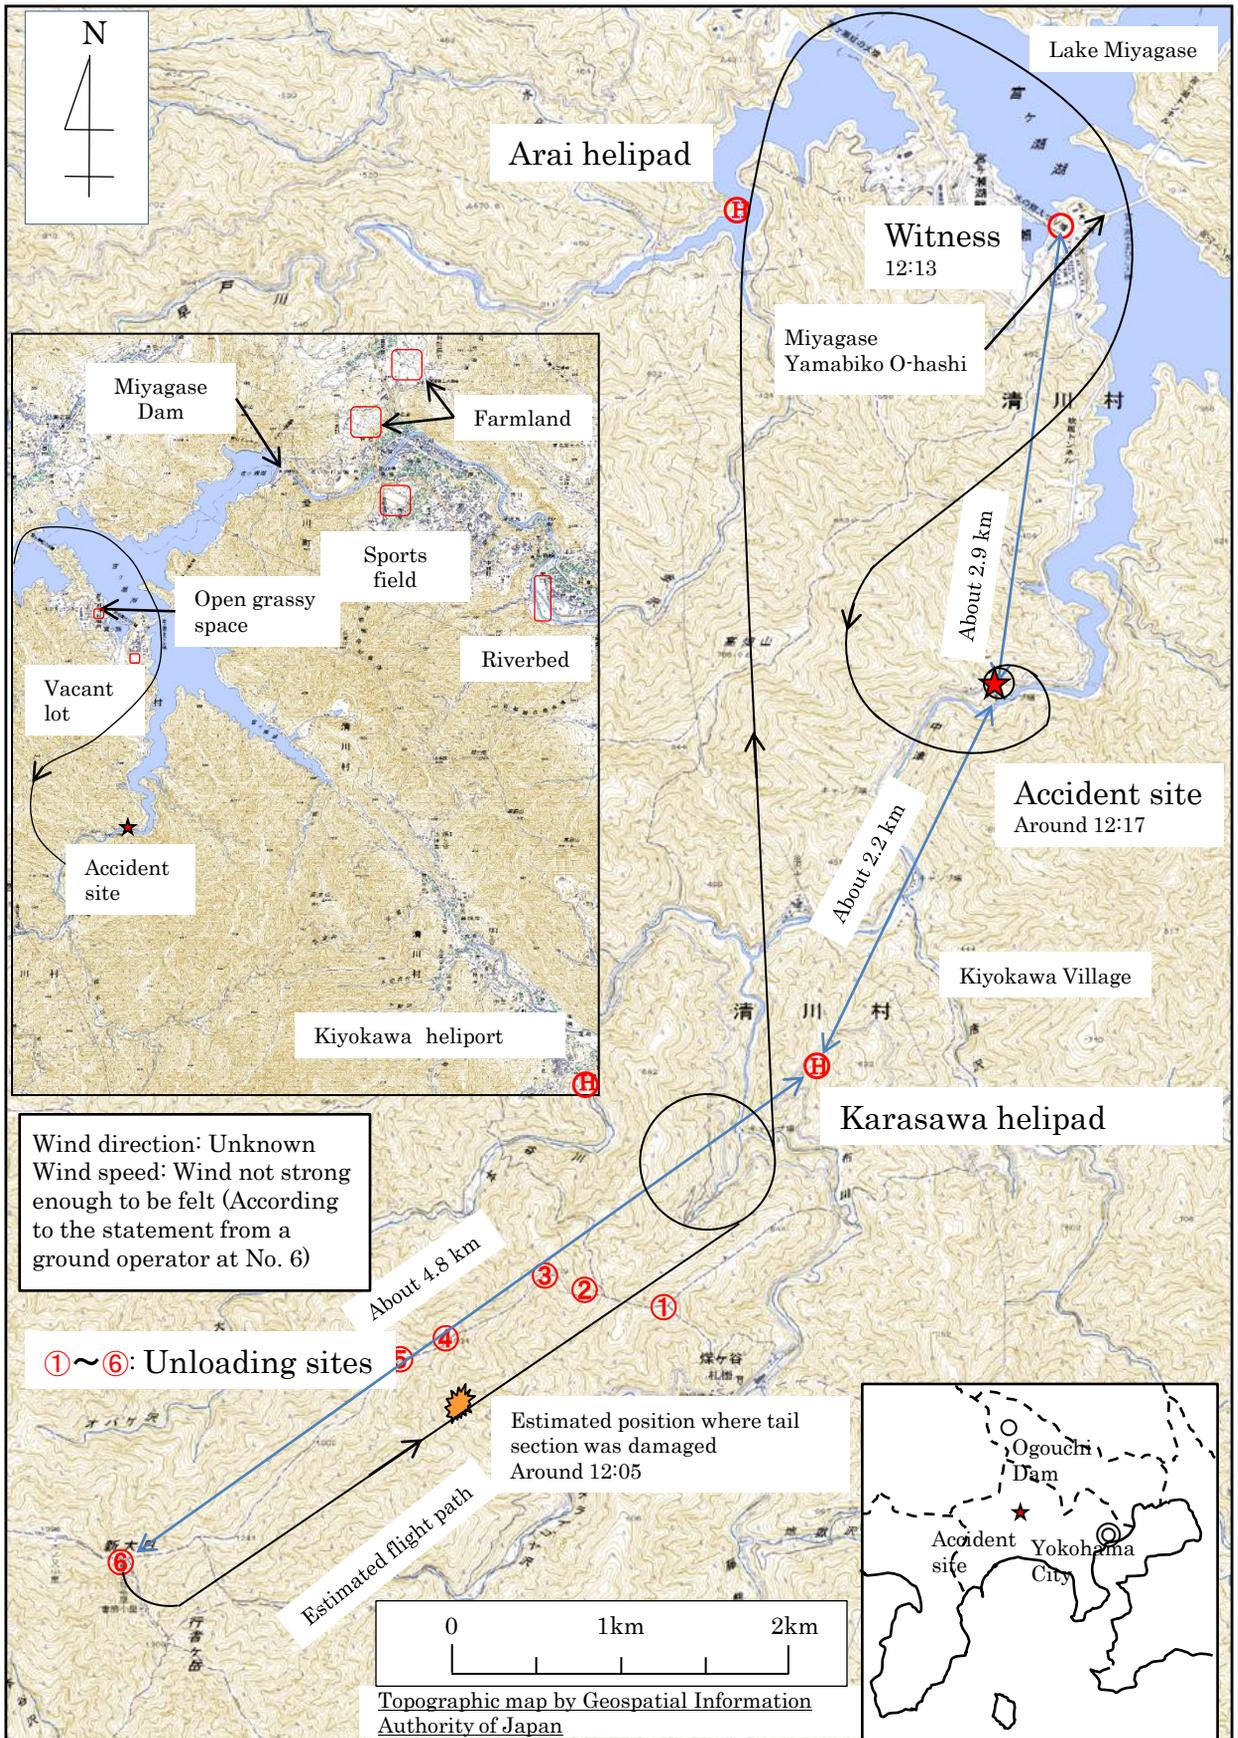
Figure 1 Estimated Flight Path

Before transporting cargoes, the Pilot had a meeting with those involved in the construction to map the locations of unloading sites No. 1 to No. 6 (hereinafter referred to in the text and in Figure 1 simply as "No.1" to "No. 6"), which are situated along the mountain ridge, to confirm the number of times transport was required, and to discuss other details. At around 09:20, the Pilot, who occupied the front right seat, took off on a flight for about ten minutes to observe and check these sites along with the onboard mechanic, who was in the back left seat, and the person who ordered the construction work (hereinafter referred to as "the Customer"), who was in the front left seat. During the flight, they were not able to approach close to No.6 due to the presence of gas^{*1}.

(See Figure 1 "Estimated Flight Path" and Figure 2 "Accident Site.")

(See Figure 1 “Estimated Flight Path” and Figure 2 “Accident Site”)

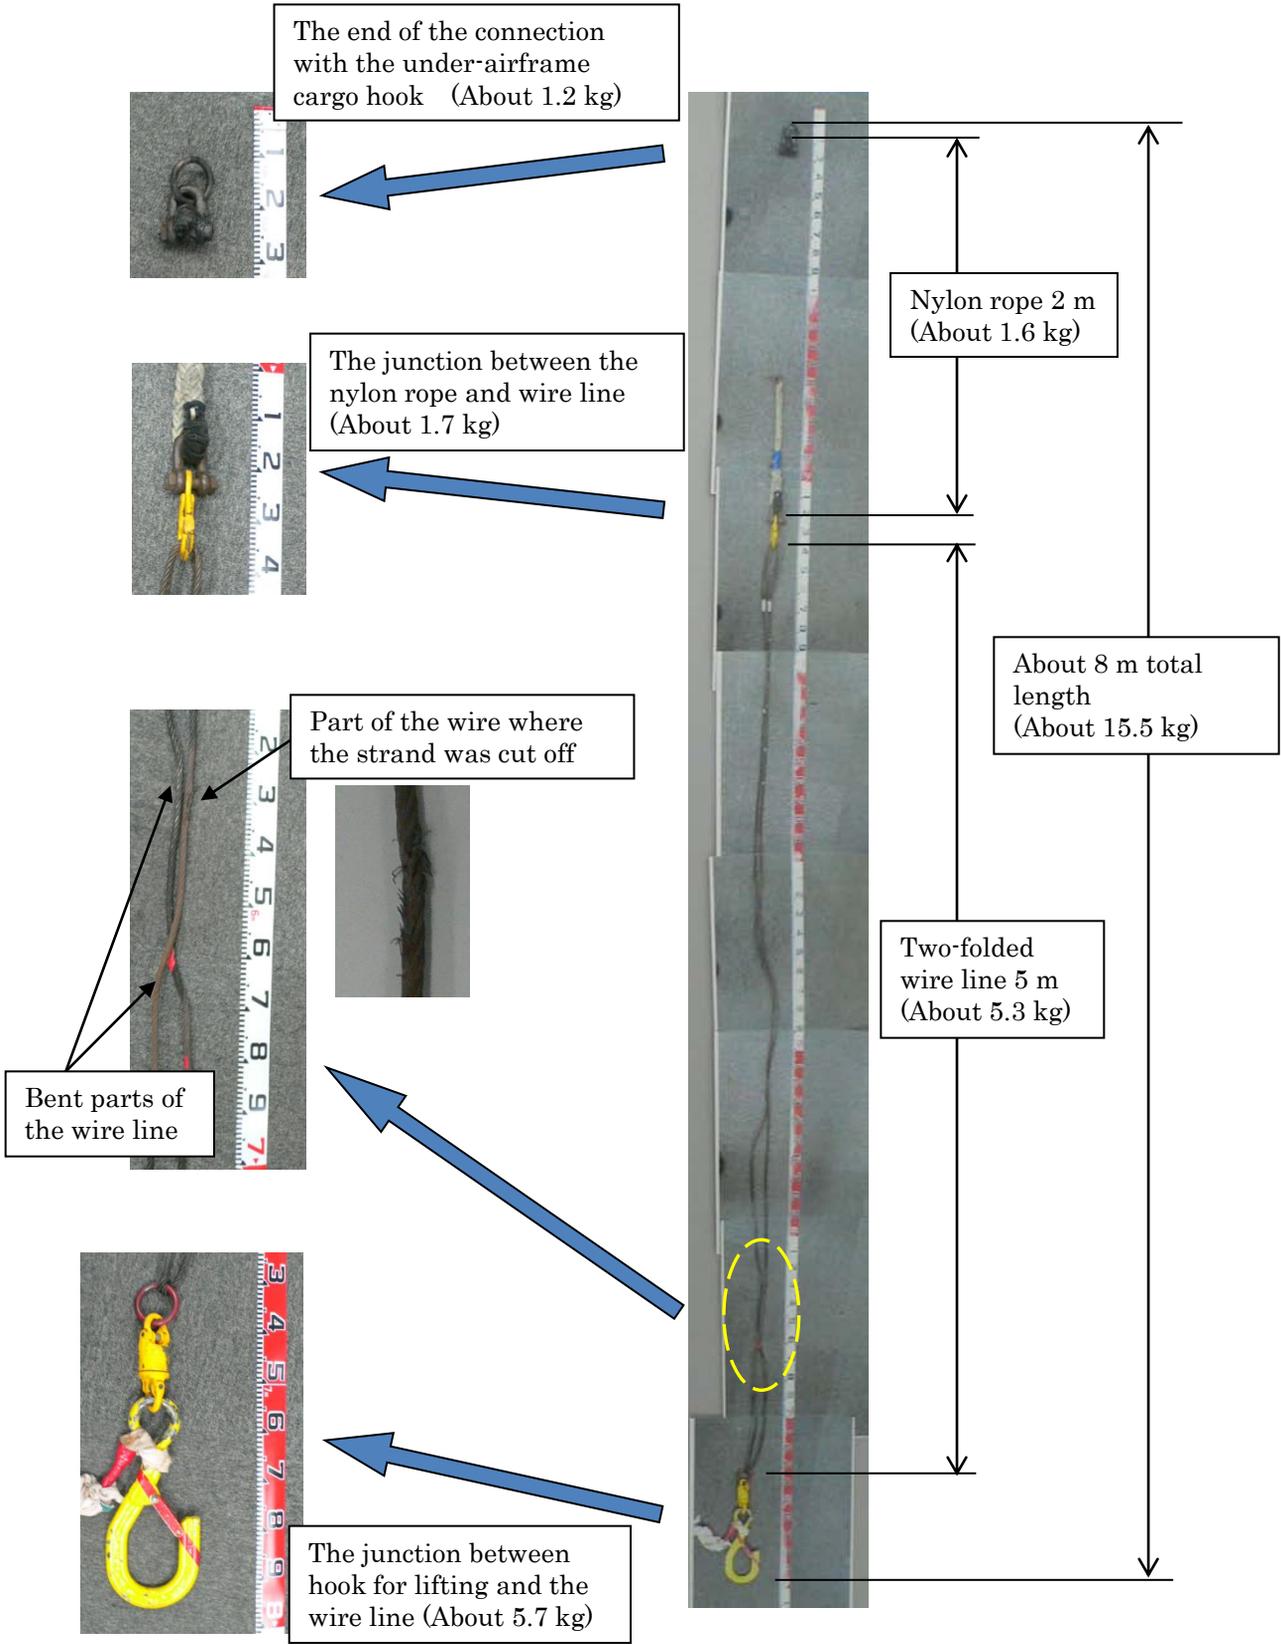
Figure 4 Seven-meter Sling Cable

(See Figure 4 “Seven-meter Sling Cable.”)

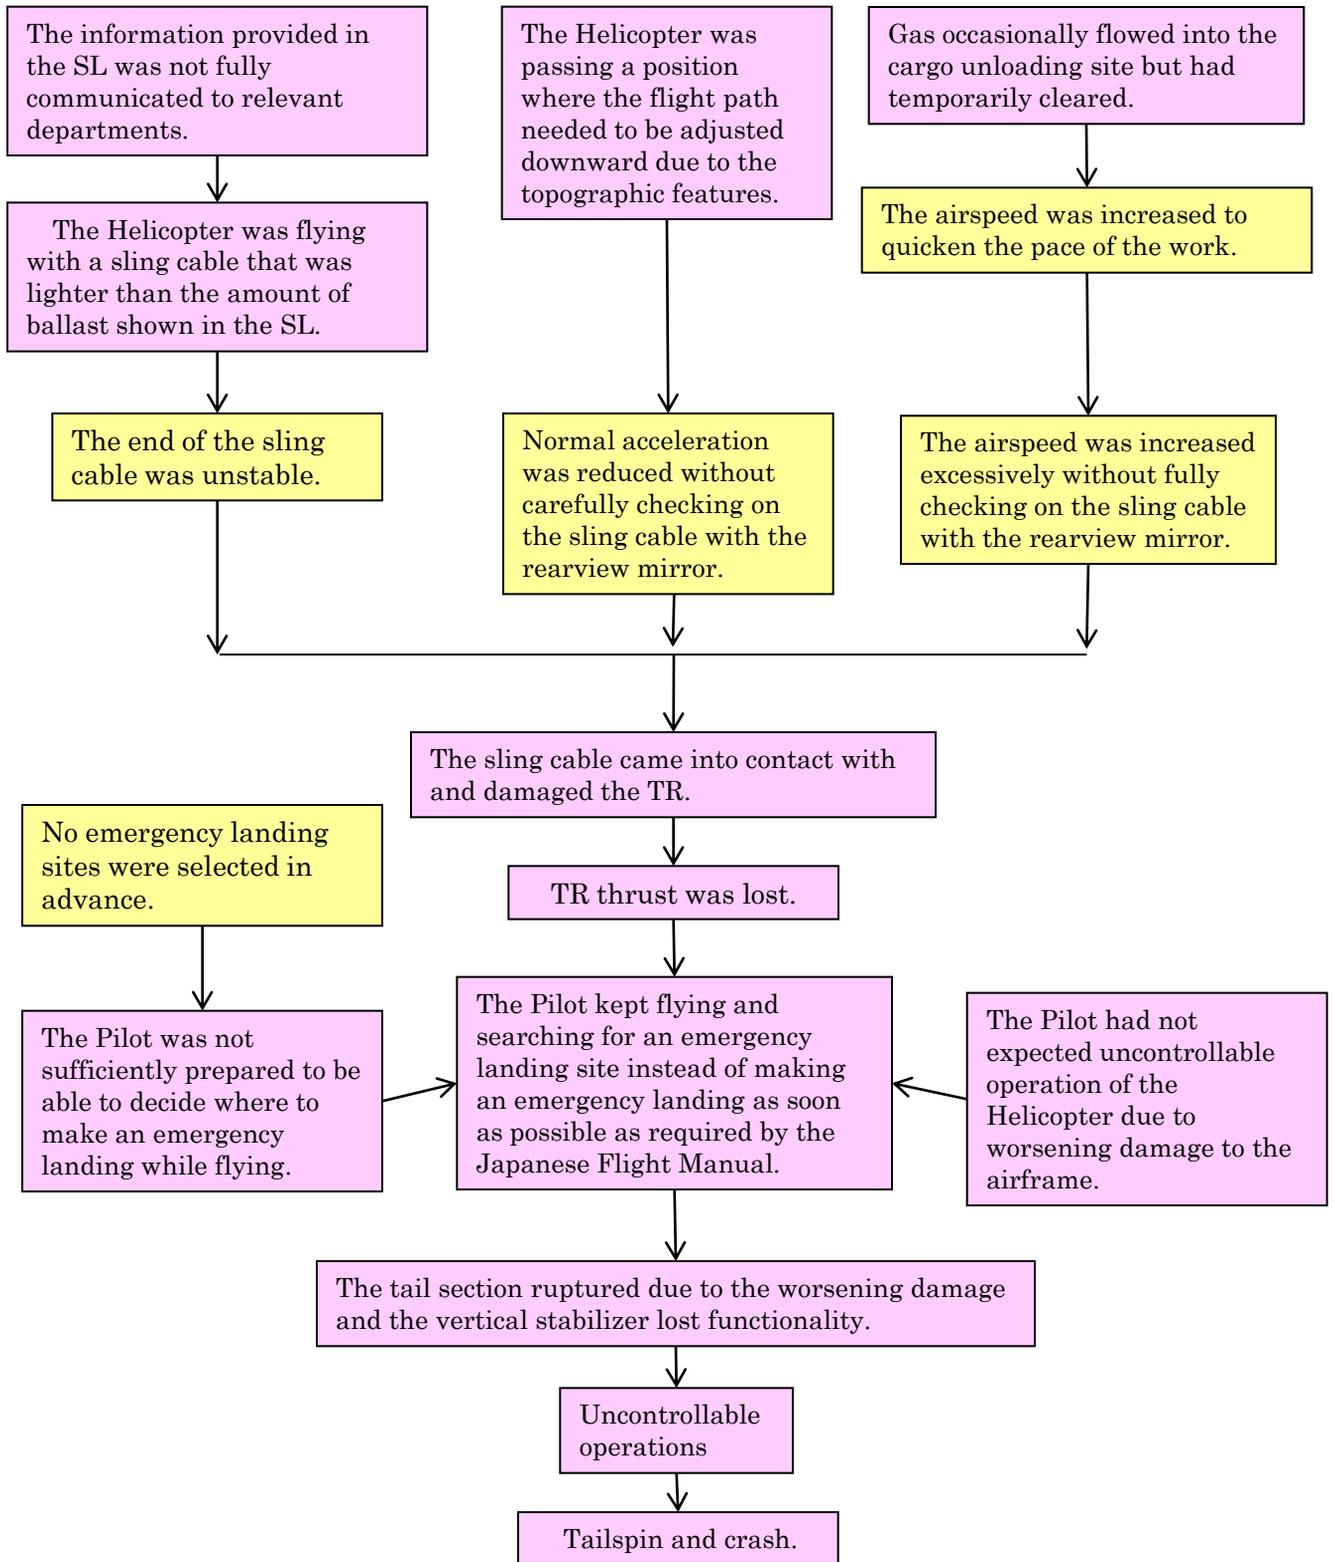
Figure 5 Chain Reaction of Contributing Factors to the Accident

(See Figure 5 “Chain Reaction of Contributing Factors to the Accident.”)

It is probable that the accident occurred as follows: The Helicopter sling cable contacted the TR, damaging the tail section and resulting in a loss of TR thrust. The Pilot, however, did not make an emergency landing as soon as possible as stipulated in the Japanese Flight Manual, but instead continued to search for a suitable emergency landing site, during which time the damage to the tail section, including the vertical stabilizer, was exacerbated leading to its rupture, and the Helicopter became uncontrollable and crashed into the ground.
