AIRCRAFT ACCIDENT INVESTIGATION REPORT

**AERO ASAHI CORPORATION
MCDONNELL DOUGLAS MD900 (ROTORCRAFT)
JA6757
ATSUGI AIRFIELD, AYASE-CITY
KANAGAWA PREFECTURE
AROUND 11:21 JST, SEPTEMBER 14, 2004**

January 26, 2007

**Aircraft and Railway Accidents Investigation Commission
Ministry of Land, Infrastructure and Transport**

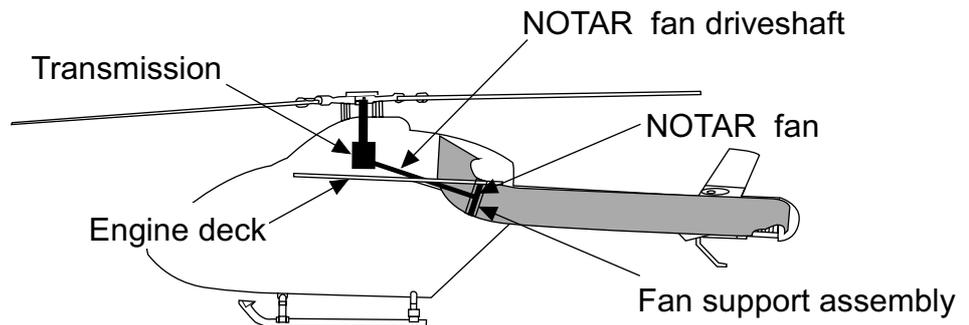
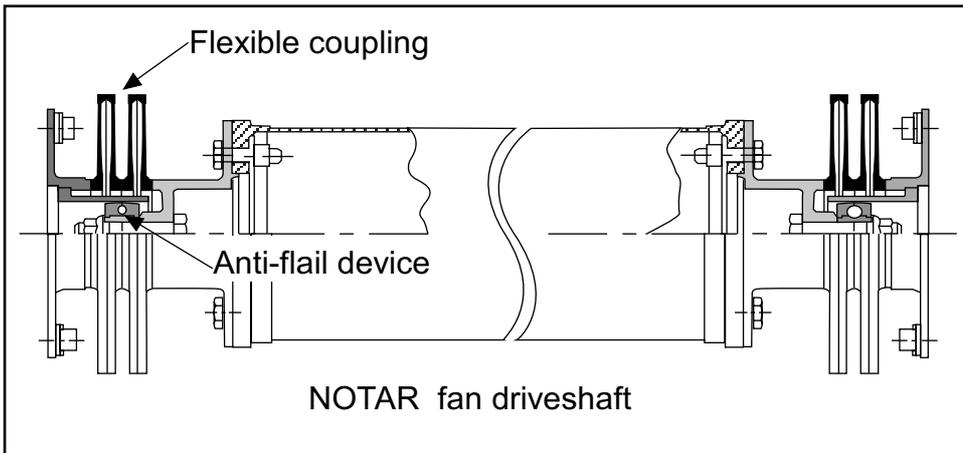
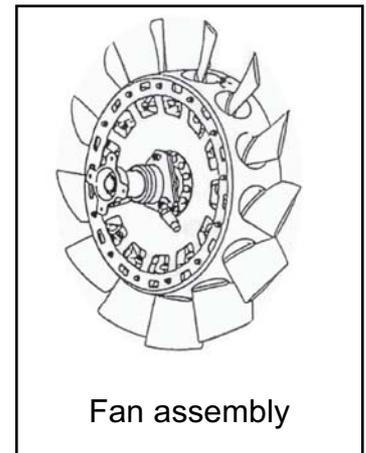
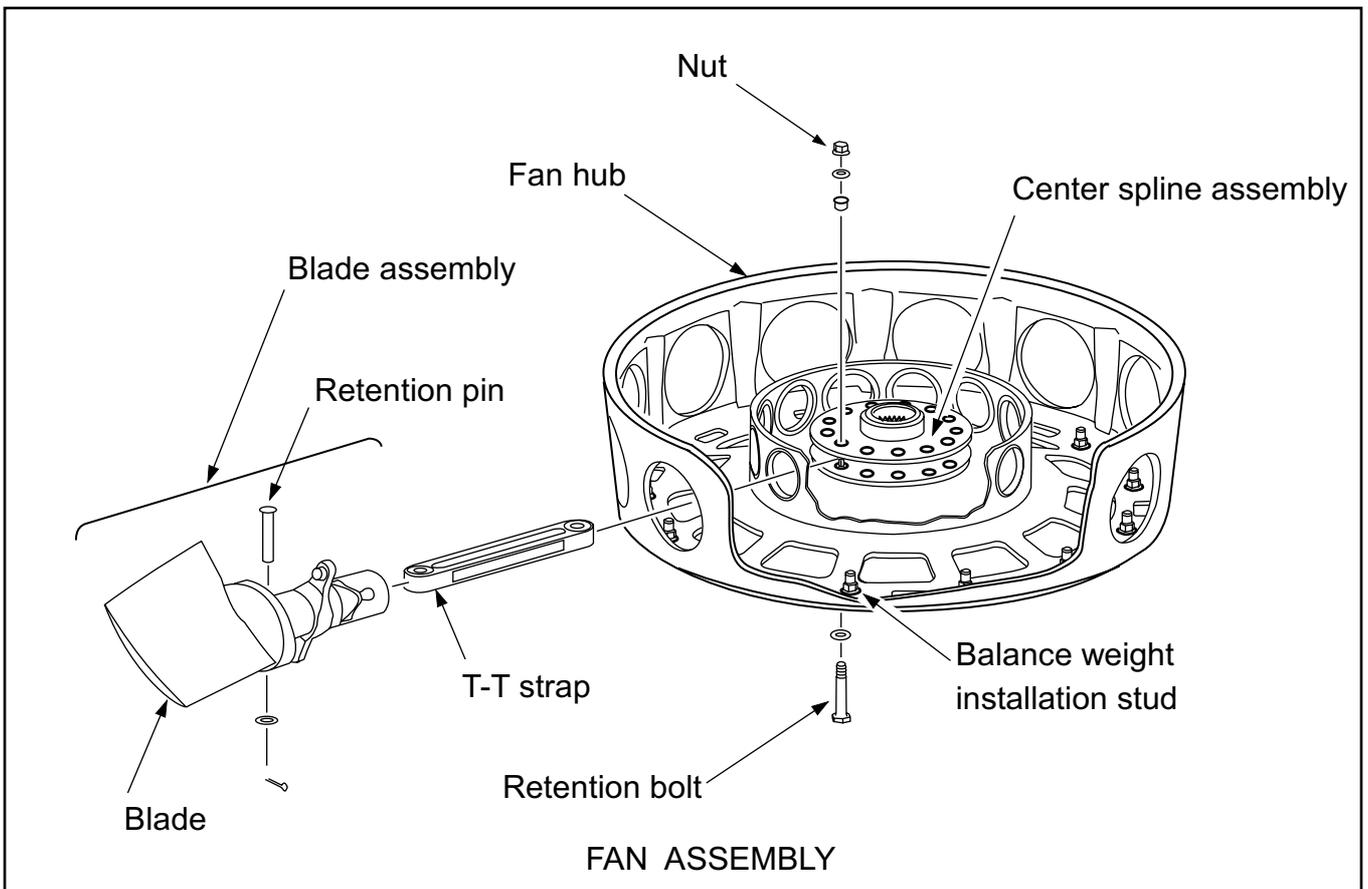
Figure 5 NOTAR fan assembly

assembly was fractured. Remaining fan blades were all damaged. (6) NOTAR fan drive shaft: It was fractured into three portions. The flexible coupling at the transmission side was broken and anti-flail device built in the coupling to be mentioned in 2.12.3, was detached. Driveshaft-side part of the broken flexible coupling had no scratch marks on it. (7) Fuel line: Fuel line to No.2 engine was fractured at frangible valve on the engine deck. No fuel leak from the fuel tanks was found. (See Figure 5, Pictures 2, 3 and 4)
