**AIRCRAFT ACCIDENT  
INVESTIGATION REPORT**

**J A 6 7 9 6**

**Japan Transport Safety Board**

**JAPAN COAST GUARD  
BELL 412 EP (ROTORCRAFT), JA6796  
NEAR SANAGIJIMA, TADOTSU- CHO, NAKATADO- GUN,  
KAGAWA PREFECTURE, JAPAN  
AROUND 15:10 JST, AUGUST 18, 2010**

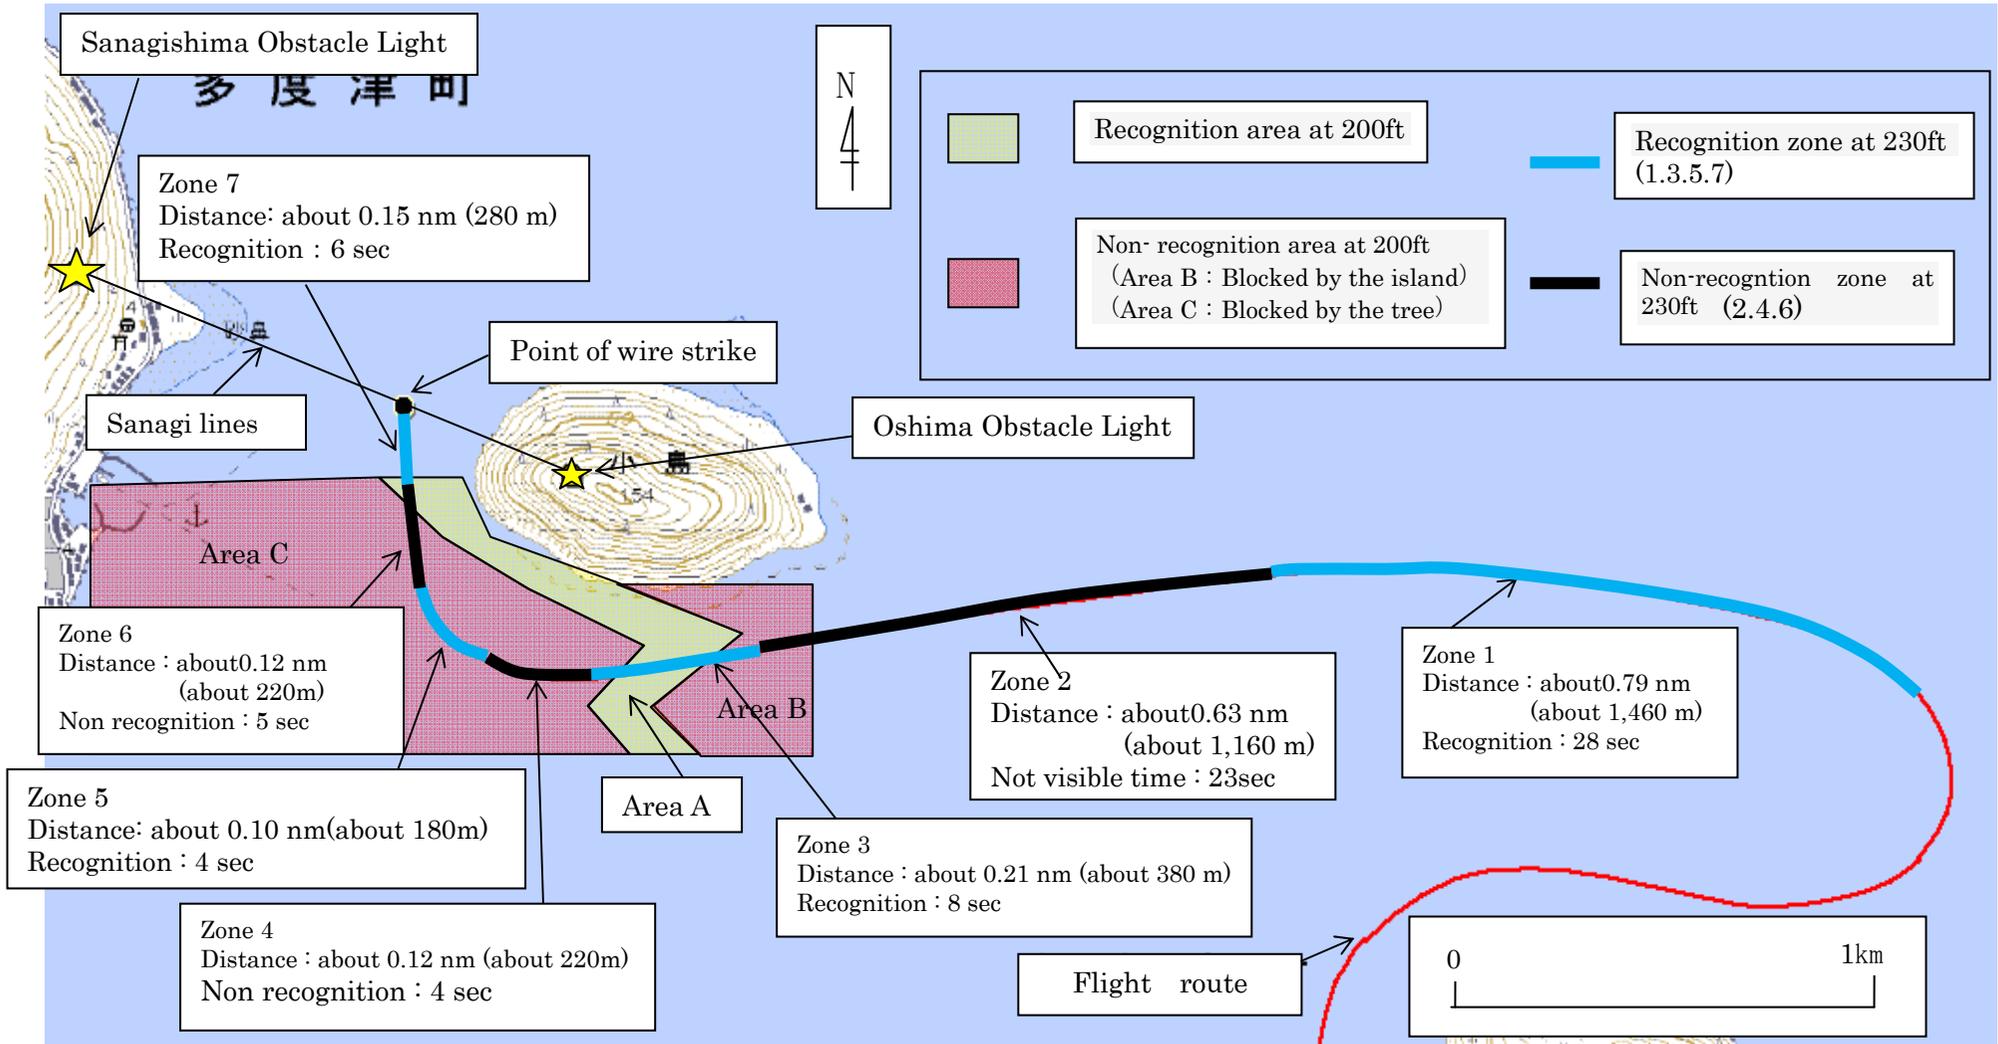
Figure 6 Airspace Layout on Visual Recognition of Sanagijima Obstacle Light

As a result of the visual detection test as described in 2.13 (3), the Sanagijima Obstacle Light could be visually detected in Zone 1, Zone 3, Zone 5 and Zone 7. In addition, as indicated by meteorological observations described in 2.7.2, there was no big difference between the meteorological conditions on the day of testing and those at the time of the accident, in terms of the wind direction, the wind velocity and other factors. Moreover, as described in 3.5, it is highly probable that the obstacle lights on Oshima and Sanagijima were normally functioning at the time of the accident. Based on the findings above, it is probable that the PIC and the Co-pilot could visually confirm Sanagijima Obstacle Light from the same zones as mentioned in the results of the visual detection test.

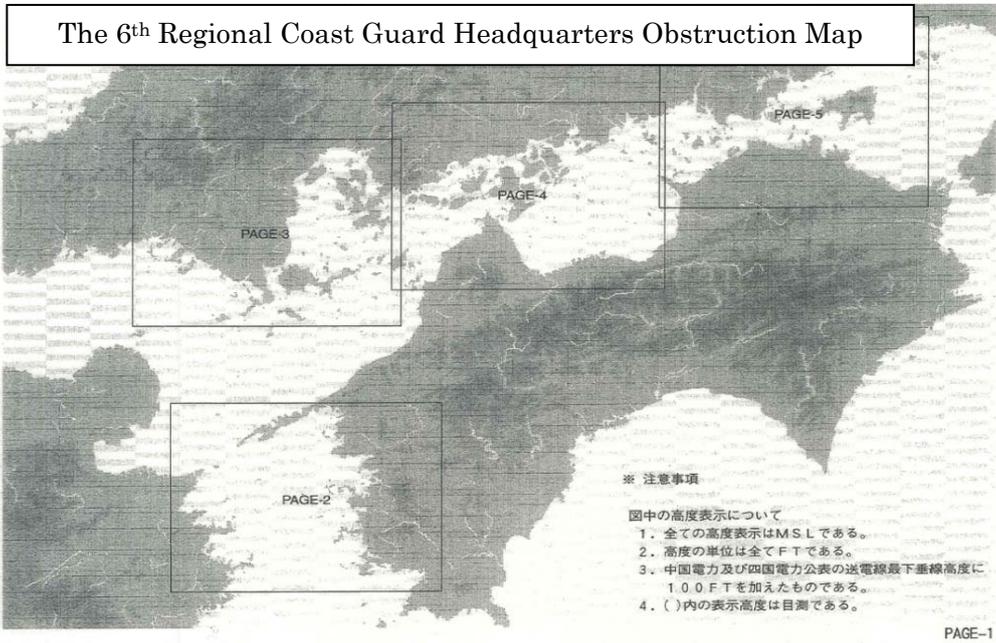
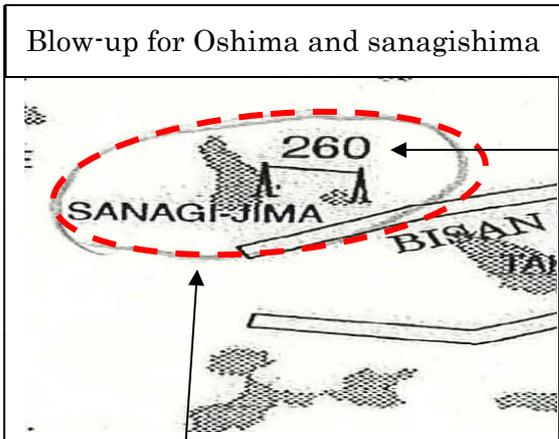
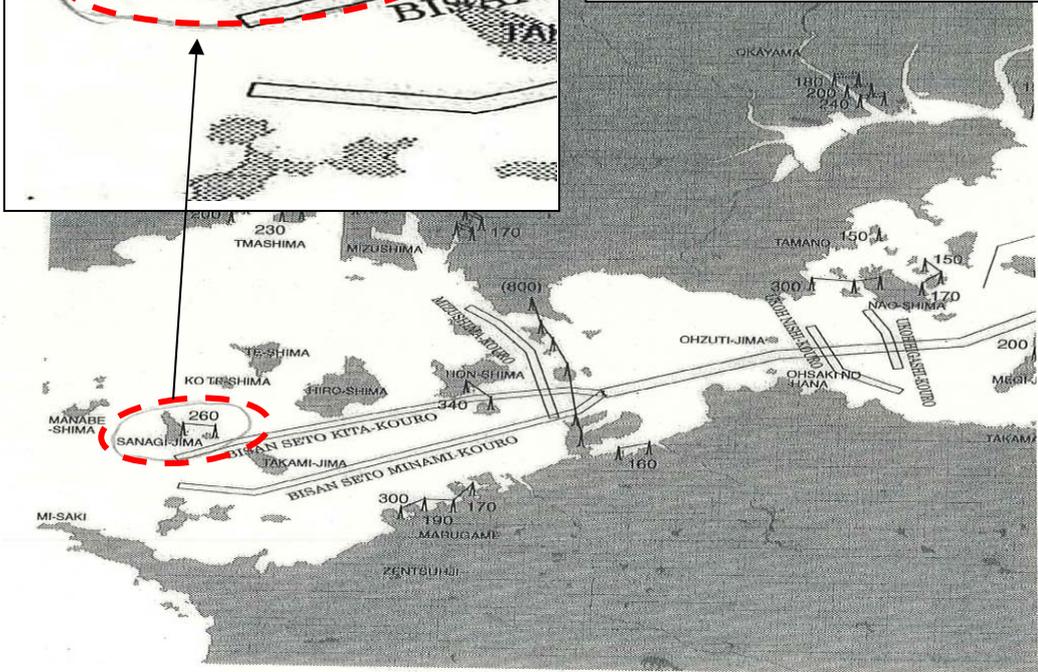
# Figure 7 Obstruction Map

260 ft is not the top elevation of a transmission tower. It includes added 100 ft to the elevation of Lowest Power Line Height.

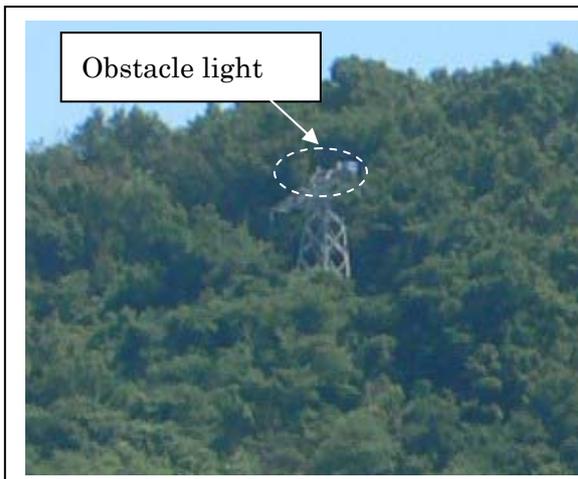
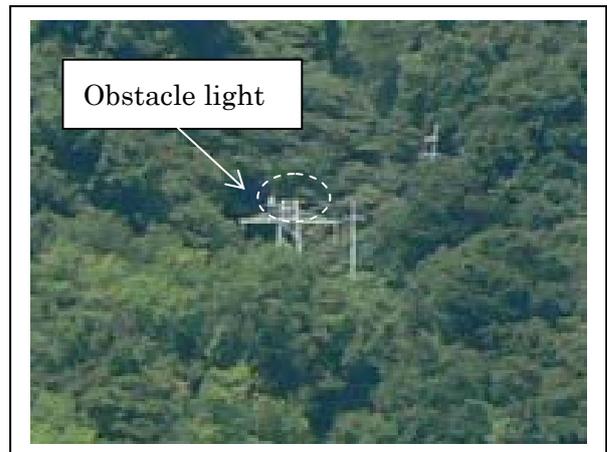
Photo 8 Towers and Obstacle Lights on Oshima and Sanagijima

The Electric Power Company explained that the cause for the field of view problem has been removed because the trees responsible for hampering the field of view of the obstacle lights on Oshima and Sanagijima have been cut down for recurrence prevention in November 2 and 3, 2010. The Electric Power Company intends to take enforced individual management of obstacle lights.
