**AIRCRAFT ACCIDENT
INVESTIGATION REPORT**

November 30, 2017

**AERO ASAHI CORPORATION
KAWASAKI BK117C-2 (ROTORCRAFT)
JA6917
DAMAGE TO THE AIRCRAFT DUE TO HARD LANDING
TEMPORARY HELIPAD
HADANO CITY, KANAGAWA PREFECTURE, JAPAN
AT AROUND 14:04 JST, AUGUST 8, 2016**

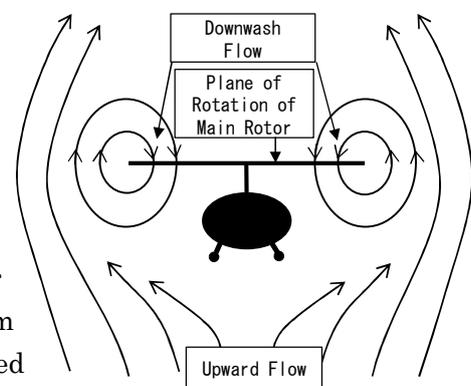
Figure 3 VRS Diagram

As a rotorcraft is increasing its descent rate while flying at low speed, at the time for a downwash flow from main rotor to equal the descent rate of the rotorcraft, the downwash flow from the main rotor goes around an outer circumference of the main rotor from bottom to top and becomes the state called Vortex Ring State (hereinafter referred to as "VRS").

Because even though pulling CP up at this situation, most of engine output is used not to generate lift, but used only to accelerate donut shaped vortex generated at the tip of rotor, the lift is not increased, on the contrary, only descent rate increases by descending through own down washed flow. (Figure 3)

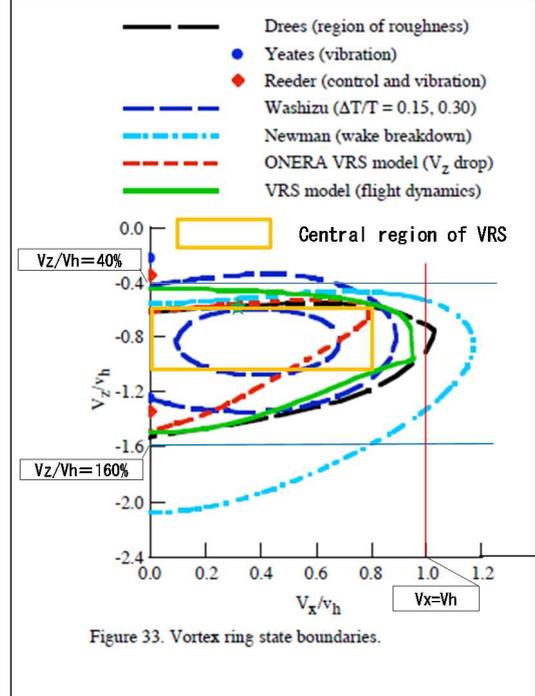
Figure 4 VRS boundaries

Figure 4 is the figure of Vortex Ring State boundaries included in STI (Scientific Technical Information) Report by National Aeronautics and Space Administration (NASA) and expresses an occurrence condition in diagram. Looking at the numerical values which are almost common to each model illustrated in this figure, from the position ($V_z/V_h = -0.4$), VRS starts to develop at where V_x/V_h is 1.0 or less and vertical descent velocity (V_z) is near
