**AIRCRAFT SERIOUS INCIDENT
INVESTIGATION REPORT**

**JAPAN AIRLINES CO., LTD.
J A 8 2 9 9**

BOEING 767-300, JA8299

ATTEMPTED LANDING ON RUNWAY

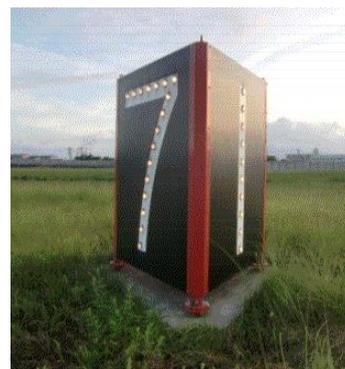
Photo 1 Runway Distance Marker Lights

The Aerodrome has one runway with a length of 2,500 m, a width of 45 m, and an orientation of 11 / 29, with a total of 14 runway distance marker lights located on both sides of the runway at equal intervals of about 1,000ft (about 305m) inside the landing area*⁸ (outside the runway) parallel to the runway centerline and about 50m away from said centerline. The lights are configured to display distances in units of 1,000 ft using about 10-20 light bulbs for each numeral. Runway distance marker lights are useful equipment for pilots when ascertaining the remaining length of the runway, but a malfunction of these fixtures will not compromise the operation of aircraft.

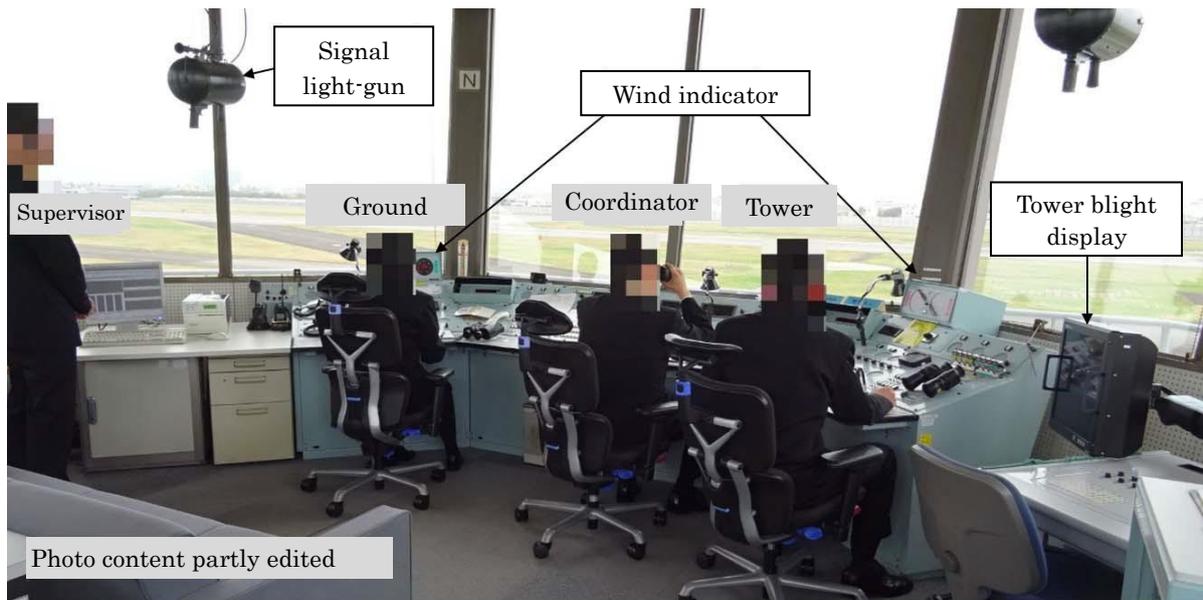
Photo 2 Standard layout of the Aerodrome control tower

When workers had entered the runway and the need arose to have them evacuate in an emergency, and also when the transceiver could not be used due to trouble and others, the method of using the signal light-gun (see Photo 2) to emit a red flashing light, or blinking the runway lights, was adopted as a method of transmitting instructions from the Tower.

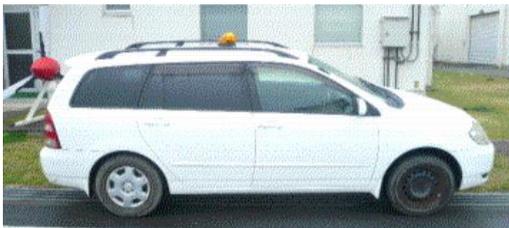
Photo 4 The Work Vehicle

Vehicles used for electric maintenance work were owned by a contractor entrusted with this work and permanently stationed in the Aerodrome. These had been cleared for use inside the Aerodrome.
