**AIRCRAFT ACCIDENT
INVESTIGATION REPORT**

AIR NIPPON CO., LTD.

J A 8 3 8 4

AIR NIPPON CO., LTD.
AIRBUS INDUSTRY A320-200, JA8384
DAMAGE DUE TO TAILSTRIKE
ON THE RUNWAY 27 OF SENDAI AIRPORT, JAPAN
AT ABOUT 09:03 JST, FEBRUARY 5, 2012

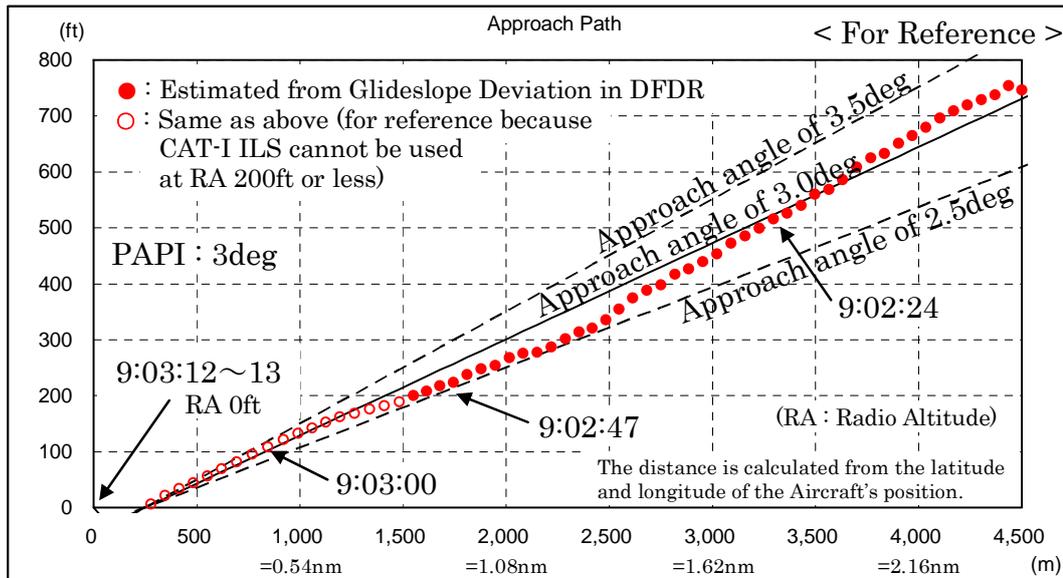
Figure B : Estimated Final Approach Angle
(For Reference because the Aircraft made a Visual Approach.)

- 9:01:47 The radio altitude for the Aircraft was 1,000 ft.
- 9:02:24 The radio altitude was lowered to 500 ft, prompting the first officer to call, “Five hundred.” The captain replied, “Stabilized.”
- Around 9:02:35-50 The Aircraft’s approach angle declined temporarily.

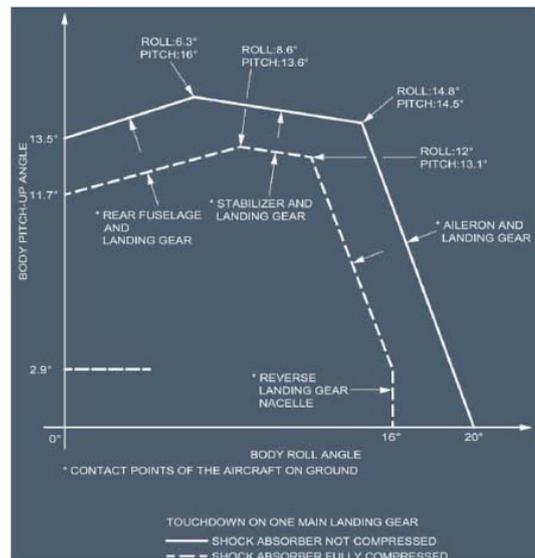
If the main landing gears touch the ground with the body’s roll angle at zero degree, the rear fuselage is in contact with the runway:

- When the pitch-up angle is 11.7 degrees if

- the shock absorber is compressed completely, and
- When the pitch-up angle is 13.5 degrees if the shock absorber is not compressed.

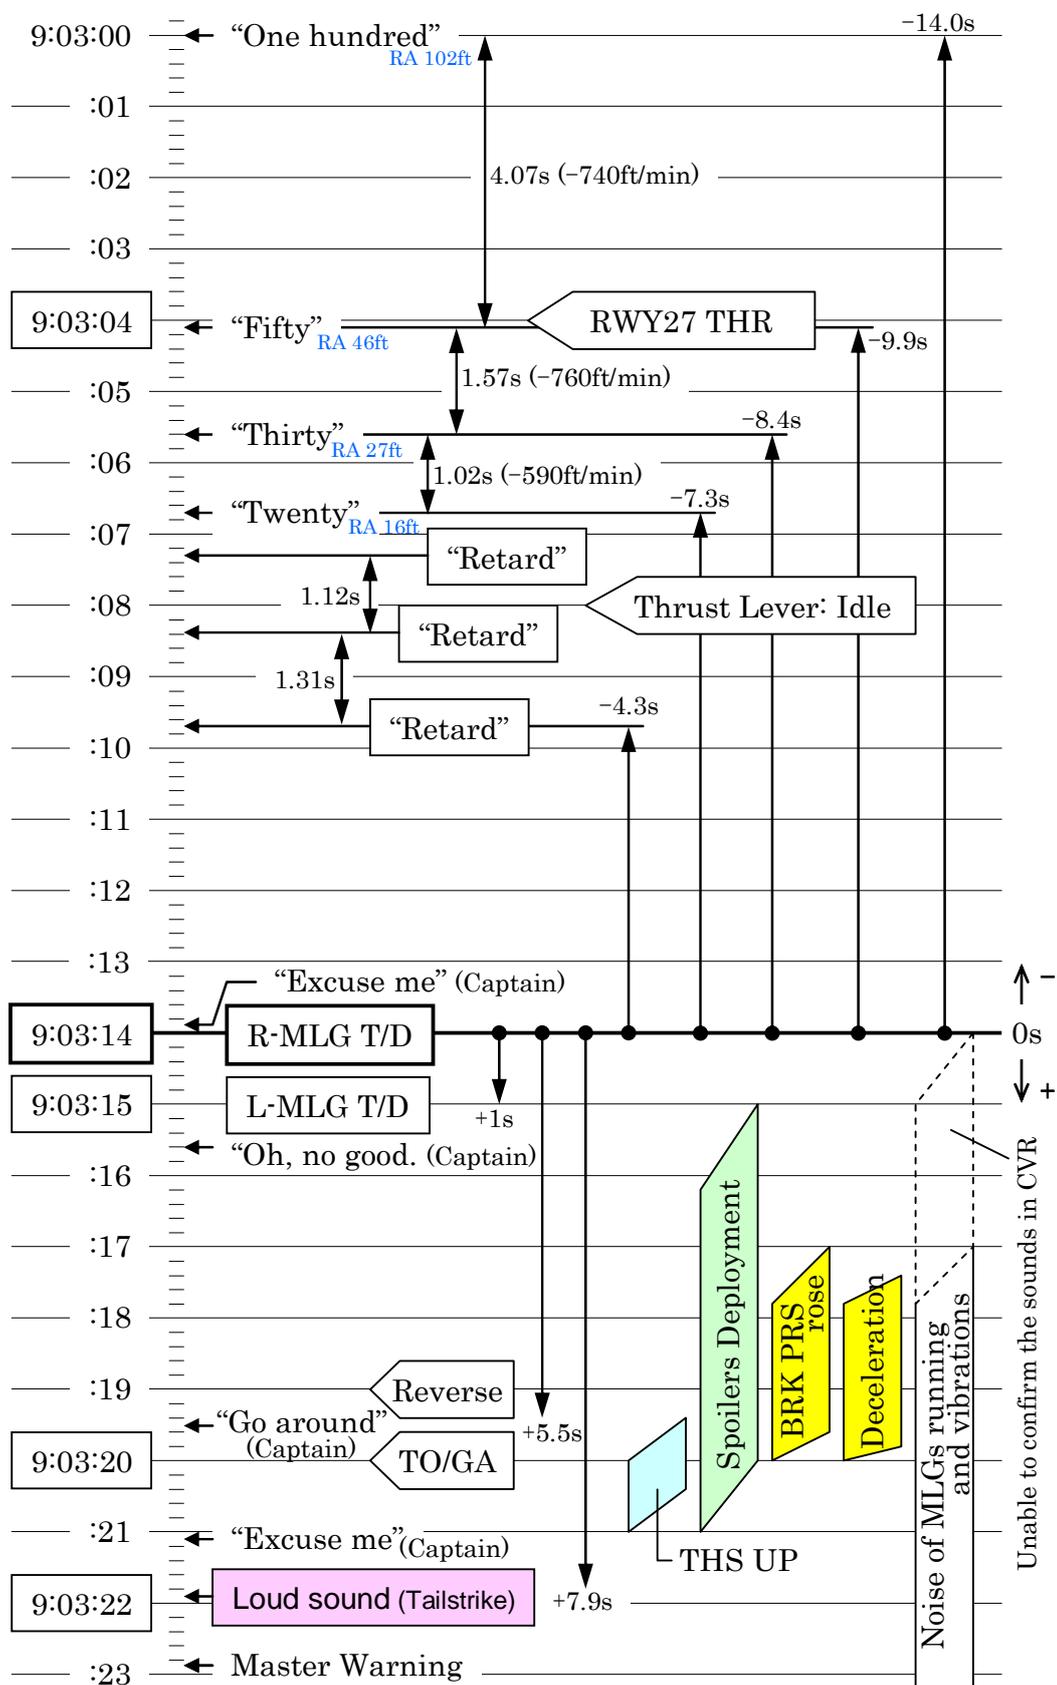
Figure 3: Condition of Touchdown based on DFDR/CVR

At that time, the pitch angle of the Aircraft sharply increased from +1.8 degrees to +12.7 degrees in 2.25 seconds. This means that the nose was raised at an average rate of about 4.4 degrees per second (momentarily up to about 8.4 degrees per second), sharper than the rate of about three degrees per second recommended at takeoff as described in FOBN in 2.9.6 (2) and AOR in 2.9.8. (meaning that the nose was raised very sharply). Based on the statements of the cockpit crew included in 2.1.2, however, it is highly probable that neither the captain nor the first officer recognized during the go-around operation that the nose of the Aircraft went up substantially.

In this accident, it is highly probable that when the Aircraft rejected the landing after touching Runway 27, its nose was raised sharply, causing the lower part of the rear fuselage to contact with the runway and be damaged.
