**AIRCRAFT SERIOUS INCIDENT  
INVESTIGATION REPORT**

**ALL NIPPON AIRWAYS CO., LTD.  
JA85AN**

MULTIPLE MALFUNCTIONS IN ONE OR MORE SYSTEMS  
EQUIPPED ON AIRCRAFT IMPEDING  
THE SAFE FLIGHT OF AIRCRAFT  
TOKYO INTERNATIONAL AIRPORT  
AT AROUND 08:22 JST, MAY 27, 2016

ALL NIPPON AIRWAYS CO., LTD.  
BOEING 737-800, JA85AN

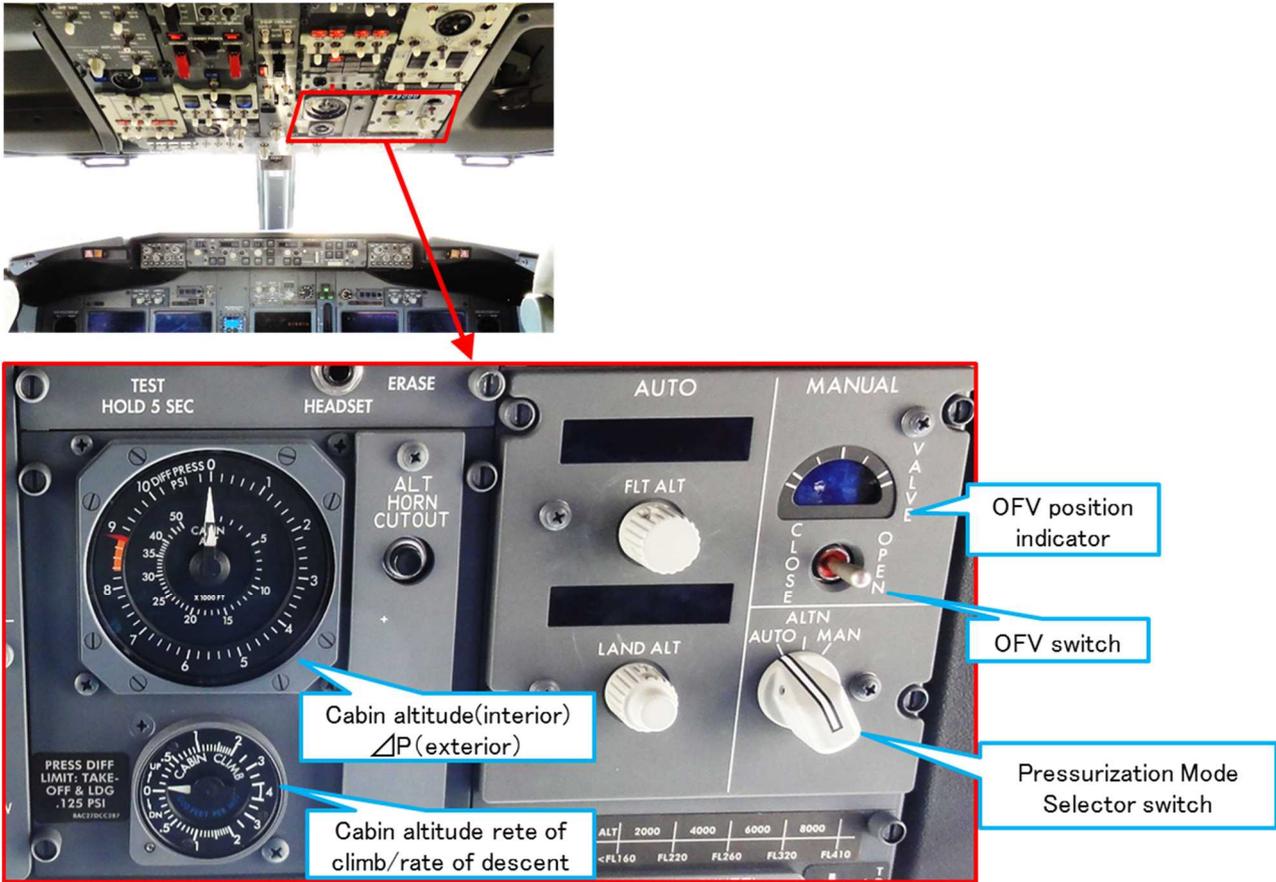
Figure 3 Cockpit Panels Relating to Cabin Altitude and Pressurization Mode Operation

It is probable that, until the warning device activated, there were no warnings to notify the flight crewmembers of the abnormal pressure, and that flight crewmembers could not know about the abnormal pressure without reading the abnormal cabin altitude on the Cabin Altitude Panel (see Figure 3).

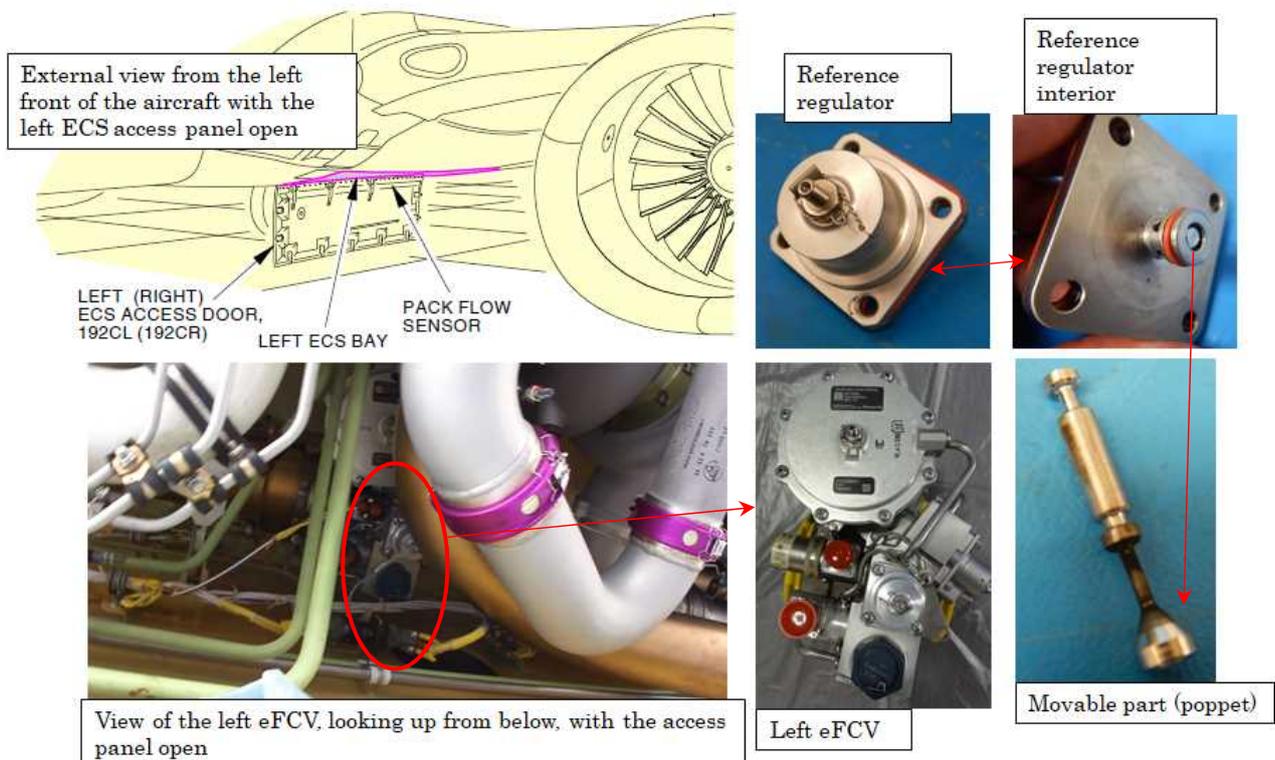
Figure 5 Left eFCV Equipment Positions

As is shown in Figure 5, eFCVs are installed in the left and right Environmental Control System (ECS) bays located in the bottom center of the fuselage. The reference regulator is located on the bottom of its eFCV.

Teardown inspection	Visual inspection	When the reference regulator was disassembled and visually inspected, black grime was found along the air passage. Additionally, a small number of abrasions were found on the movable part within the reference regulator.
	Material (composition) analysis	When particles attached to the movable part within the reference regulator were analyzed, atmospheric dust and other constituents were detected.

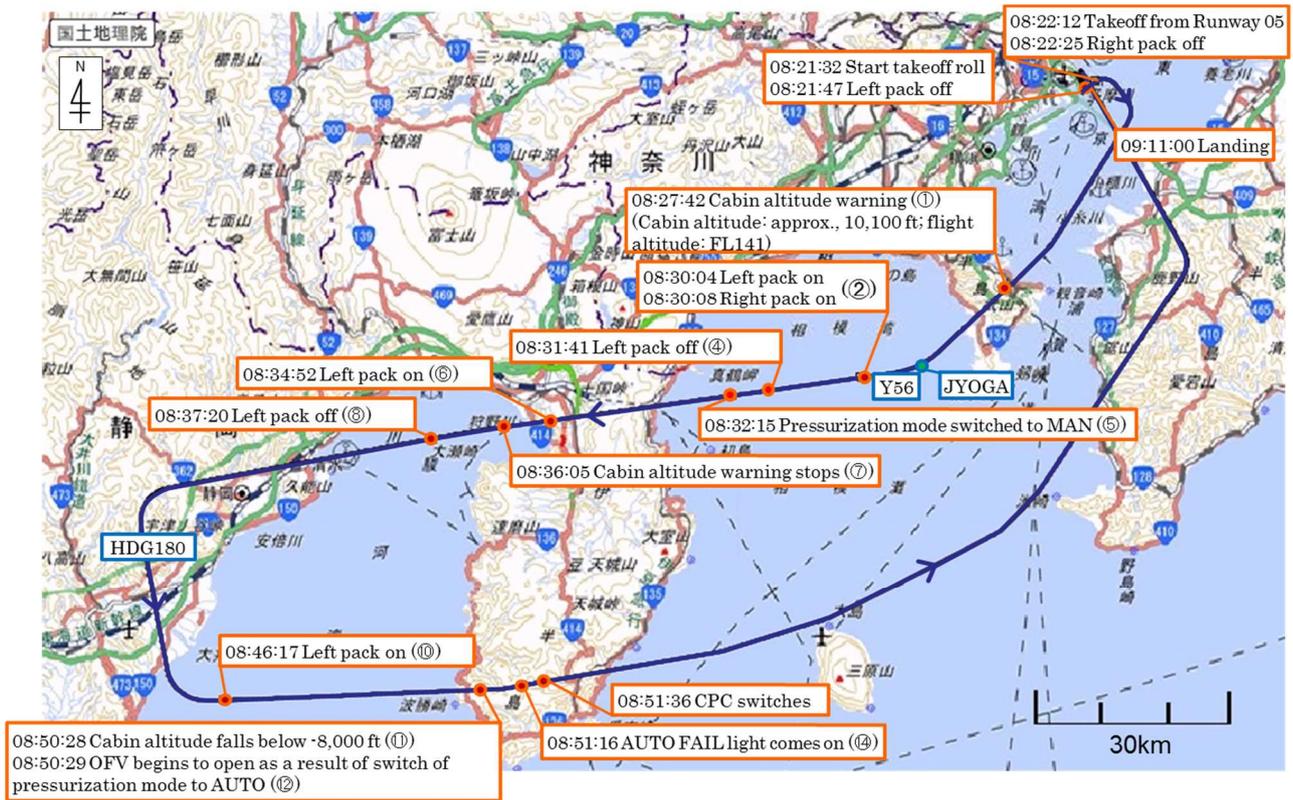
Attached Figure 1 Estimated Flight Path

Items ①, ②, ④ to ⑧, ⑩ to ⑫, and ⑬ correspond to the items mentioned in 2.1.1 and 3.7 of the main text.
