**AIRCRAFT SERIOUS INCIDENT
INVESTIGATION REPORT**

NAKANIHON AIR SERVICE CO., LTD.
AÉROSPATIALE AS332L (ROTORCRAFT)
JA9660

DROPPING OF OBJECTS
DURING EXTERNAL CARGO SLING OPERATION
TAKAHAMA TOWN, OI GUN, FUKUI PREFECTURE, JAPAN
BETWEEN 10:35 AND 10:40 JST, OCTOBER 8, 2015

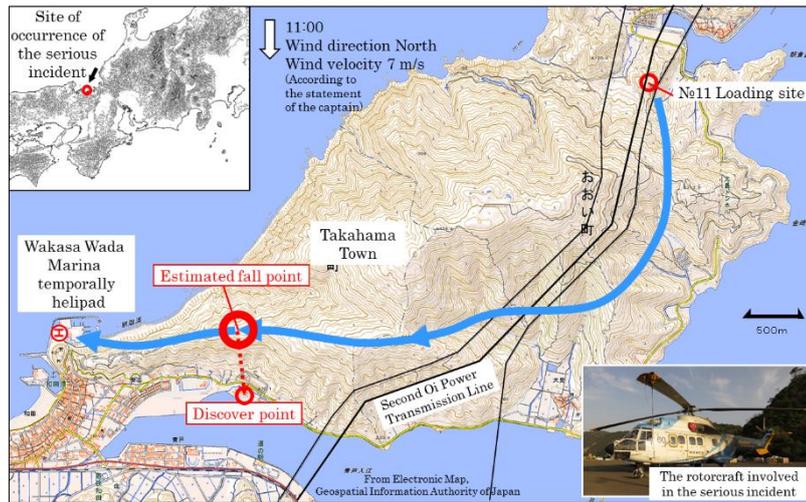
Fig. 1 Estimated flight route

The serious incident occurred at the time between 10:35 and 10:40, at the point with an altitude of about 1,500 ft, about 1.4 km east of the temporarily helipad (35°29'55"N, 135°35'35"E).
