**AIRCRAFT ACCIDENT  
INVESTIGATION REPORT**

**KOREA PILOT SCHOOL  
N 1 7 6 C D**

AIRCRAFT DAMAGE CAUSED BY FORCED LANDING  
KOREA PILOT SCHOOL  
OPERATED BY PRIVATELY CONTRACTED PILOT  
CIRRUS SR20, N176 CD (THE UNITED STATES)  
NISHIKATA, IBUSUKI CITY, KAGOSHIMA PREFECTURE, JAPAN  
At ABOUT 14:30 JST, OCTOBER 12, 2014

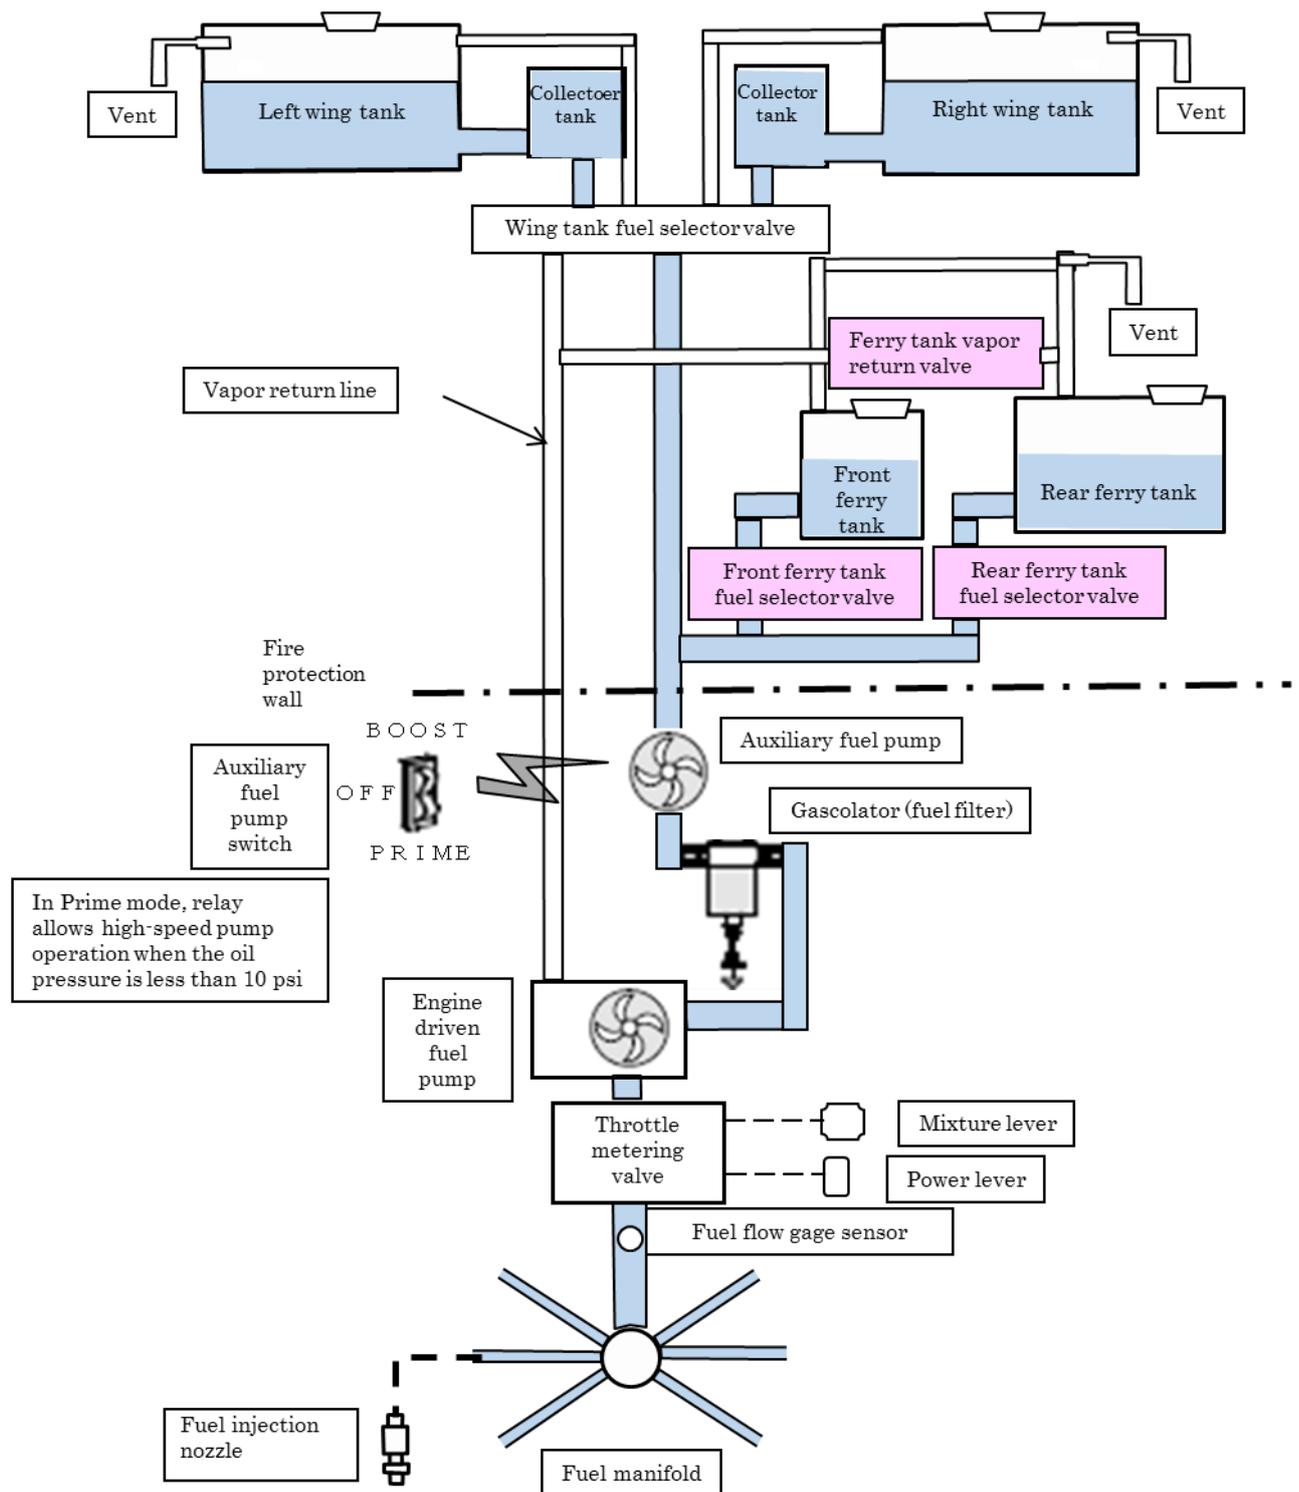
Diagram 1 The Fuel System

The front ferry tank and the rear ferry tank are placed higher than the engine. Each tank is equipped with a fuel selector valve that have OPEN and CLOSE positions, moreover, a vapour return valve with OPEN and CLOSE position is located in one section of the rear ferry tank.

In order to use the ferry tank, in accordance with the ferry fuel system operations instructions as described in 2.11.1.1 b, the fuel selector valve of the front or rear ferry tank has to be in OPEN position, the vapour return valve have to be in OPEN position and the wing tank selector valve which is the fuel system of the aircraft has to be in CLOSE position. Besides, when closing the ferry tank and returning to the aircraft fuel system, the wing tank fuel selector valve has to be positioned in RIGHT or LEFT, and the vapour return valve of the ferry tank has to be in CLOSE, and the fuel selector valves of the front and rear tank have to be in the CLOSE position.

Moreover, when switching within the ferry tanks in the system aspect, for example when switching from the rear ferry tank to the front ferry tank, first the auxiliary fuel pump has to be ON, and the front ferry tank fuel selector valve has to be OPEN, then the rear ferry tank fuel selector valve has to be in CLOSE position, finally if there are no abnormalities then the auxiliary fuel pump is to be tuned OFF. As described in 2.11.1.1.b, this procedure is not written in the operation instructions, or other documents. And as described in 2.1.2 only been explained orally. However according to the Pilot, he had understood this procedure.

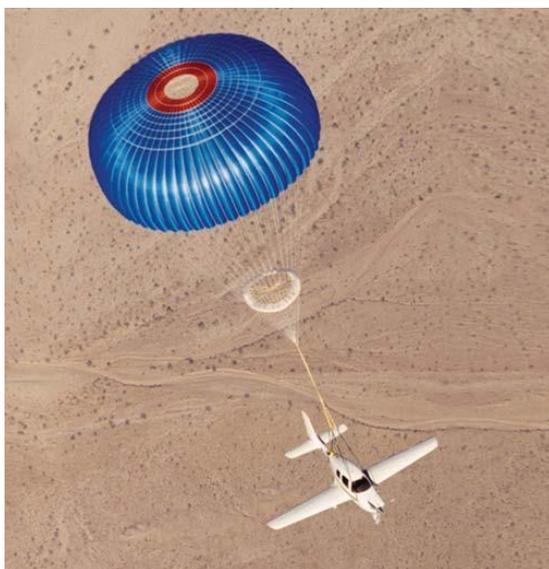
Photo F Emergency Parachute System

Under these circumstances, it is probable that the Aircraft which could not maintain an altitude would not be able to carry out an instrument approach such as GCA vectored by the Kanoya Radar. In such condition, it is probable that the Aircraft was able to accomplish a forced landing in a limited space, and although the aircraft was damaged, no crews was injured because the emergency parachute system had functioned effectively.
