AIRCRAFT ACCIDENT INVESTIGATION REPORT

FEDERAL EXPRESS CORPORATION

N 5 2 6 F E

**CRASH DURING LANDING
FEDERAL EXPRESS CORPORATION
MCDONNELL DOUGLAS MD-11F, N526FE
NARITA INTERNATIONAL AIRPORT
MARCH 23, 2009**

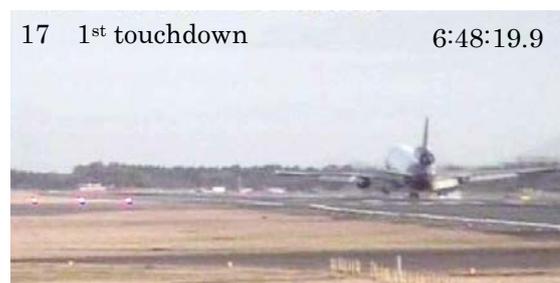
17 1st touchdown 6:48:19.9

airplane touched down on the right MLG at 06:48:20. A Camera Image showed white smoke spewing out from the right MLG tire. The CAS at the time of the touchdown was 166.0 kt (just after this, the CAS increased to 169.0 kt). The heading was 333° with the roll angle of 0.4°. The vertical acceleration recorded was 1.63 G (the G sensor was installed near the CG point). The Camera Images showed that airplane was relatively stable with no sign of being tossed about by the winds. The Broadcast Image showed that the first touchdown was made near the runway threshold where a 60-meter-long runway aiming point marking is located.

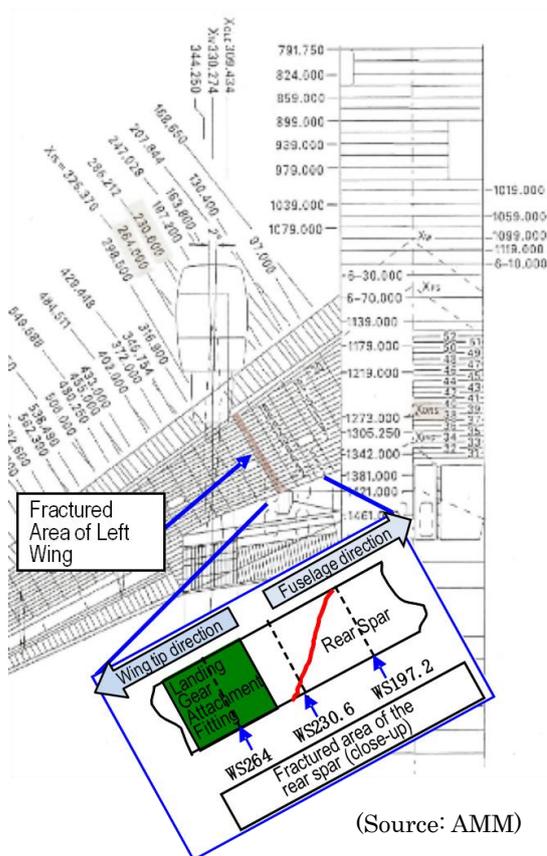
Figure 2 Fracture Surface of Left Wing

The fire consumed the wing root section, leading edge along with the inboard slats near the wing attachment point to the fuselage, leaving leading edge and slats. The trailing edge surface was sooted, but the fractured area of the rear spar had retained its original shape. The double-plated rear spar, which consisted of the same thickness plate, was fractured almost at the same place. The fracture formed a diagonal line linking the lower end near WS*³230.6 and the upper end near WS197.2. Bends and cracks perpendicular to the fracture line were observed at the mid section and the stringer at the base of the spar had span-wise cracks. The outer skin in the area involved exhibited no vertical bending. (See Photo 3 and Figure 2)

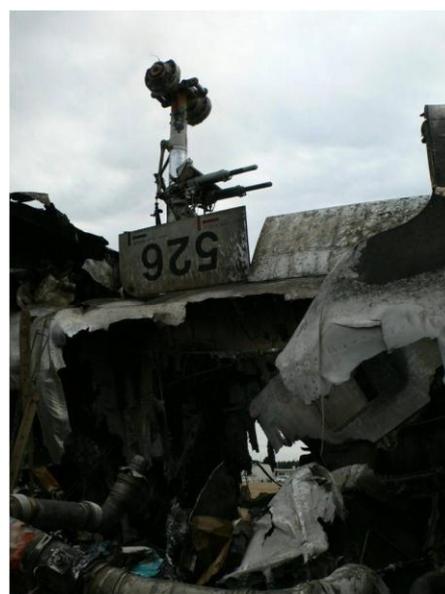
Photo 9 Nose Landing Gear

The NLG remained attached to the fuselage. The wheel rims were broken, and the broken rims, tires and the wheel caps were detached. The right wheel was able to rotate by hand; on the contrary, the left wheel was unable. Part of the left wheel hub outer surface was grinded and some tie bolts were lost or loosened. The strut torque link was fully extended. The NLG support in the NLG wheel well exhibited no sign of structural damage, except cracks in the web near the NLG support.

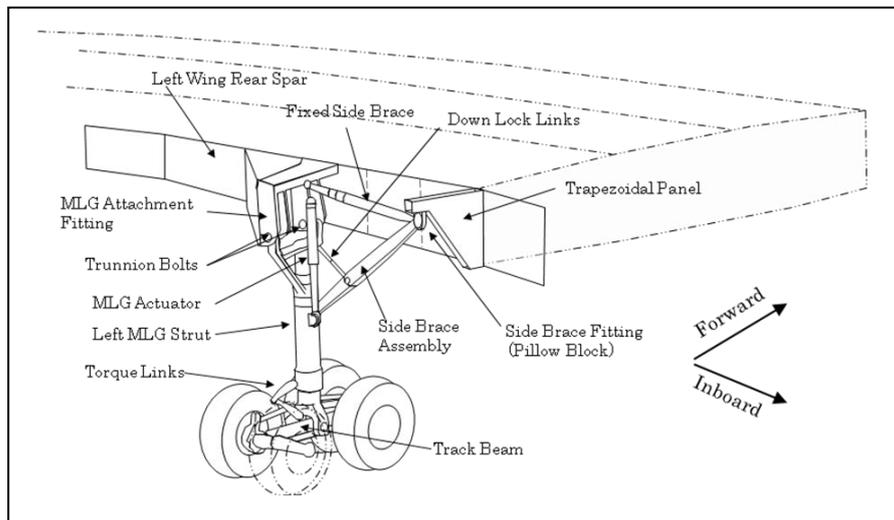
Figure 3 Left MLG-to-Wing Attachment

attached to the MLG. The forward trunnion bolt (fuse pin) was slightly deformed, however, it did not fail. About the two bolts which were attached to the side brace fitting (pillow block) and the trapezoid panel, the inboard bolt was broken leaving part of it in the panel, while the outboard bolt was removed from the pillow block out of the broken bolt hole, remained in the pillow block with the landing gear. A

lug, which is connected to the lower end of the landing gear, was torn apart. The sooted left MLG strut was fully extended with no apparent damage. The surface of the four wheels and tires were all burned and sooted. There were slight traces of scratch on the two outer wheels. No. 5 and No. 6 tires were deflated without any indications of burst. The torque link was undamaged. The MLG attachment fitting had no damage, but in the lower part of fitting, there was dent caused by the strut. (See Photos 9, 10 and 11, Figure 3)

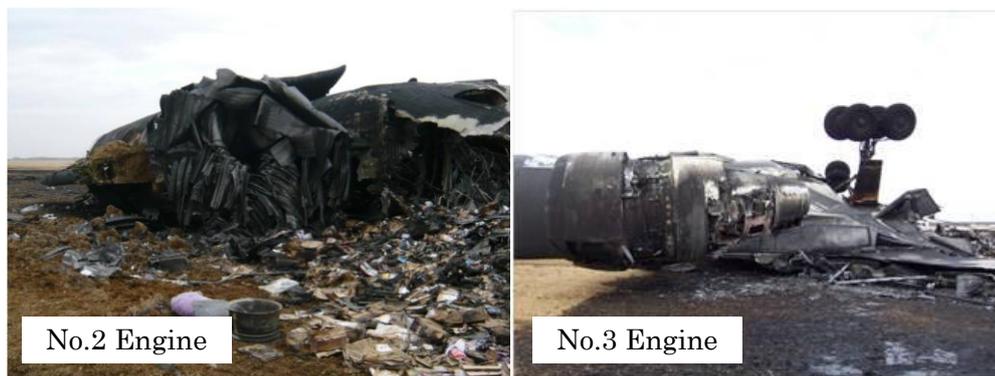
Photo 14 No.2 and No.3 Engine

position. There was no indication of in-flight engine fire.

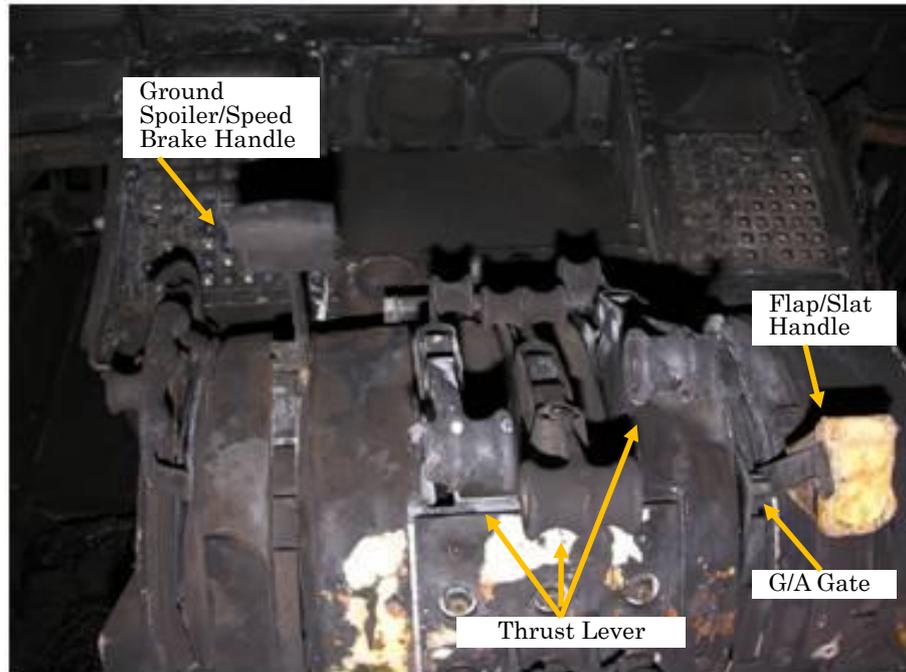
Photo 16 Center Pedestal

The flap/slat handle was in 28° G/A (go-around) gate. The No. 1 thrust lever was in the mid-forward position, the No. 2 lever in the backward (pulled) position and the No. 3 lever in the forward (pushed) position. All reverse levers were in the retracted (not for use) position, while the ground spoiler/speed brake handle was in the retracted position. The engine fire handle on the overhead panel was in the UP position.

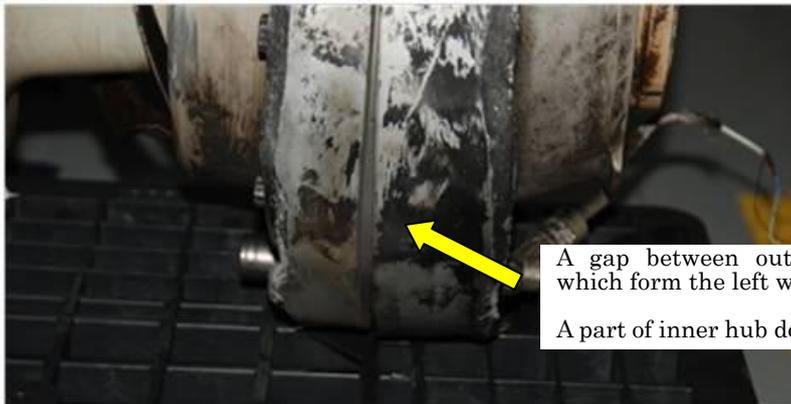
A gap between outer and inner hubs which form the left wheel

A part of inner hub deformed to the inside

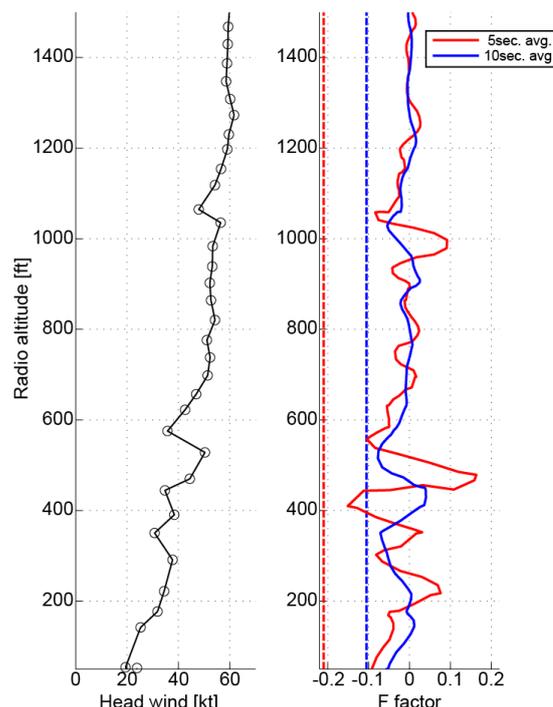
Figure 6 Evaluation of Operation of Windshear Warning Device

According to the DFDR records, a head wind component of the horizontal winds which the airplane encountered below 1,500 ft RA were about 60 kt at 1,000 ft or above, about 50 kt from 1,000 ft to 500 ft, and about 25 kt near the ground, meaning that there were the wind velocity difference of about 25 kt between the ground and 500 ft or more. (Figure 6) The onboard windshear warning device was functional and didn't activate the windshear warning.

According to FAA TSO-C117a, which prescribes the minimum performance standards for the windshear warning systems, the system generate an alert when the F Factor*7 exceeds the threshold value (-0.21 on a 5 second average and -0.105 on a 10 second average). The F Factor (Figure 6), estimated with the DFDR records, was below the thresholds both on a 5 second average (red broken line in Figure 6) and a 10 second average (blue broken line in Figure 6).

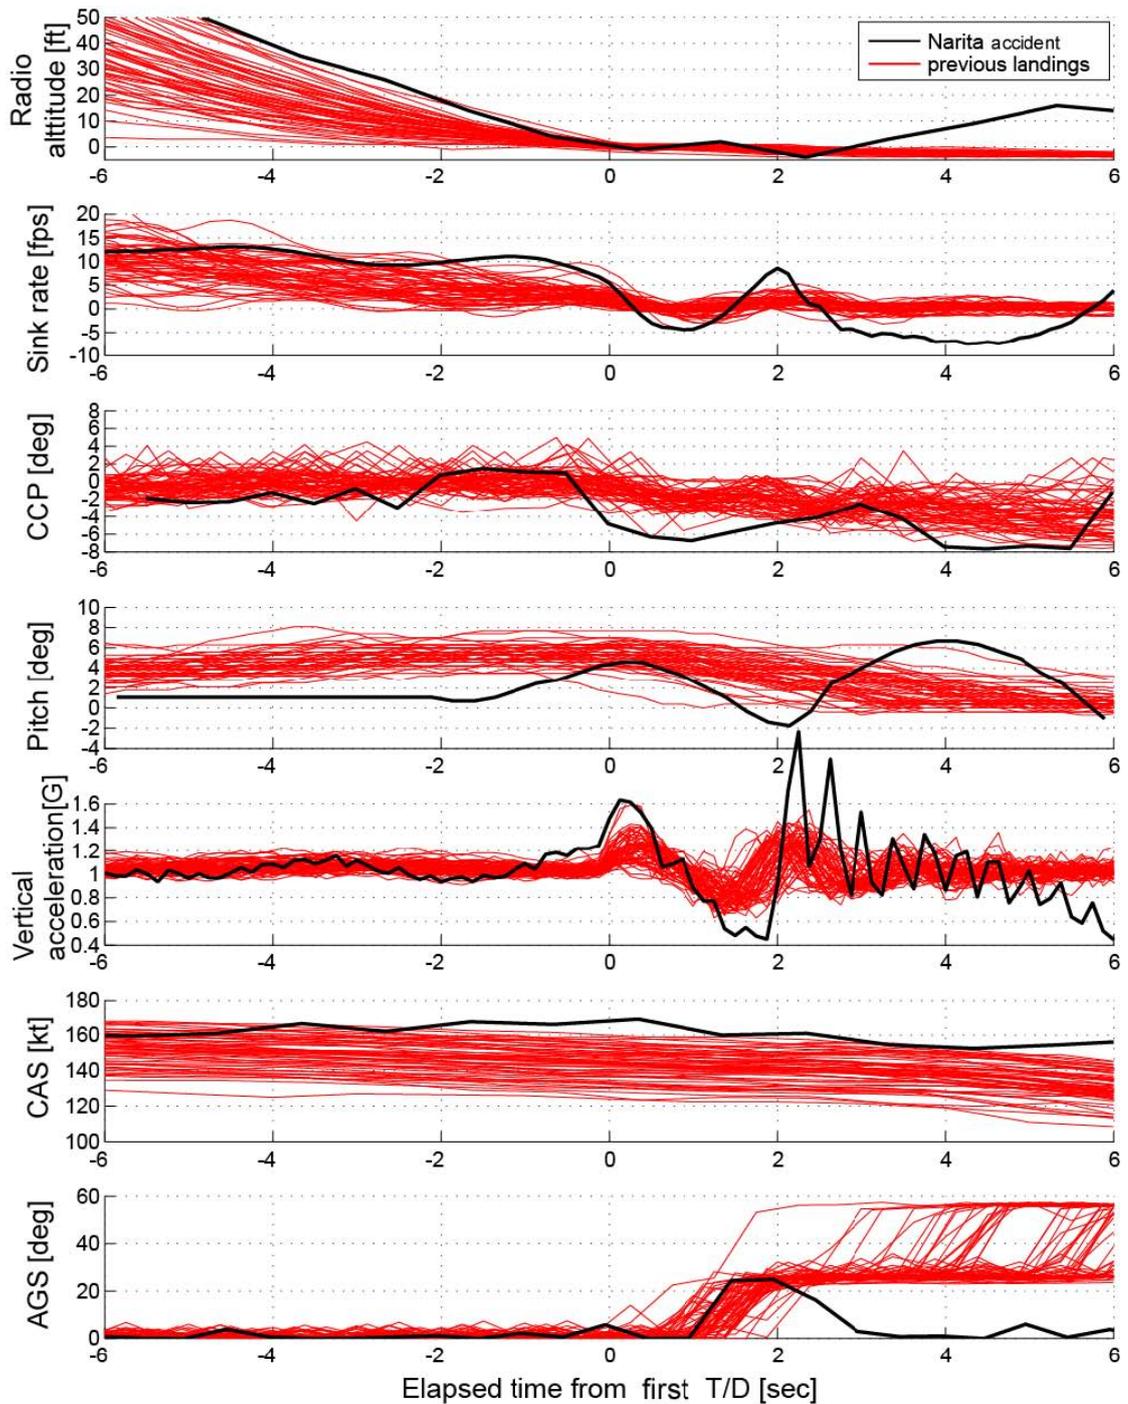
Figure 7 Comparison of the Accident Landing with Previous 60 landings

- a. The descent angle and the sink rate are large until touchdown. The sink rate at 50 ft RA was about 13 fps and the sink rate at touchdown was about 7 fps.
- b. The control column input just before and during the touchdown is large. The control column was pulled backward about 2 seconds before touchdown, held there and pushed forward with large stroke just before the touchdown.
- c. Pitch attitude variation just before and during the touchdown are large. The airplane approached with the smallest pitch angle until flare and the pitch angle increased rapidly just before the touchdown. Then, the pitch angle decreased rapidly to negative when it made the second touchdown.

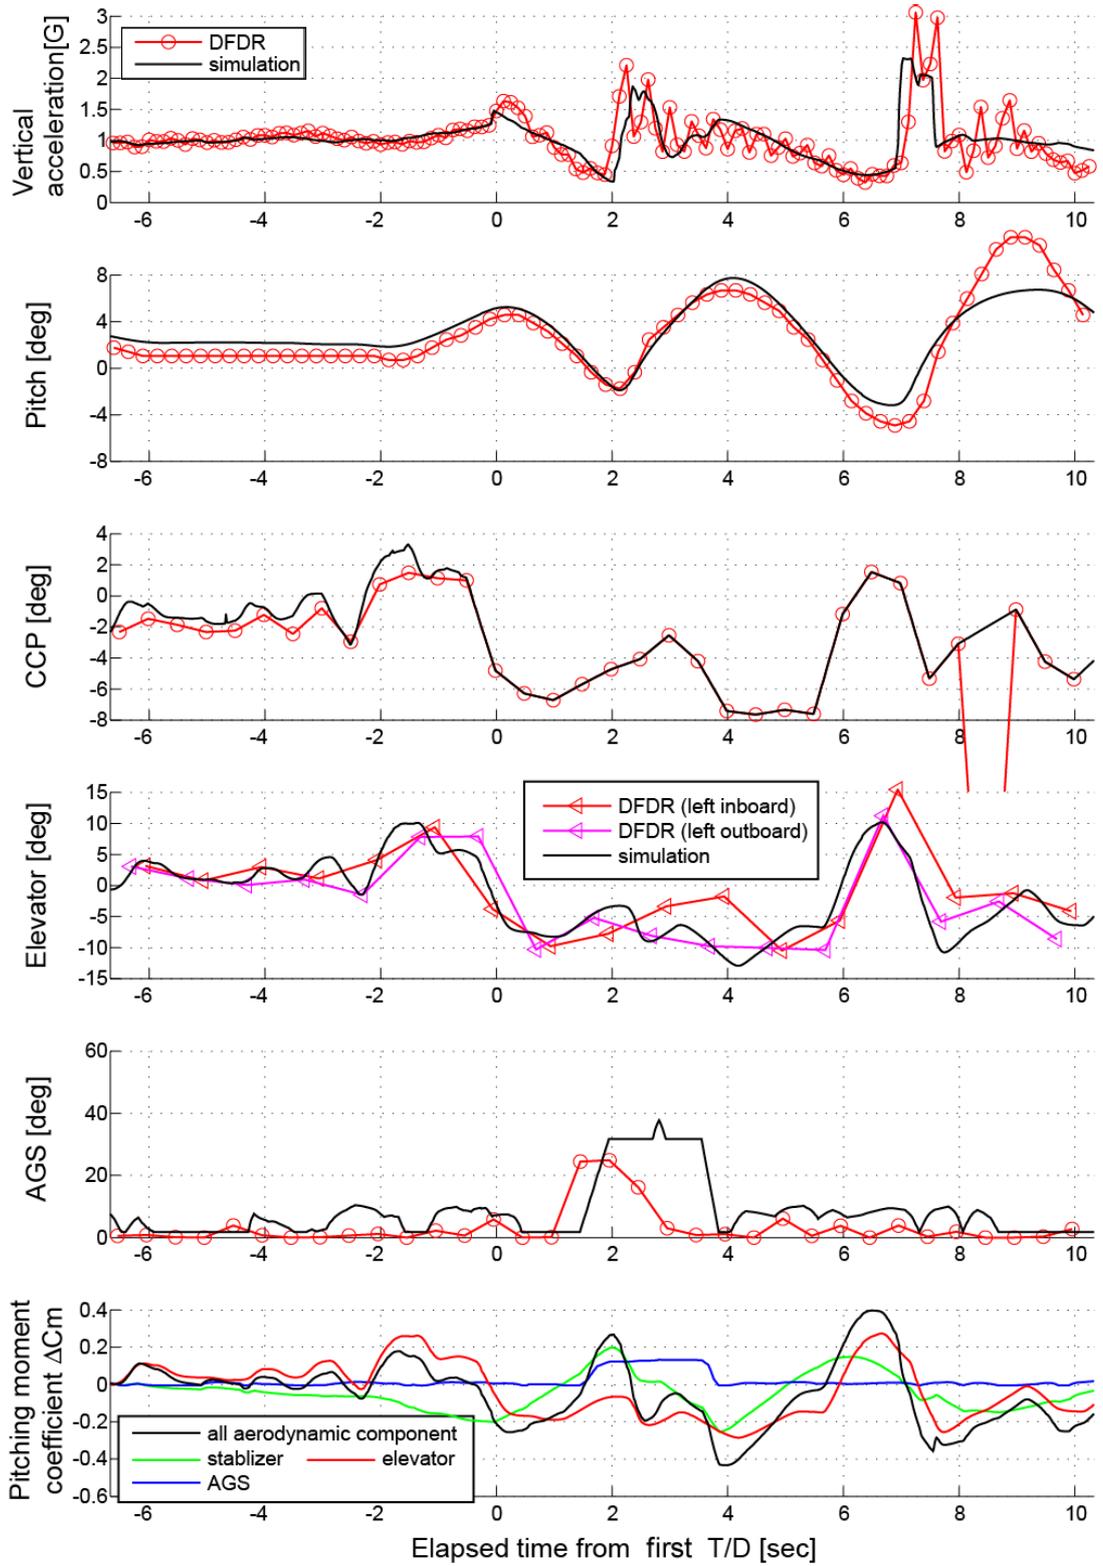
Figure 8 Factors Linked to Pitch Attitude Variation

The observed pitch attitude variations were large in this accident. Therefore, contributing factors to the pitching moment were examined by using a flight simulation program made by the airplane manufacturer. The examination revealed the following: (Figure 8)

- c. Ground spoiler deployment generates nose-up pitching moment.

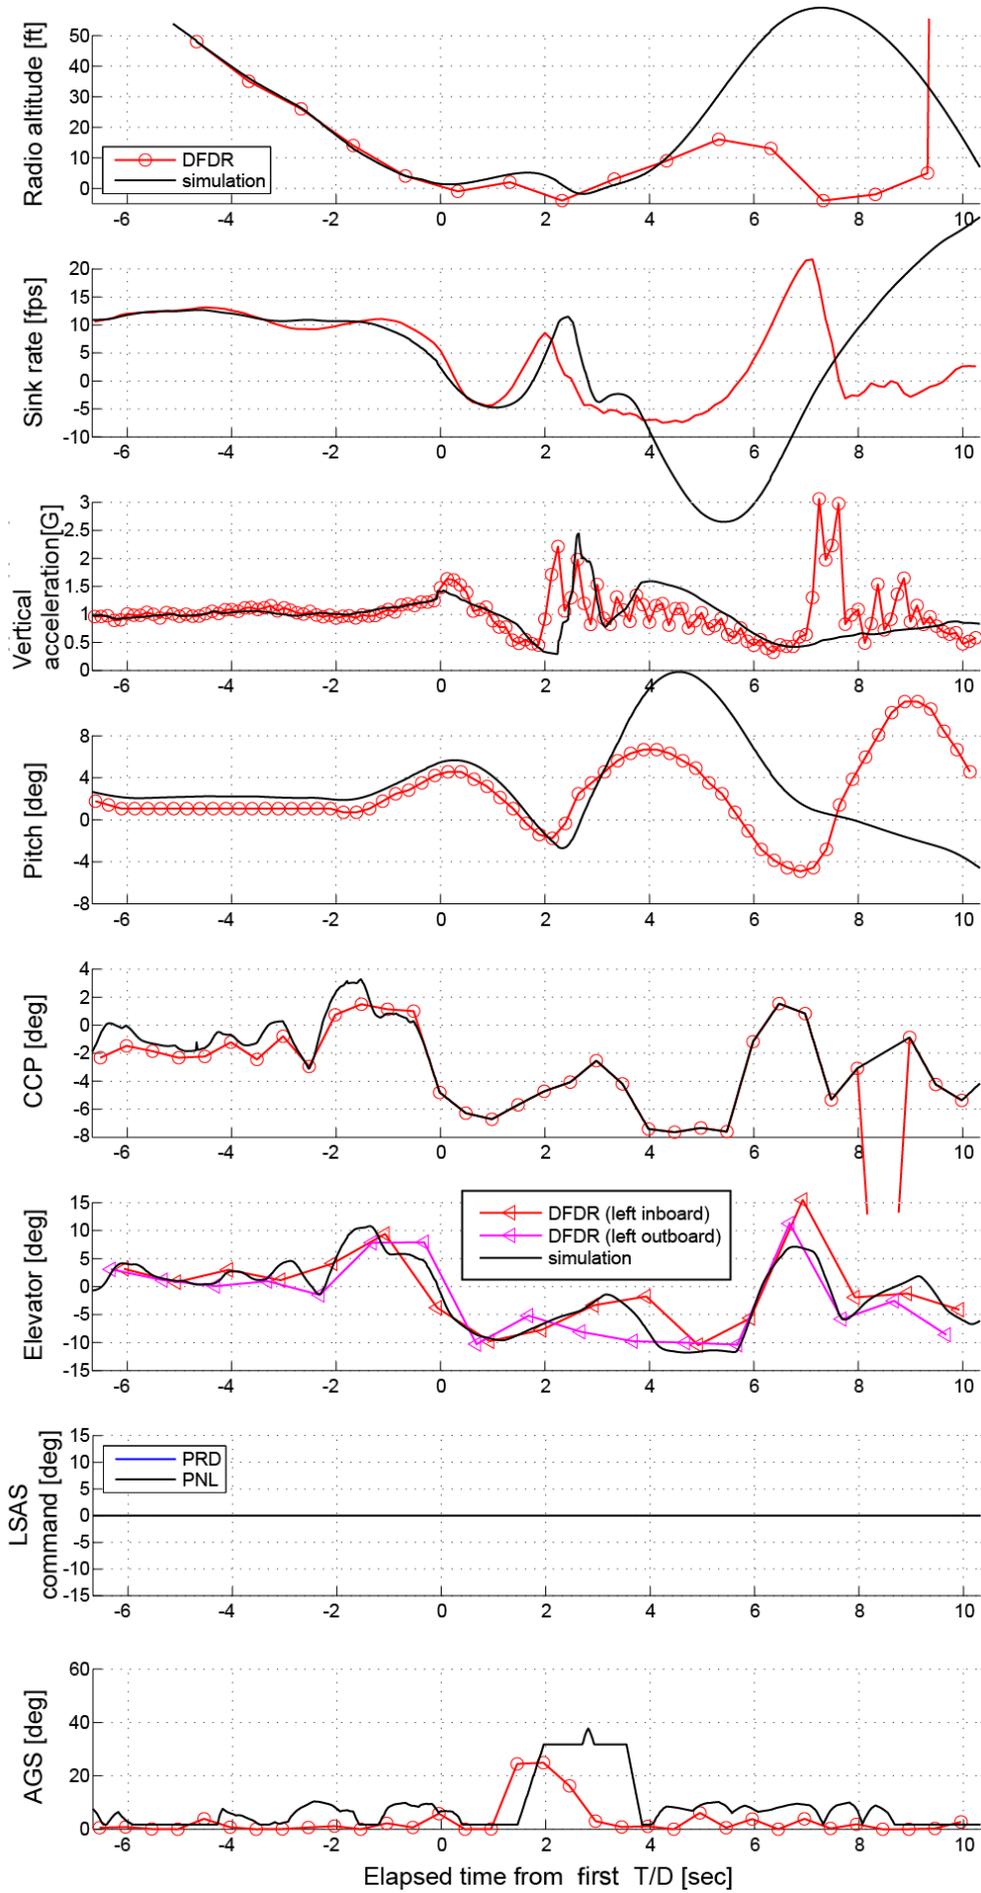
Figure 9 Simulation with LSAS Off

- b. In a simulation with LSAS off, the pitch attitude and the bounce after the second touchdown were larger, when compared to this accident. The sink rate at the third touchdown was also larger than 21.5 fps recorded in this accident.
- c. It is highly probable that LSAS had eventually worked in pursuit of curbing the pitch attitude variations.

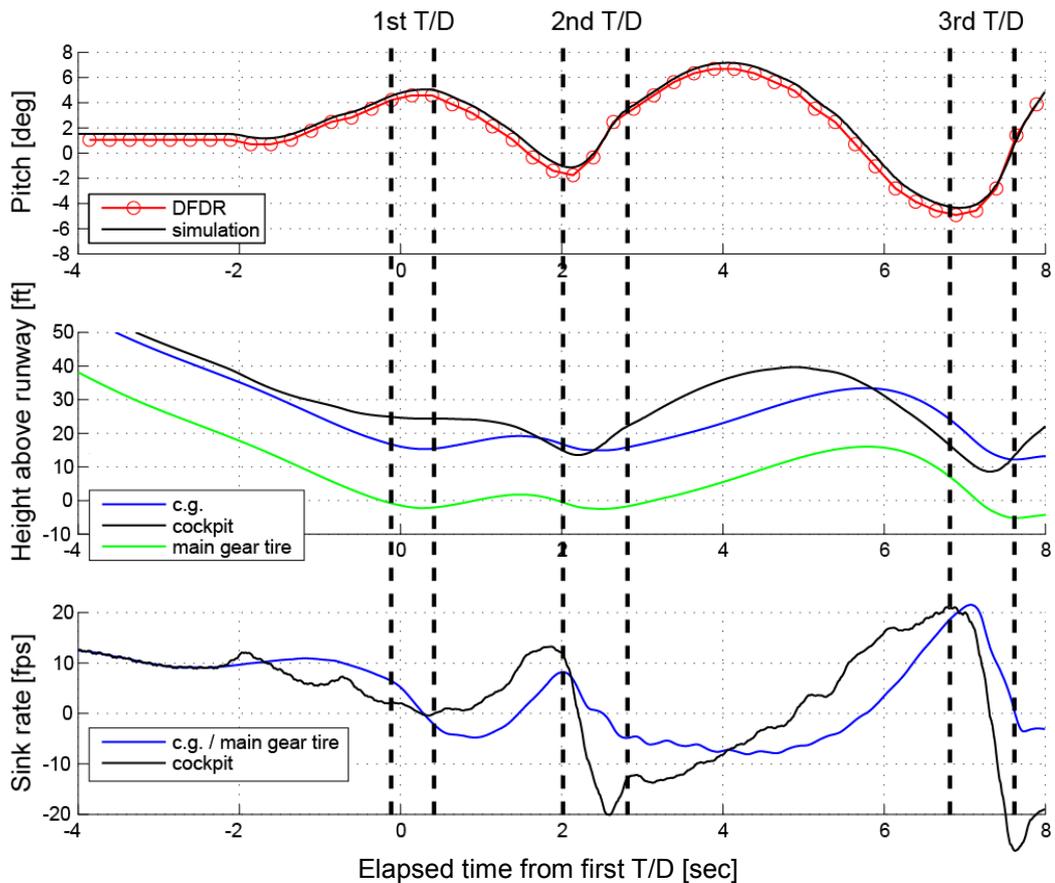
Figure 11 Analysis of Pilot's Eyes (Place) on Touchdown

The cockpit of MD-11 series airplane is far ahead (by 31 m) of the CG. Hence, when the pitch attitude variation is large, as was the case in this accident, it is possible that the cockpit height changes differently from that of the CG. Hence, the height of the CG, cockpit and MLG tires (height above runway) were examined with the flight simulation program made by the airplane manufacturer. As the compression of the landing gear strut is not taken into account, some MLG heights are shown below zero. (Figure 11)

- The pitch angle started to increase about 1.5 seconds before the first touchdown and this continued until the touchdown resulting in the smaller cockpit sink rate than that of the CG. When the airplane touched down, the cockpit sink rate was about 2 fps against the MLG tires' about 7 fps.
- At the time of the first bounce, the CG and MLG tires moved up about 4 ft. Meanwhile, the cockpit sank about 9 ft not going up, due to the pitch angle decrease.
- About 3 seconds after the second touchdown, the cockpit reached the highest point of about 40 ft. About 1 second later, the CG and the MLG tires reached the highest point of about 33 ft and 16 ft, respectively.

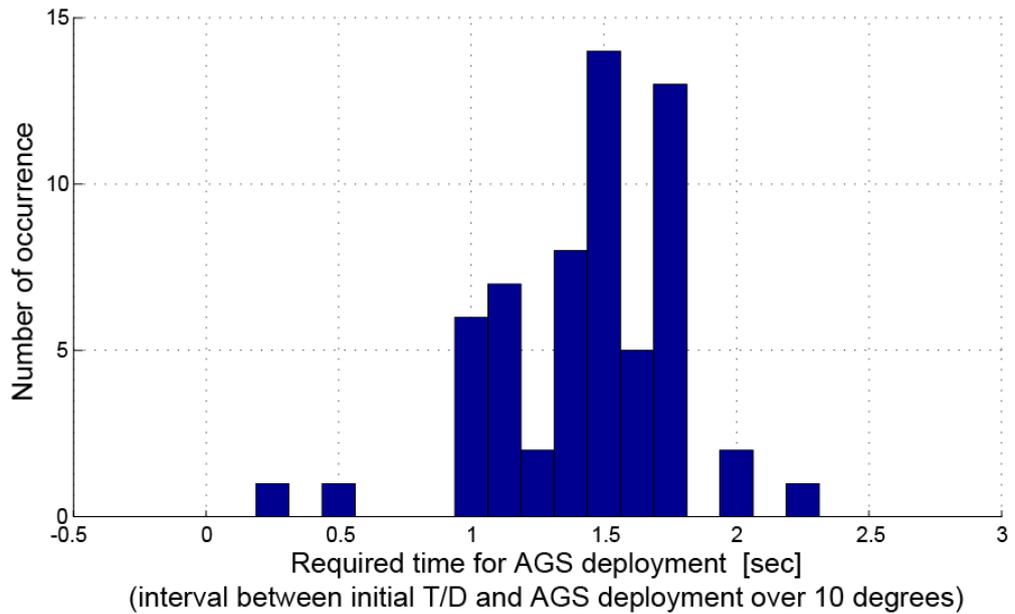
Figure 12 Observed Required Time for AGS Deployment in the Previous 60 Landings

- (2) The required time to start the AGS deployment (the time from the increase in the vertical acceleration following the first touchdown to the extension of the AGS by 10° or more) was examined for the landing in this accident and in the previous 60 landings. (Figure 12)

The designer/manufacturer's manual states that the AGSs deploy up to 30° upon the MLG touchdown by sensing the MLG wheels spin-up, and continue to deploy to 60° maximum upon the NLG touchdown by sensing the compression of the NLG strut. The DFDR records show that the AGS angle in this accident was about 25° maximum.

Required time for AGS deployment = 1.4 sec (averaged for 60 previous landings)

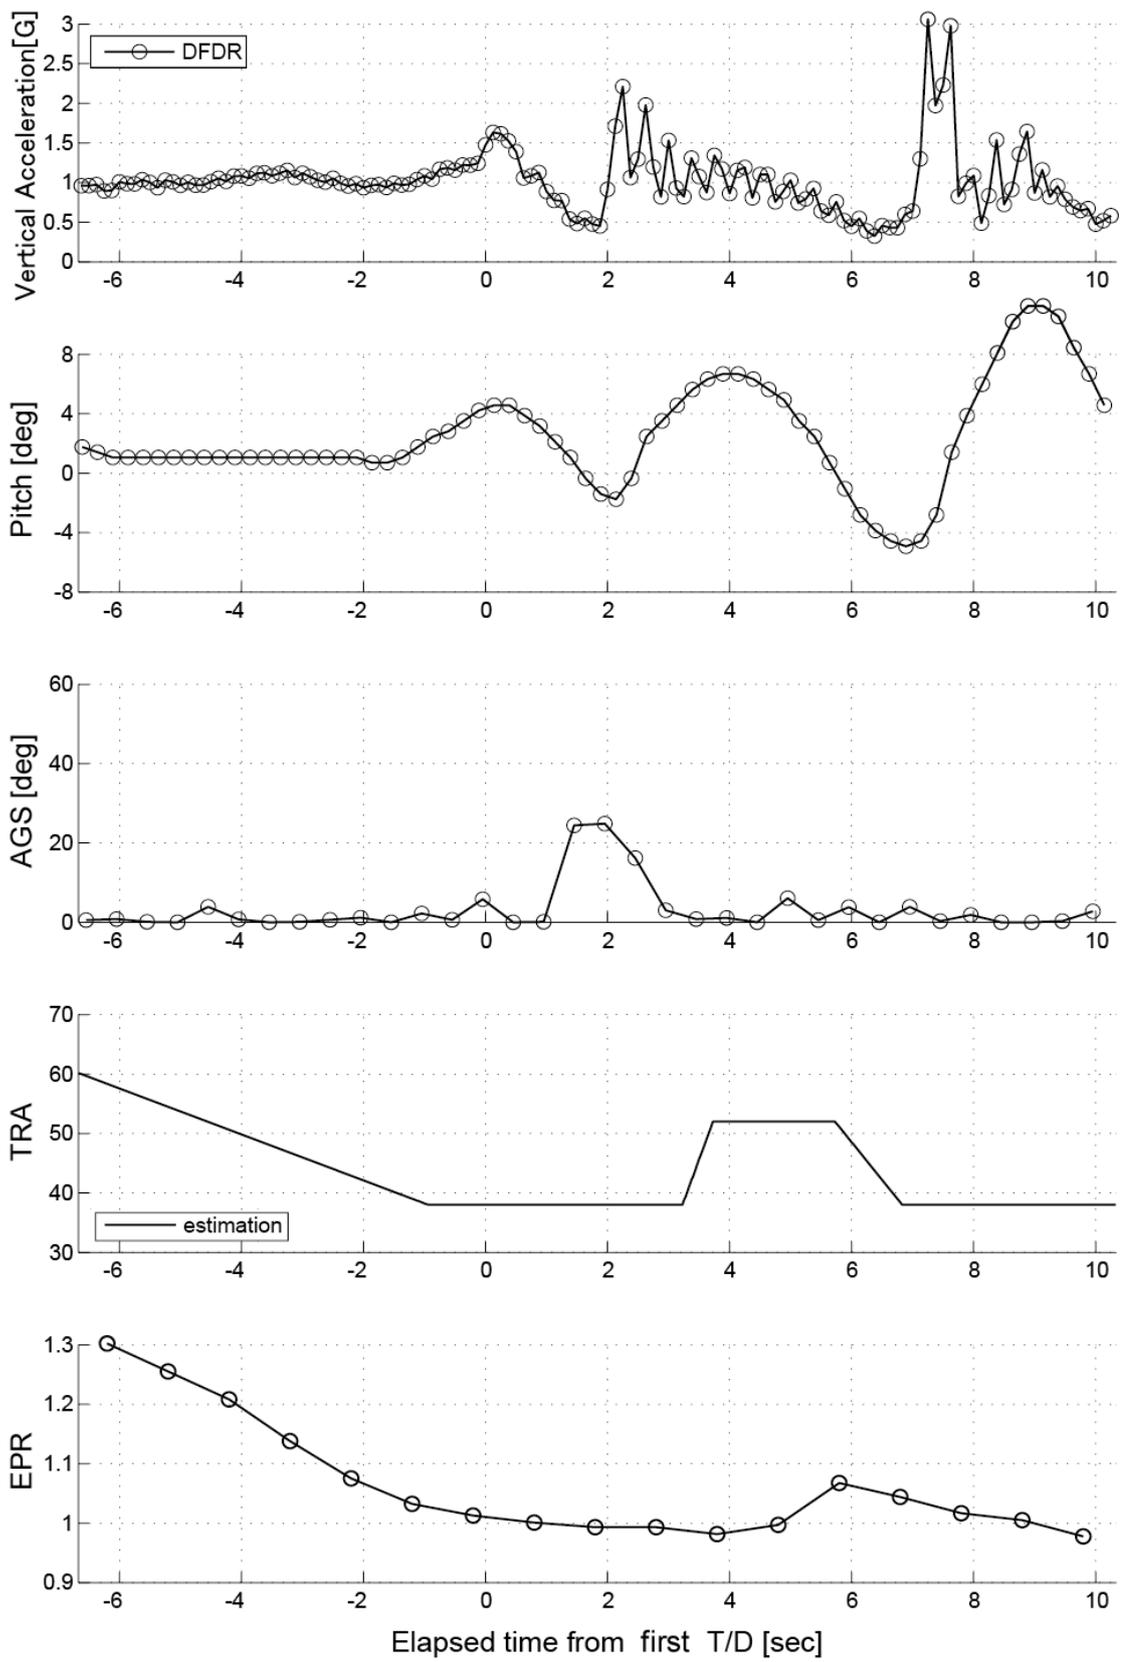
Figure 13 AGS Retraction

According to the airplane manufacturer's manual, advancement of the No. 2 (central) engine thrust lever triggers the retraction of the deployed AGS. Because the DFDR does not record thrust resolver angle (TRA), we used the calculated TRA using the engine manufacturer's conversion program to know the relation between the thrust lever operations and AGS retraction. The examination revealed the following: (Figure 13)

- (1) The DFDR records show that the AGS was retracted between 2.0 and 3.0 seconds after the first touchdown. Note that this value may have errors due to the data recording intervals which are 0.5 seconds for AGS and 0.125 seconds for the vertical acceleration.
- (2) According to the TRA estimation, the No. 2 engine thrust lever was advanced about 3.2 seconds after the first touchdown.
- (3) Above mentioned findings suggest that the AGS was retracted almost at the same time when the No.2 engine thrust lever was advanced.

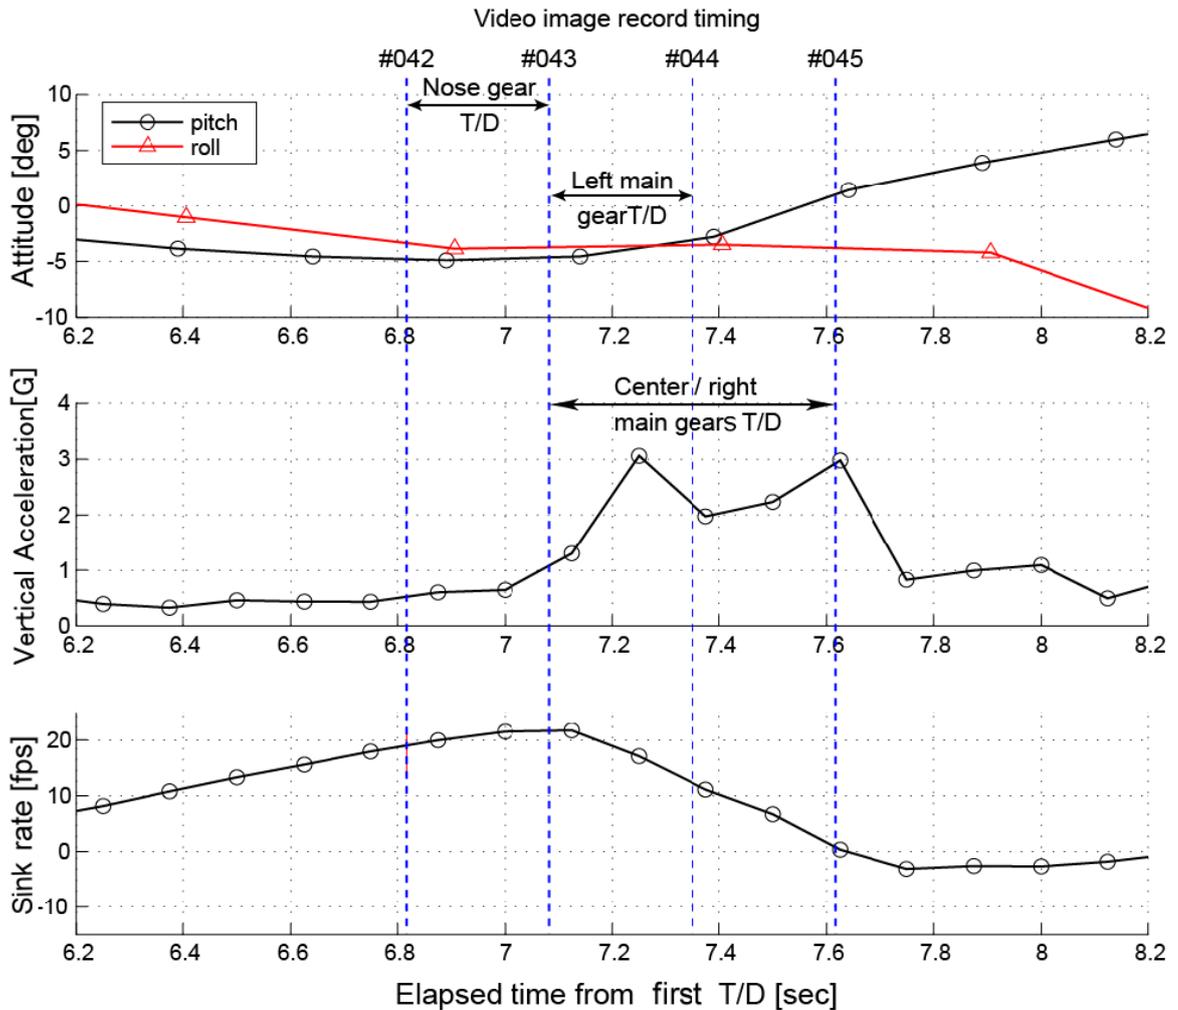
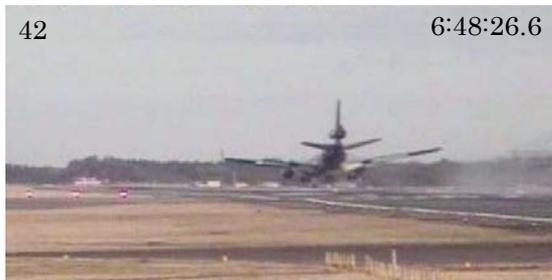
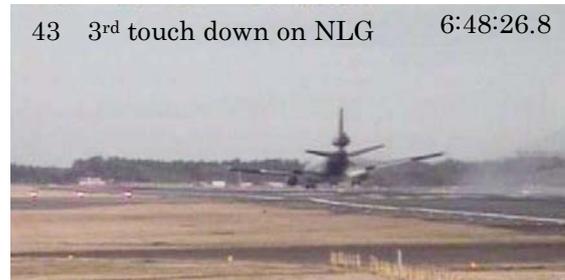
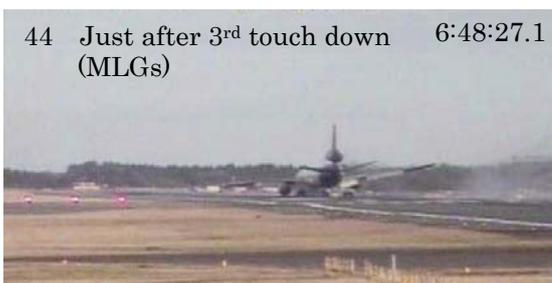
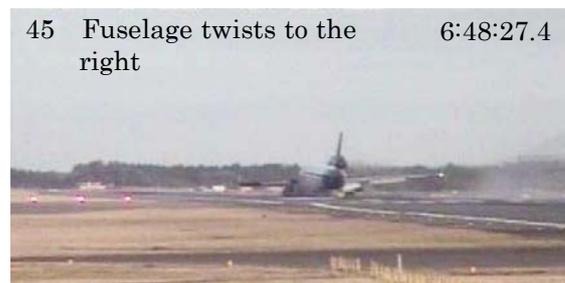
Figure 14 Estimation of Third Touchdown Status

These Images and DFDR records are synchronized to be shown in Figure 14. The synchronization was made by comparing calculated sink rate from the image analysis with that from the DFDR records.

The touchdown timing calculated from the Images corresponds to the attitude and acceleration data from the DFDR records; The following reasons made it impossible to get more detailed touchdown timing of each landing gear:

- a. The Camera Images interval was about 267 milliseconds,
- b. The number of pixels in each pictures was 672 by 224, and
- c. The recorded time in the Camera Images had not aligned to JST/UTC, so there were some time errors.

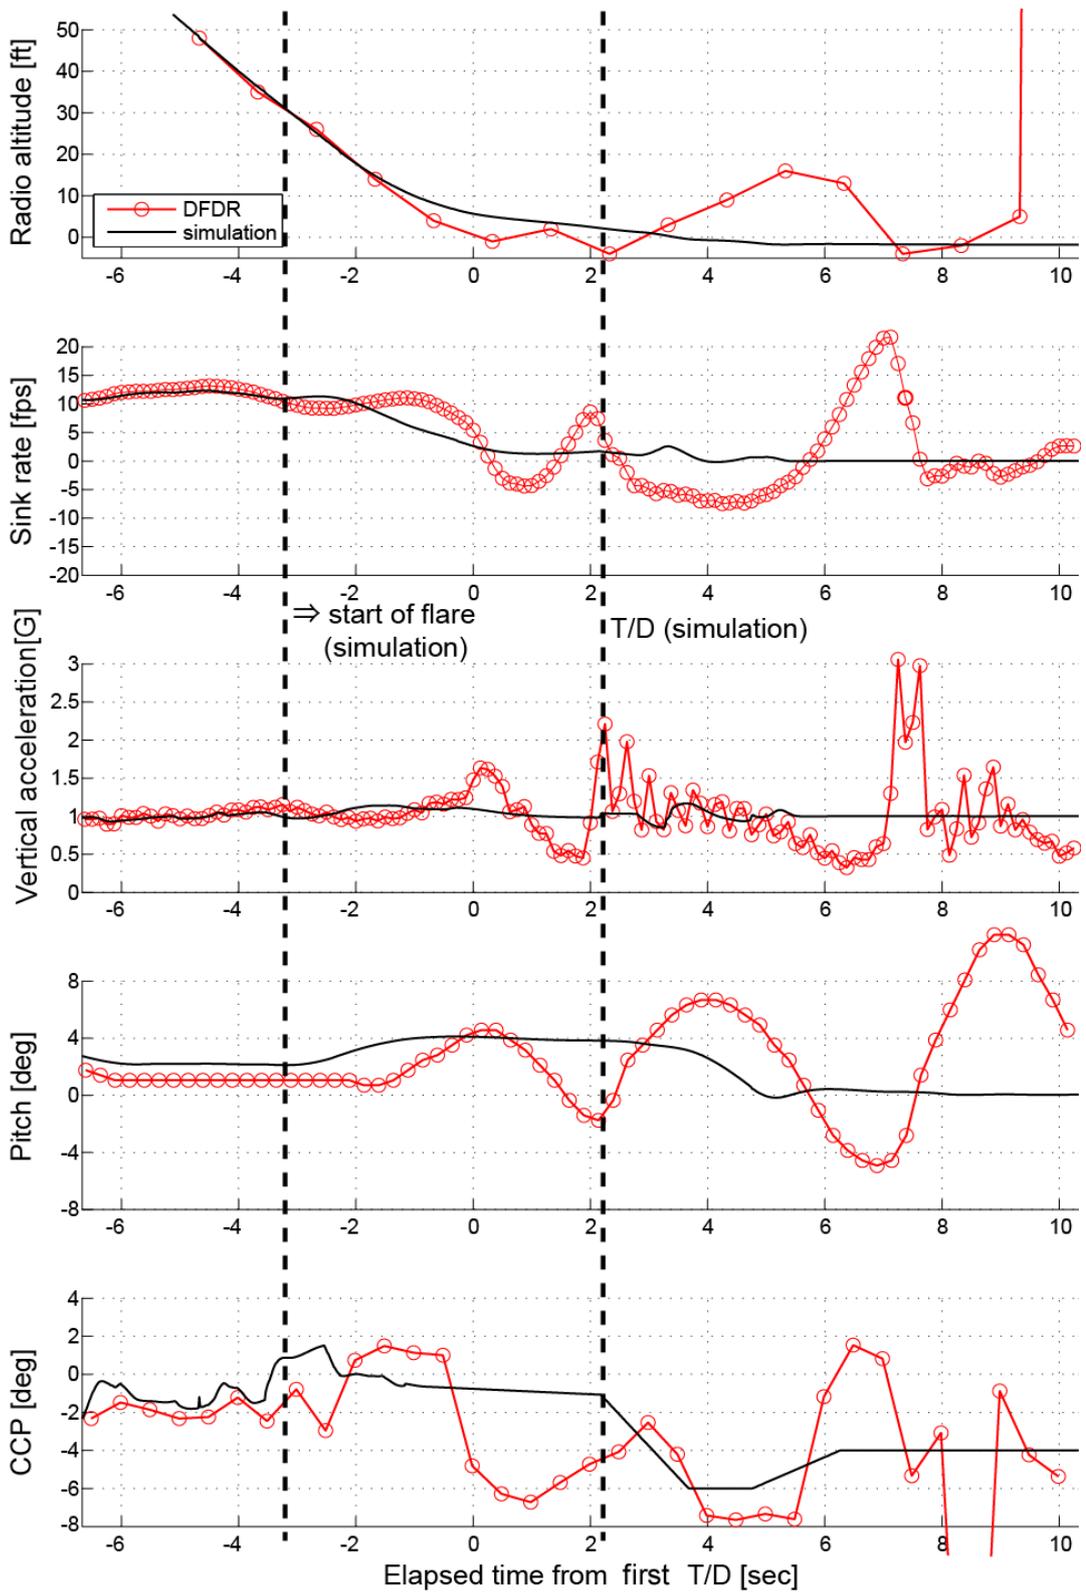
Figure 15 Simulation for a Case When the Flare is Started from 30 ft RA

The airplane behavior was examined for the case where the airplane approaches in the same manner as in this accident until 30 ft RA and starts flare at 30 ft RA. The examination revealed the following: (Figure 15)

- a. The DFDR records show that the sink rate did not decrease until around 10 ft RA and it remained still 7 fps when the airplane touched down. Meanwhile, in the case of flare start at 30 ft RA, the sink rate began to decrease around 20 ft RA and the sink rate decreased to 2 fps at the time of touchdown.
- b. When the flare started at 30 ft RA, the vertical acceleration on touchdown was about 1.1 G. The bounce height after the touchdown was limited, and the vertical acceleration on the second touchdown after the bounce was about 1.2 G. This means if the flare had started in an appropriate manner at 30 ft RA, large bounces after the touchdown, such as seen in the first and second touchdowns which triggered this accident, would have not occurred.

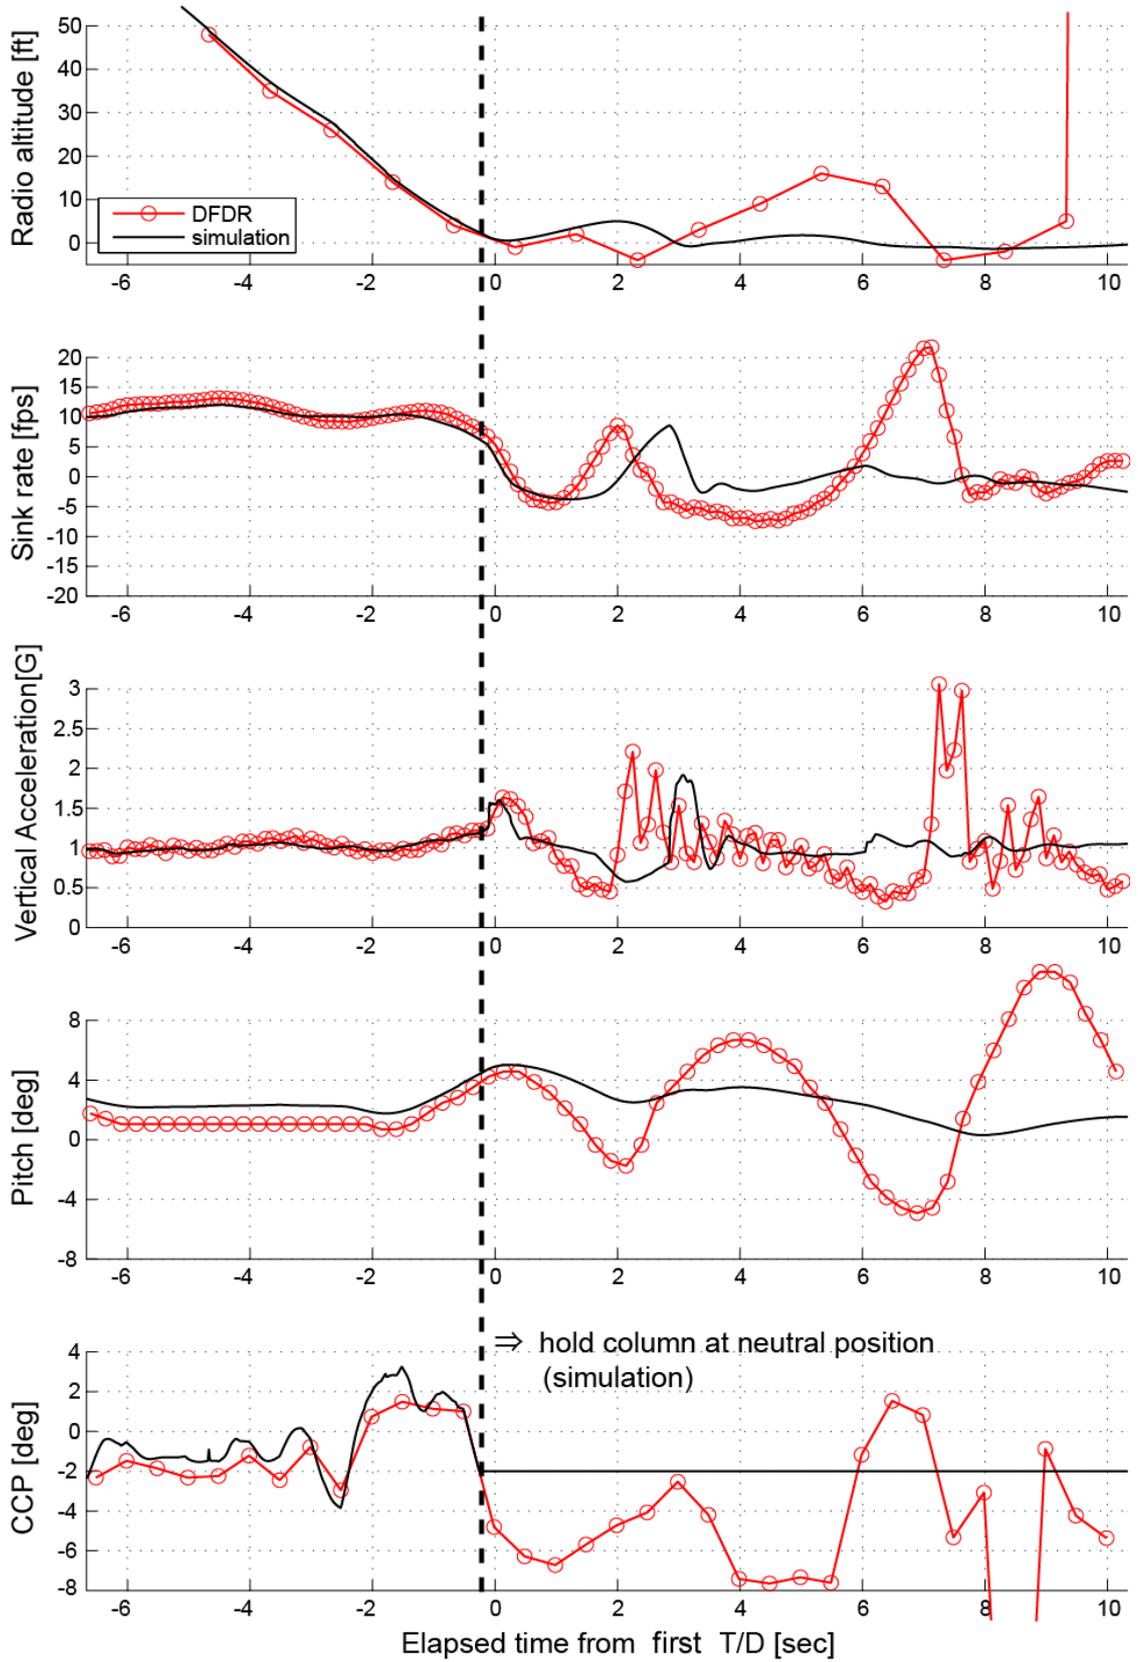
Figure 16 Simulation for a Case Where a Nose-Down Column Input Held at the Neutral Position Just Before First Touchdown

As described in 2.14.4, the elevators deflections corresponding to the control column input, have the largest influence on the pitch attitude variations just before and after the first touchdown and the nose-down motions during the two bounces. The airplane behavior was examined in the case where the nose-down control column input just before the first touchdown is limited to the neutral position (-2°) and held it thereafter. The examination revealed the following: (Figure 16)

- a. The maximum pitch angle after the first touchdown was 5.0° and there was no significant difference from that of 4.6° recorded in this accident.
- b. Although the first bounce was larger than that of the accident, the second bounce was quite small. No large pitch attitude variations occurred, either.
- c. The airplane landed on the MLG first at the second touchdown with almost the same sink rate of the second touchdown as that of the accident.
- d. The maximum vertical acceleration (1.9 G) was observed upon the second touchdown, but it was far less than the airplane tolerance limit which leads to a destruction.

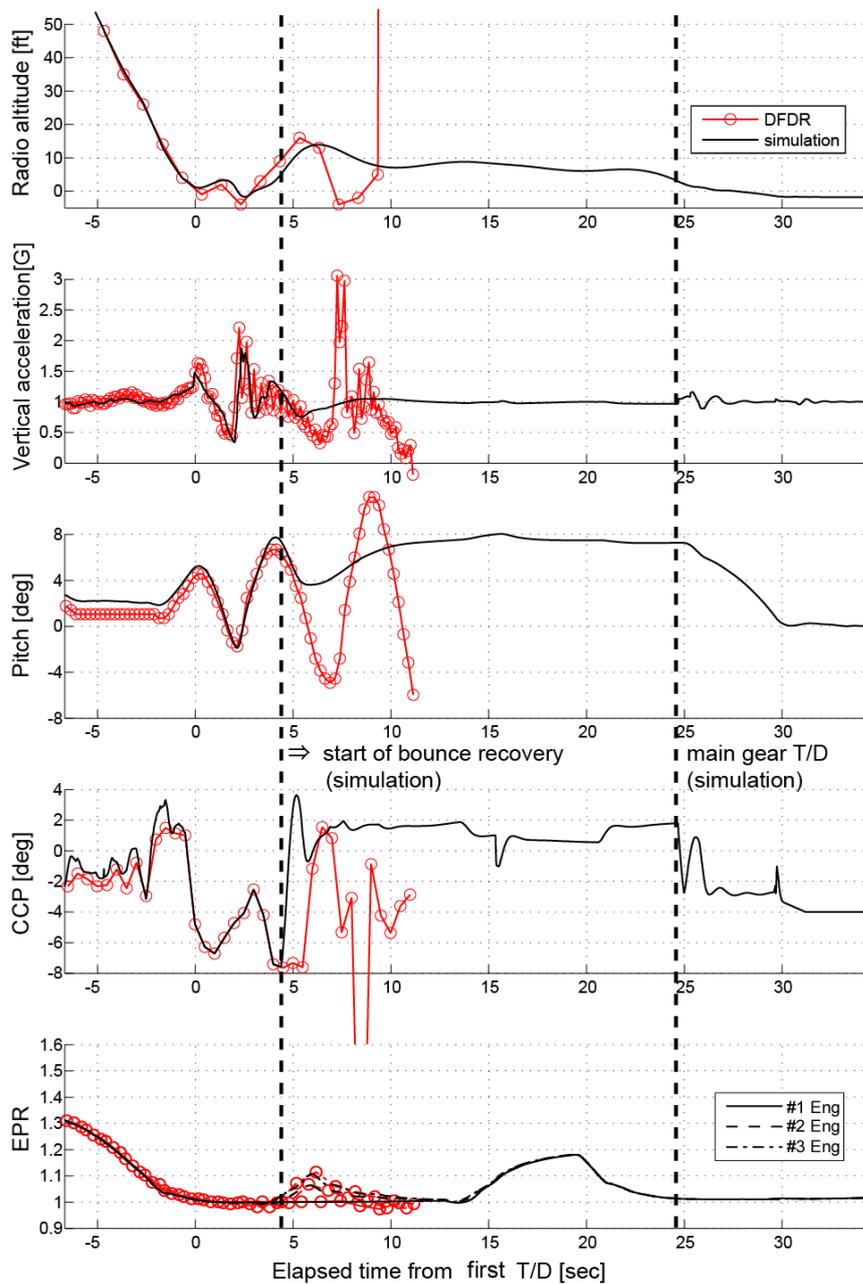
Figure 17 Simulation for a Bounce Recovery Operation during the Second Bounce

The airplane behavior was examined in the case where a bounce recovery is initiated at 5 ft RA during the second bounce. The results are as follows: (Figure 17)

- The pitch angle had already begun to decrease at the time of the recovery initiation, but even at this stage the subsequent rapid nose-down motion could have been avoided by applying large backward column input, and negative pitch attitude could have been avoided.
- Sink rate control by maintaining pitch angle 7.5° together with added thrust made it possible to limit the vertical acceleration on the third touchdown to less than 1.2 G.

However, the timing of the third touchdown is prolonged until 22 seconds after the second touchdown by this bounce recovery. Considering that appropriate attitude and power control are necessary during that recovery operation and also additional runway length is required, the bounce recovery may not be practical.
