AIRCRAFT ACCIDENT INVESTIGATION REPORT

FEDERAL EXPRESS CORPORATION

N 5 2 6 F E

**CRASH DURING LANDING
FEDERAL EXPRESS CORPORATION
MCDONNELL DOUGLAS MD-11F, N526FE
NARITA INTERNATIONAL AIRPORT
MARCH 23, 2009**

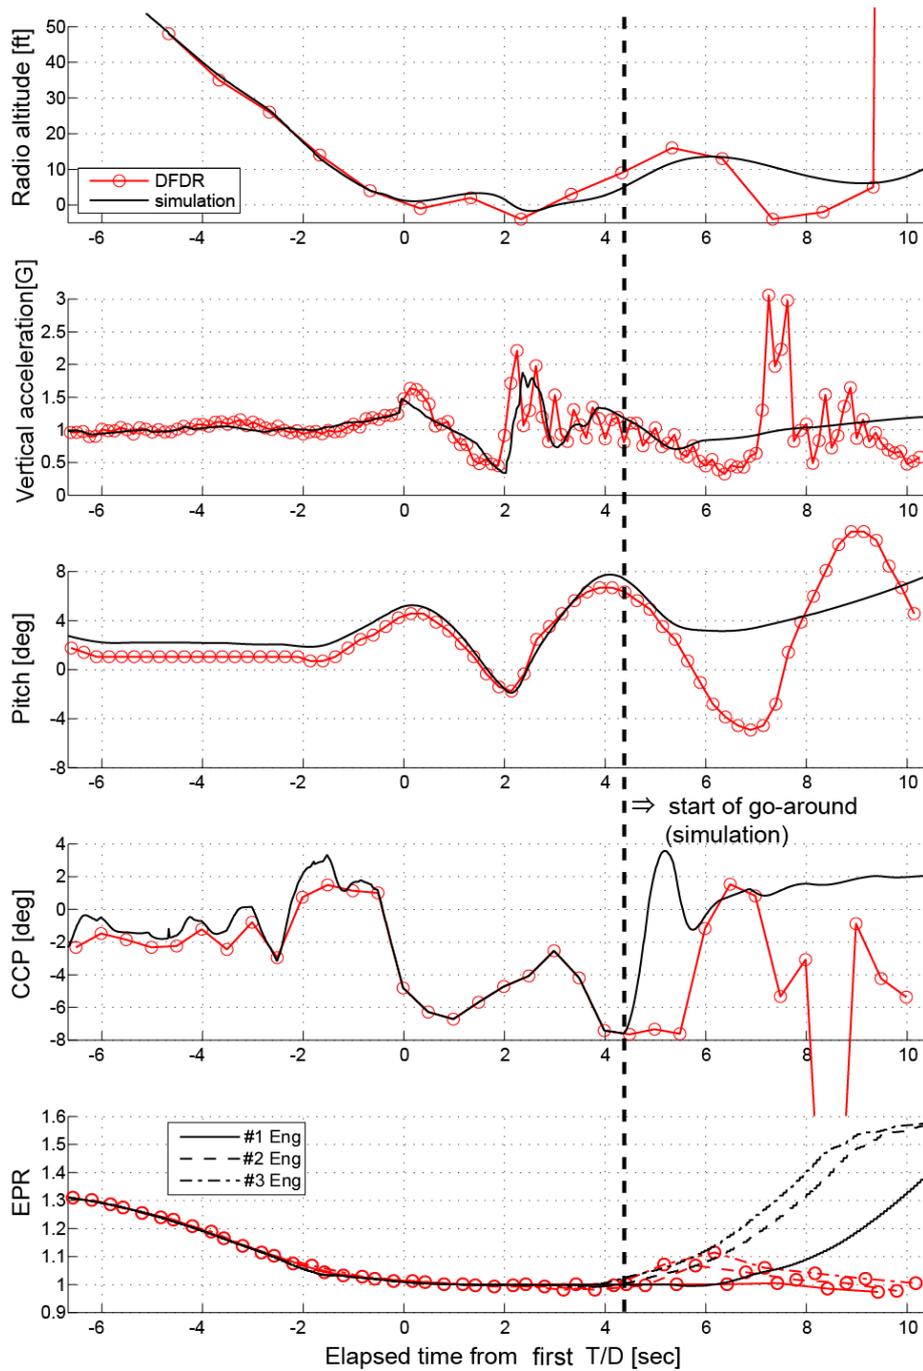
Figure 18 Simulation for Go-around during the Second Bounce

The airplane behavior was examined in the case where a go-around is initiated at 5 ft RA during the second bounce. The results are as follows: (Figure 18)

- a. The pitch angle had already begun to decrease at the time of the go-around initiation, but even at this stage the subsequent rapid nose-down motion could have been avoided with large backward column inputs, and negative pitch attitude could have been avoided.
- b. A go-around was possible before the third touchdown by increasing the thrust simultaneously with a nose-up control column inputs mentioned above.

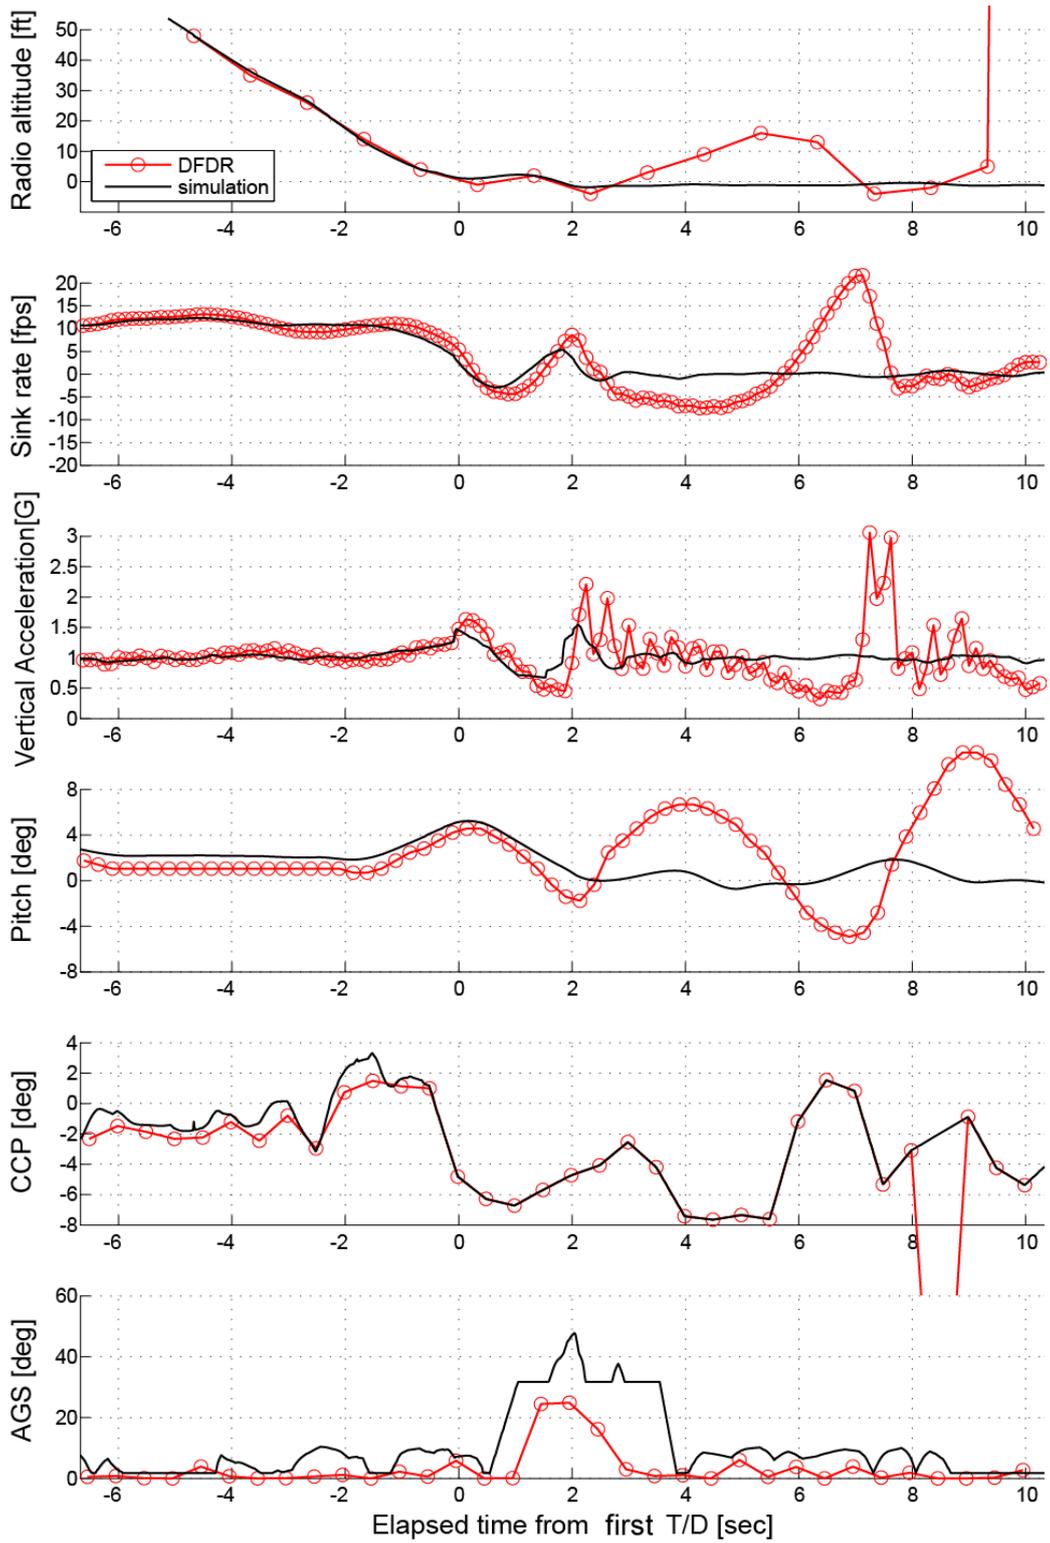
Figure 19 Simulation for a Case with Reduced Required Time for AGS Deployment

We examined the airplane behavior in the case where the required time for AGS deployment is 0.61 seconds—almost the half of that observed in the accident. The results are as follows: (Figure 19)

- b. As the nose-down motion during the first bounce was restrained, the pitch angle upon second touchdown was positive—2.0°, and the airplane touched down on the MLGs. The loss of lift during the first bounce was also restrained since nose-down restraint brought a higher angle of attack. This resulted in a smaller sink rate at the touchdown—6 fps, smaller than 9 fps recorded in this accident.

- c. Because the second touchdown was made on the MLGs, the NLG did not receive a bounce back from the runway surface resulting in very small nose-up moment after the second touchdown. On the other hand, the sink rate was smaller than that of the accident, so was the vertical acceleration on the second touchdown—1.5 G, smaller than that of the accident. These factors prevented any bounce from happening after the second touchdown.

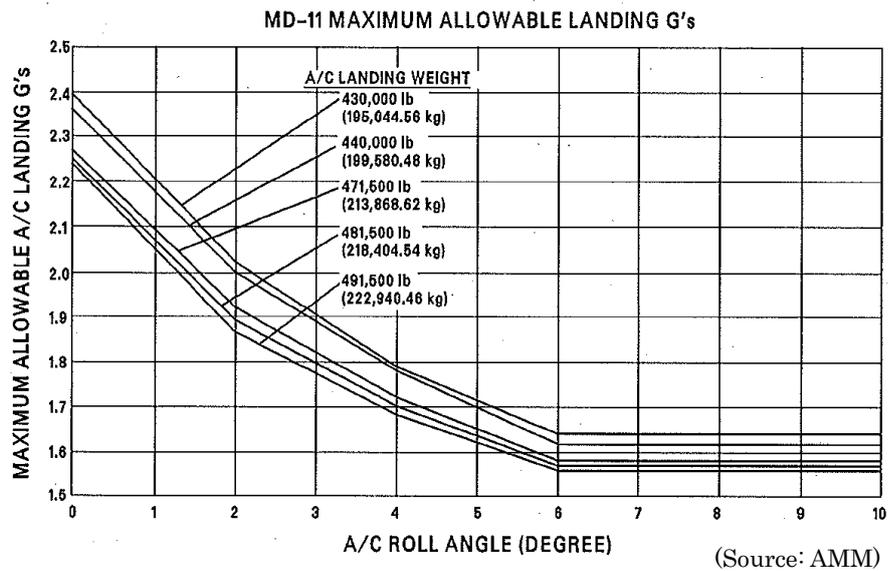
Figure 20 Landing G's vs Roll Angle

accelerations at the beginning of the touchdown, and the airplane roll and pitch attitude effects on the number of effective landing gears that absorb the landing energy. If the vertical acceleration at the beginning of the landing is less than 1G, the potential energy that is normally accommodated by wing lift may instead be transmitted into the landing gear.

- D. Operators should evaluate the effects of pitch and roll and determine if a singular landing gear may have absorbed significant loading. To determine if such loading has occurred, use the landing G's vs roll angle graph. If still undetermined, operator may submit landing parameter to their Boeing Field Service Representatives of Boeing Service Engineering for analysis.
